**DALTON LAKE DAM
STE. GENEVIEVE COUNTY, MISSOURI
MO 31038**

PHASE 1 INSPECTION REPORT NATIONAL DAM SAFETY PROGRAM

Name of Dam: Dalton Lake Dam
State Located: Missouri
County Located: Ste. Genevieve
Stream: Tributary Coldwater Creek
Date of Inspection: 9 August 1978

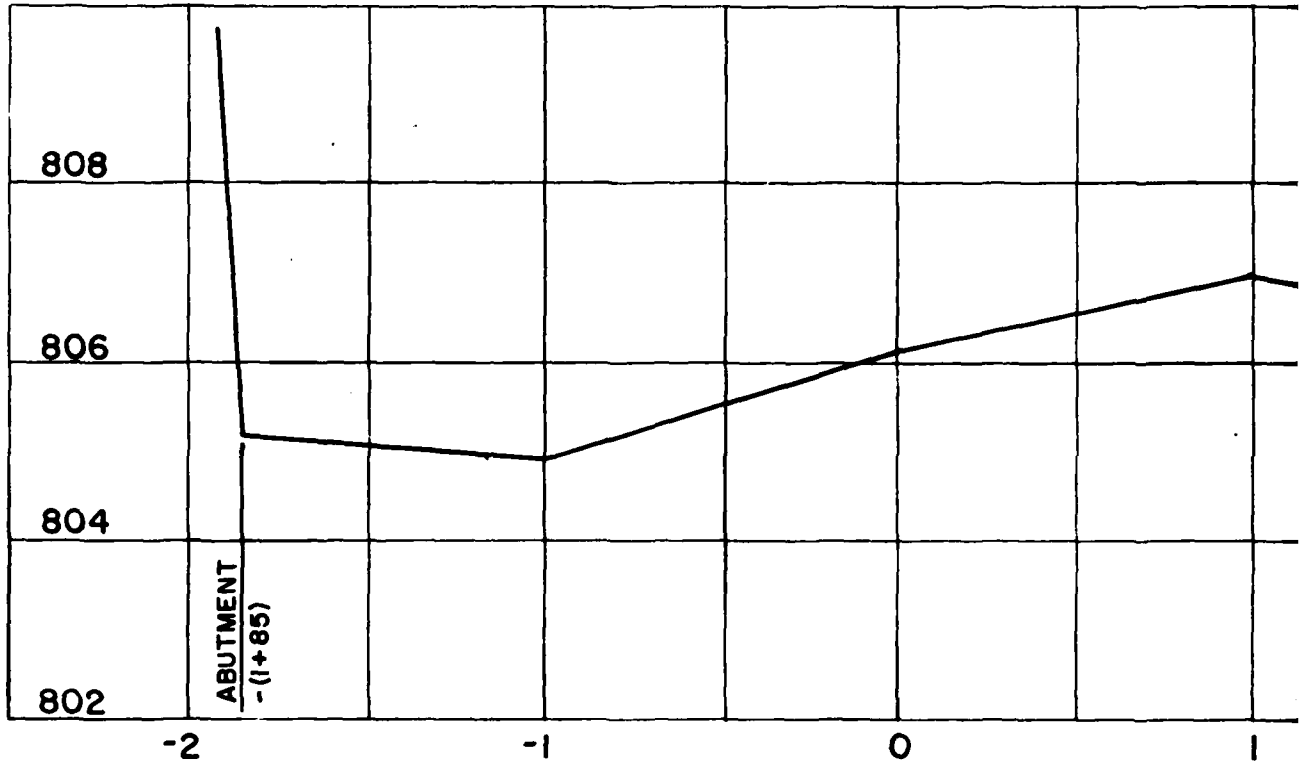
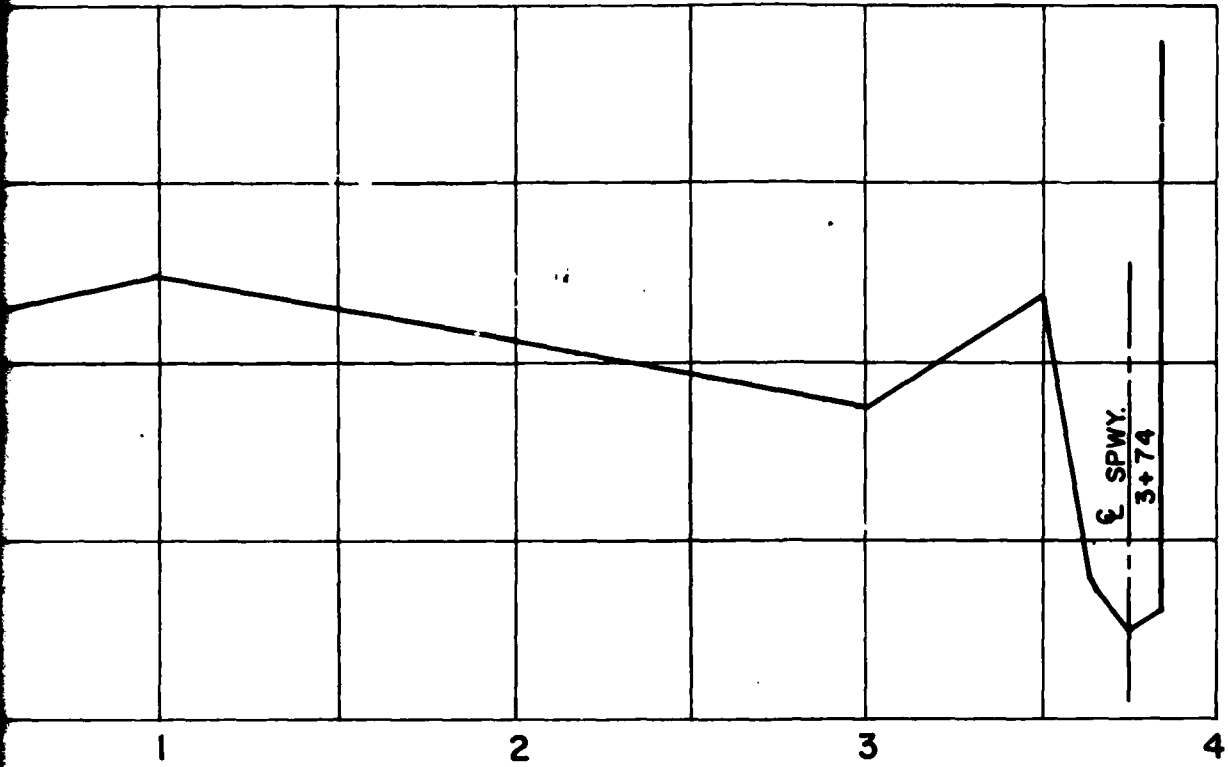
PLATE 2

The crest of the dam was found to be approximately 2 feet lower near the left abutment than in the area adjacent to the spillway. (The low point of the dam is approximately 2 feet higher than the spillway crest.) As a result, the capacity of the spillway to discharge lake outflow without overtopping the dam is reduced.

b. Dam. The visible portions of the upstream and downstream slopes (see Photos 1 and 2) of the dam appeared to be in satisfactory condition with the exception of some minor erosion of the downstream slope of the dam. Numerous small trees and brush exist on the upstream and downstream slopes. The elevation of the top of the dam was determined by survey to vary approximately 2 feet between the highest point near the center of the dam and the lowest point near the left abutment. The spillway, located at the right embankment, was determined by survey to be approximately 2 feet lower than the low point of the dam.

(2) It is recommended that the low area on the top of dam located near the left abutment be raised such that it will not limit the spillway capacity. Since it is possible that the low area is a result of settlement due to consolidation of the embankment and foundations soils, and since it is not known if all or nearly all of the settlement that is probable has taken place (the dam is about 4 years old), it is recommended that future settlement of the dam be monitored in order to determine overtopping potential and conditions affecting the operation of the spillway.
