**RUSTIC HILLS LAKE DAM
JEFFERSON COUNTY, MISSOURI
MO 30467**

**PHASE 1 INSPECTION REPORT
NATIONAL DAM SAFETY PROGRAM**

RUSTIC HILLS LAKE DAM
JEFFERSON COUNTY, MISSOURI
MISSOURI INVENTORY NO. 30467

Name of Dam: Rustic Hills Lake Dam
State Located: Missouri
County Located: Jefferson
Stream: Tributary La Barque Creek
Date of Inspection: 5 July 1978

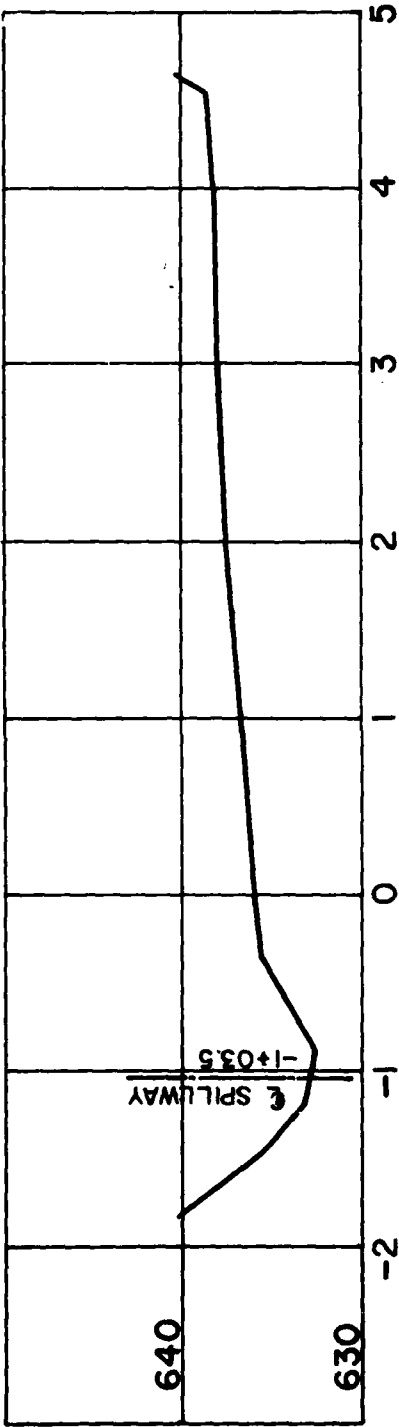
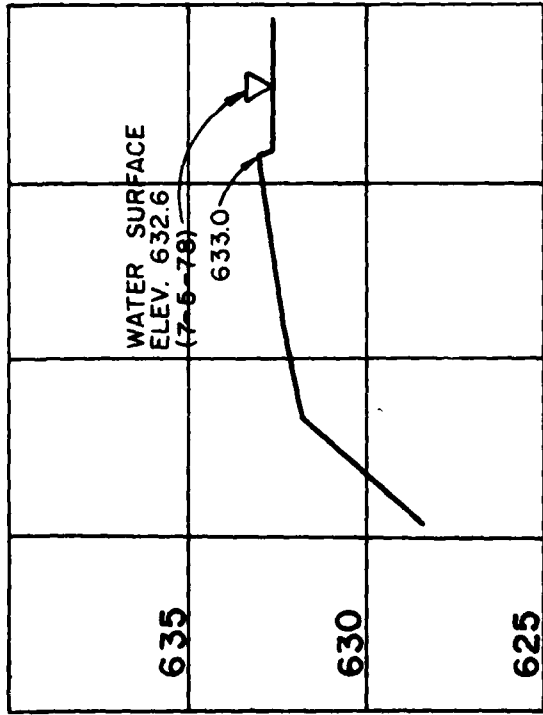
RUSTIC HILLS LAKE
 DAM & SPILLWAY PROFILES
 Horner & Shifrin, Inc. July 1978

PROFILE DAM CREST
 SCALES: $V=10V, H=100H$

PROFILE SPILLWAY
 SCALES $V=5V, H=50H$
