**LAKE FOREST DAM,  
STE. GENEVIEVE COUNTY, MISSOURI,  
MO 30087**

**PHASE I INSPECTION REPORT  
NATIONAL DAM SAFETY PROGRAM**

**PREPARED BY: U. S. ARMY ENGINEER DISTRICT, ST. LOUIS**

**DECEMBER 1978**

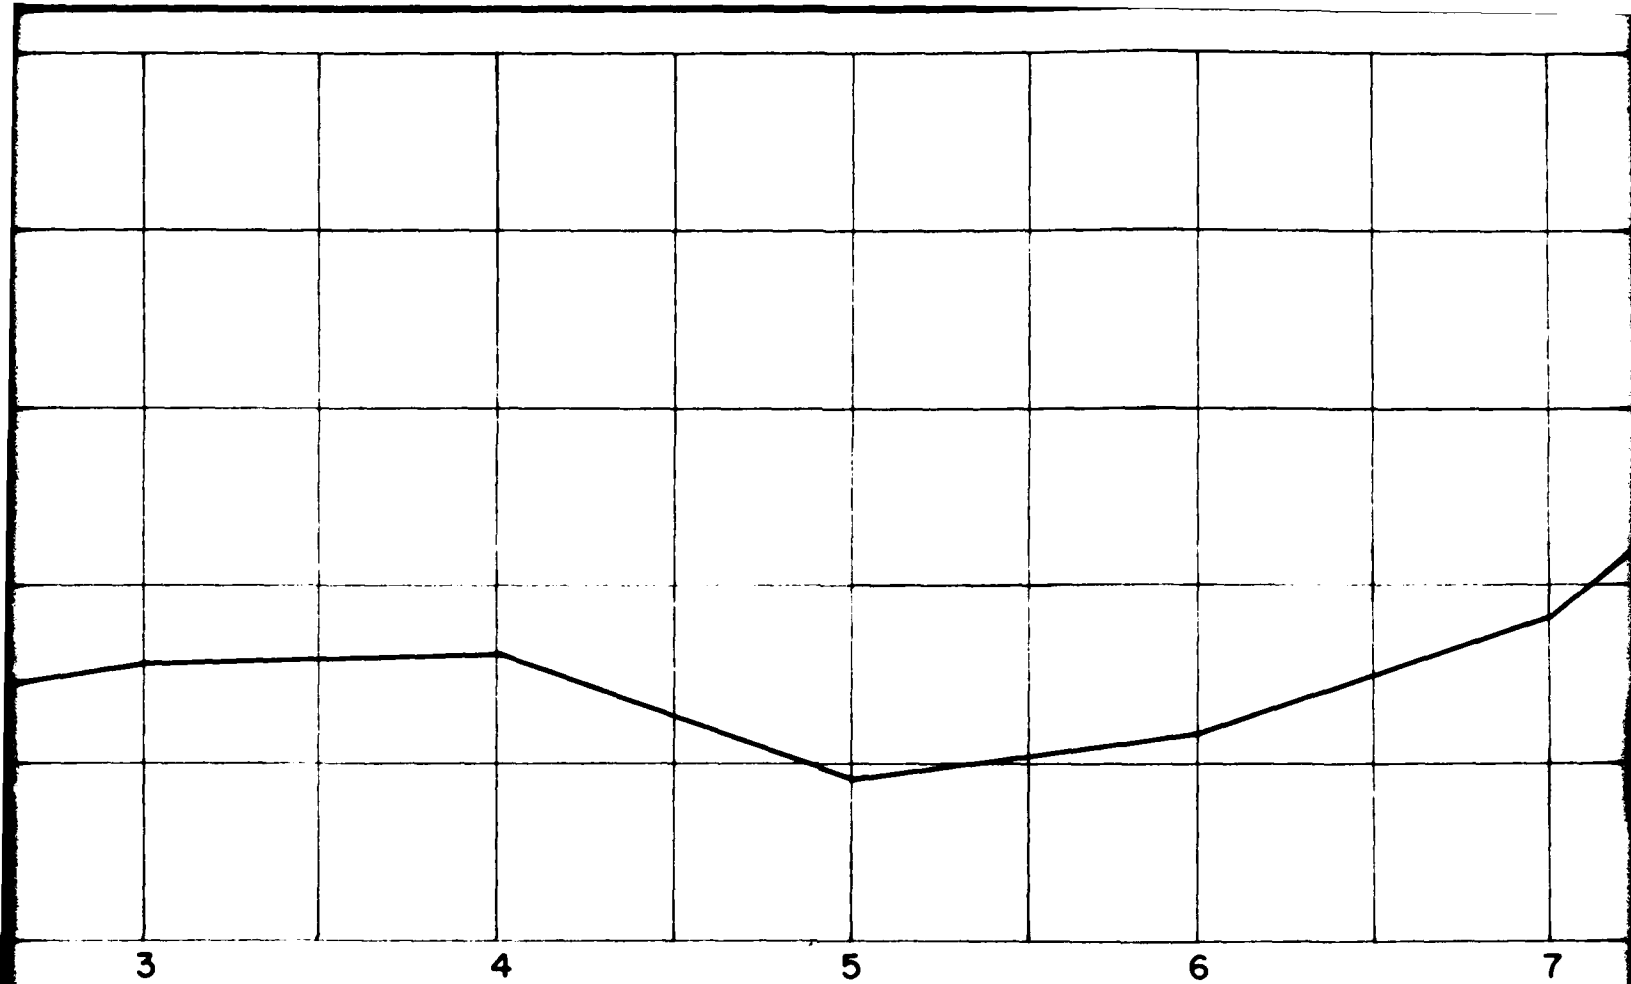
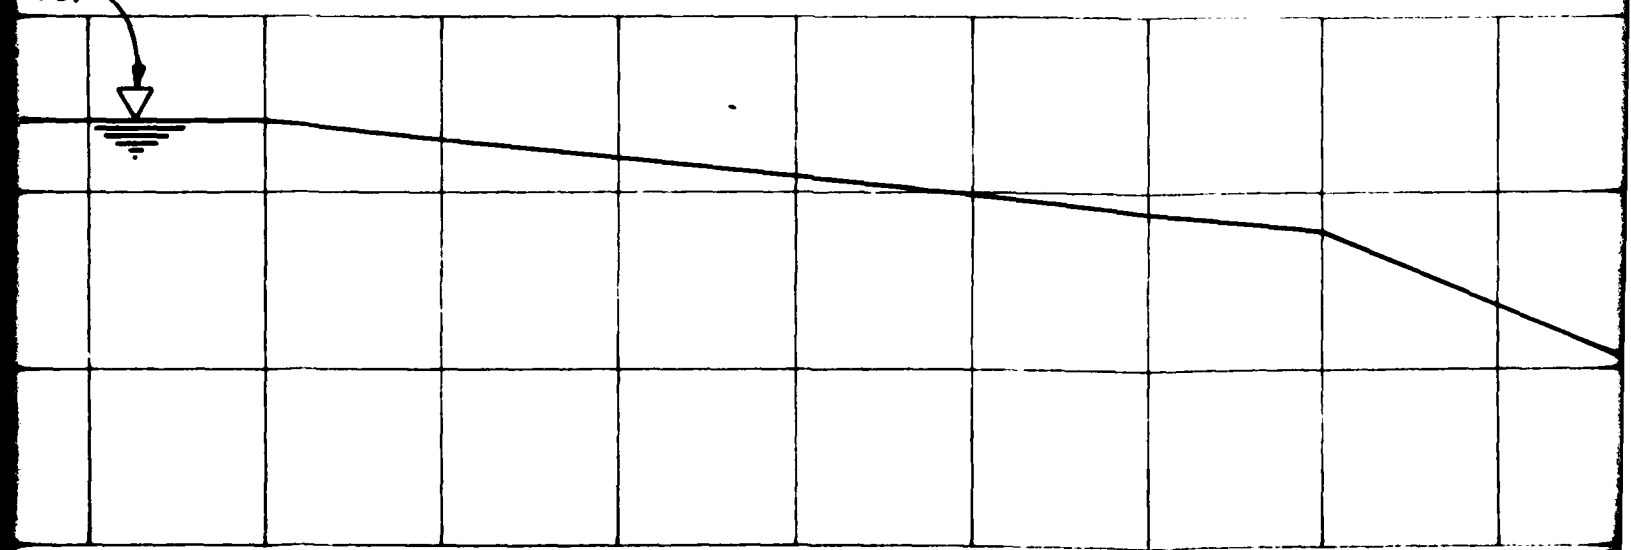
3  
 LAKE FOREST  
 DAM & SPILLWAY PROFILES  
 Horner & Shifrin, Inc. Oct. 1978

The crest of the dam was found to be approximately 5 feet lower at a point near the center of the dam than in the area adjacent to the spillway. (The low point of the dam is approximately 9 feet higher than the spillway crest.) As a result, the capacity of the spillway to discharge lake outflow without overtopping the dam is reduced. According to the criteria set forth in the recommended guidelines (see text) the minimum spillway design flood for this dam, which is classified as intermediate in size and of high hazard potential, is specified to be the Probable Maximum Flood (PMF). PMF is the flood that may be expected from the most severe combination of critical meteorologic and hydrologic conditions that are reasonably possible in the region. Results of a hydrologic/hydraulic analysis indicated that the existing spillway is inadequate to pass the lake outflow resulting from a storm of PMF magnitude. It is capable of passing the lake outflow resulting from the 1 percent chance (100-year frequency) flood. The spillway is capable of passing lake outflow corresponding to approximately 22 percent of the PMF without overtopping the dam. The length of the downstream damage zone, should failure of the dam occur, is estimated to be ten miles. There are at least two houses and one bridge crossing within the first two miles downstream of the dam.

(1) Based upon criteria set forth in the recommended guidelines, alterations should be made to the design of the dam in order to pass lake outflow resulting from a storm of at least probable maximum flood magnitude.

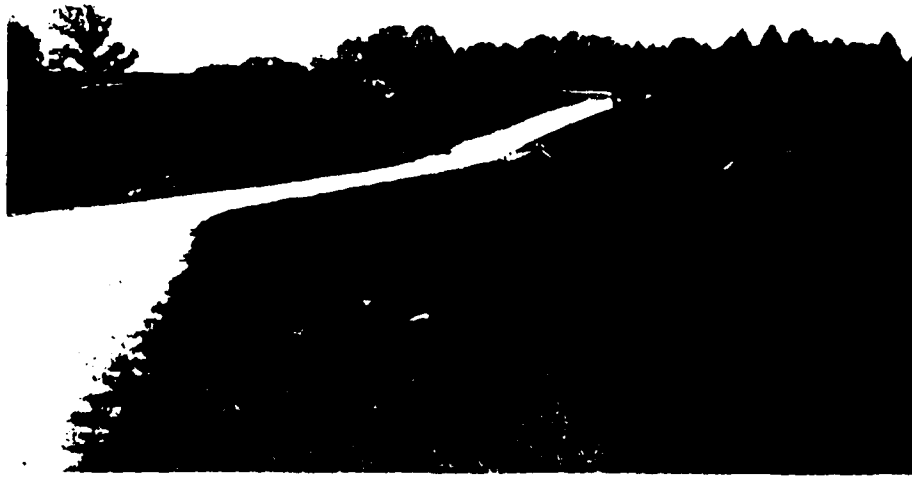
NO. 5: DAM CREST AND SPILLWAY BRIDGE

A gravel road traverses the dam crest and a concrete bridge has been installed over the spillway (see Photos 5 and 7). The elevation of the top of the dam, as determined by survey, was found to be approximately 5 feet lower at a location near the center of the dam than in the area adjacent to the spillway. A concrete boat launching ramp is located on the upstream slope near the spillway. The concrete bridge and ramp are in good condition.

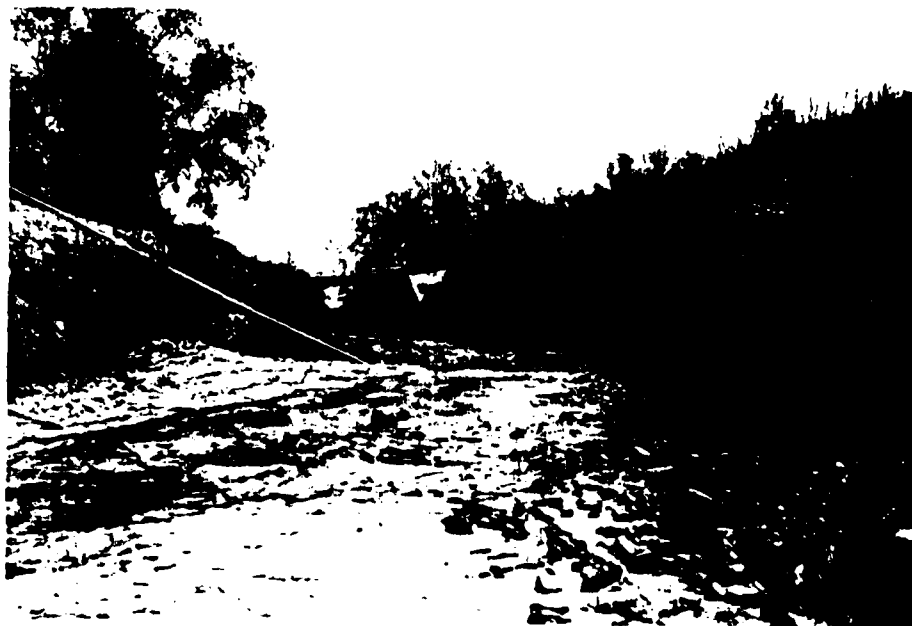
NO. 6: SPILLWAY CHANNEL

c. Spillway. The spillway is cut into rock (see Photo 6) at the left abutment. The control elevation of the spillway is approximately nine feet lower than the low point of the dam. A profile of the dam crest centerline extending through the spillway is shown on Plate 3. A concrete bridge (see Photos 5 and 7) spans the spillway channel along the alignment of the dam. The spillway channel joins Big Bottom Creek approximately 450 feet downstream of the dam. A series of rock falls is located in the spillway channel just upstream of the junction with the original stream. A profile along the spillway channel centerline through the control section is shown on Plate 3.

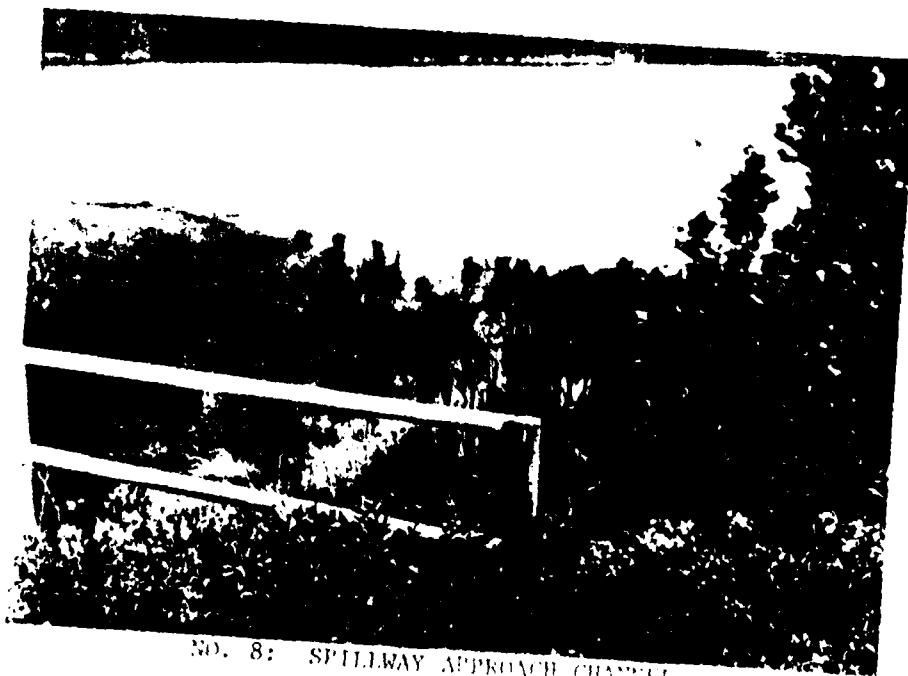
NO. 8: SPILLWAY APPROACH CHANNEL

(1) The crest of the excavated rock spillway section is in good condition. Vegetation extending above the lake water surface elevation is located in the approach to the spillway.

Based on the substantial cover of grass on the downstream slope and the riprap protection on the upstream slope, as well as the general condition of the dam, it is evident that the dam is reasonably well maintained. It is recommended, however, that the trees present in the upstream slope be removed, that the grass on the downstream slope be cut more often, and that the vegetation present in the lake at the approach to the spillway be removed.
