**WEBER HILL TERRACE LAKE DAM
JEFFERSON COUNTY, MISSOURI
MO 30449**

**PHASE I INSPECTION REPORT
NATIONAL DAM SAFETY PROGRAM**

Weber Hill Terrace Lake Dam (~~Inventory~~
~~Number~~ MO-30449), Mississippi-Kaskaskia-St
Louis Basin, Jefferson County, Missouri.
Phase I Inspection Report.

Name of Dam: Weber Hill Terrace Lake Dam
State Located: Missouri
County Located: Jefferson
Stream: Bear Creek
Date of Inspection: 19 July 1978

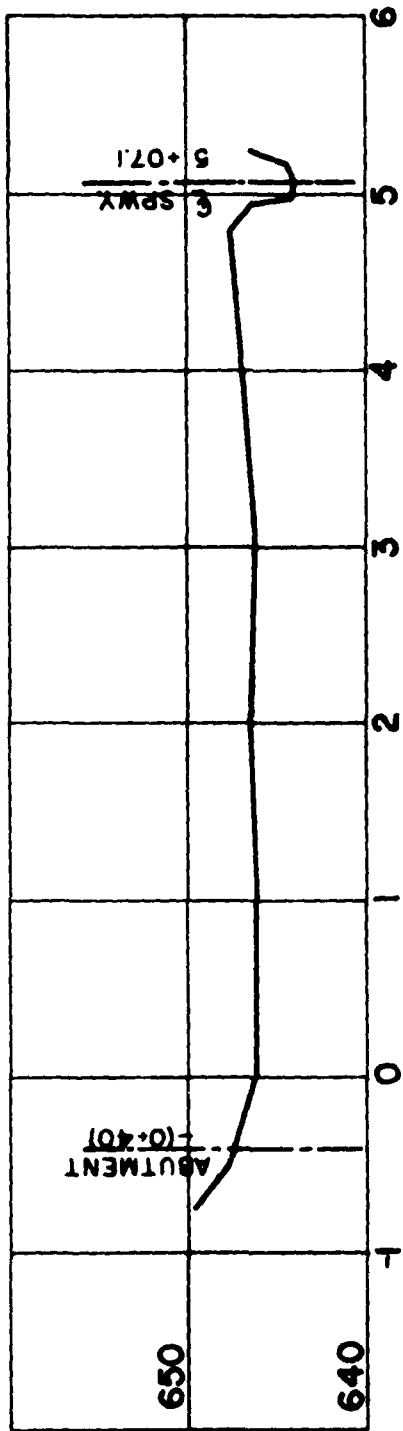
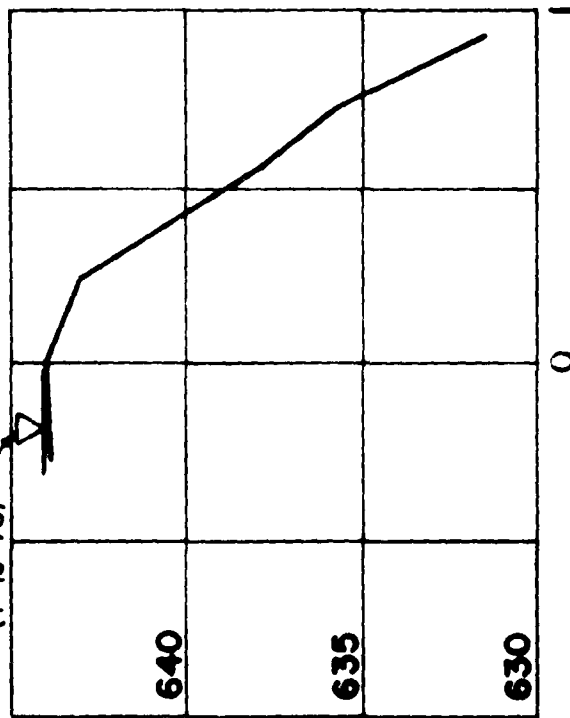
WEBER HILL TERRACE LAKE
 DAM & SPILLWAY PROFILES
 Horner & Shiffrin, Inc. July 1978

The elevation of the top of the dam, as determined by survey, was found to be from 1.0 to 1.3 feet lower across the central area of the dam than the top of dam in the area adjacent to the spillway. A profile of the dam crest centerline extending through the spillway section is shown on Plate 3.
