**WHITEWOOD LAKE DAM
PERRY COUNTY, MISSOURI
MO 30135**

**PHASE 1 INSPECTION REPORT
NATIONAL DAM SAFETY PROGRAM**

PREPARED BY: U.S. ARMY ENGINEER DISTRICT, ST. LOUIS

APRIL 1981

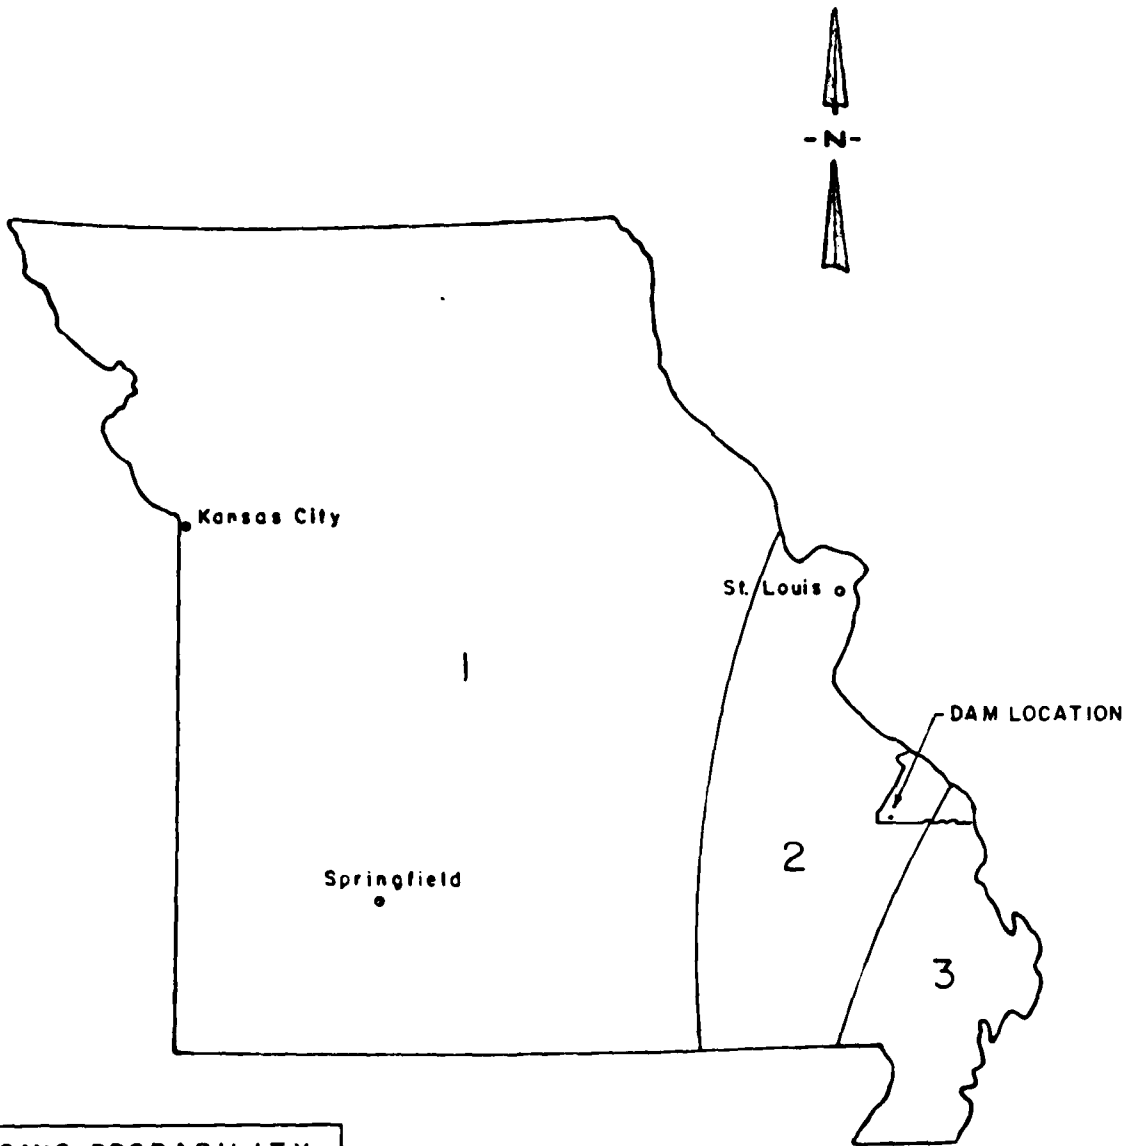
SEISMIC PROBABILITY	
ZONE	DAMAGE
1	MINOR
2	MODERATE
3	MAJOR

The "Geologic Map of Missouri" indicates several normal faults southwest and northwest of the site about 5 miles away. It should also be noted that the site is located in seismic zone 2 (moderate damage

zone) but is near the boundary of zone 3 (major damage zone - see Sheet 3 of Appendix B).

The structure is located in seismic zone 2. It is recommended that the prescribed seismic loading for this zone be applied in stability analyses performed for this dam.
