R. HAAS & A. HECK DAM
CRAWFORD COUNTY, MISSOURI
MO 30526

PHASE 1 INSPECTION REPORT
NATIONAL DAM SAFETY PROGRAM

R. HAAS & A. HECK LAKE DAM
CRAWFORD COUNTY, MISSOURI
MISSOURI INVENTORY NO. 30526

Name of Dam: R. Haas & A. Heck Lake Dam
State Located: Missouri
County Located: Crawford
Stream: Tributary of Shoal Creek
Date of Inspection: 26 June 1979

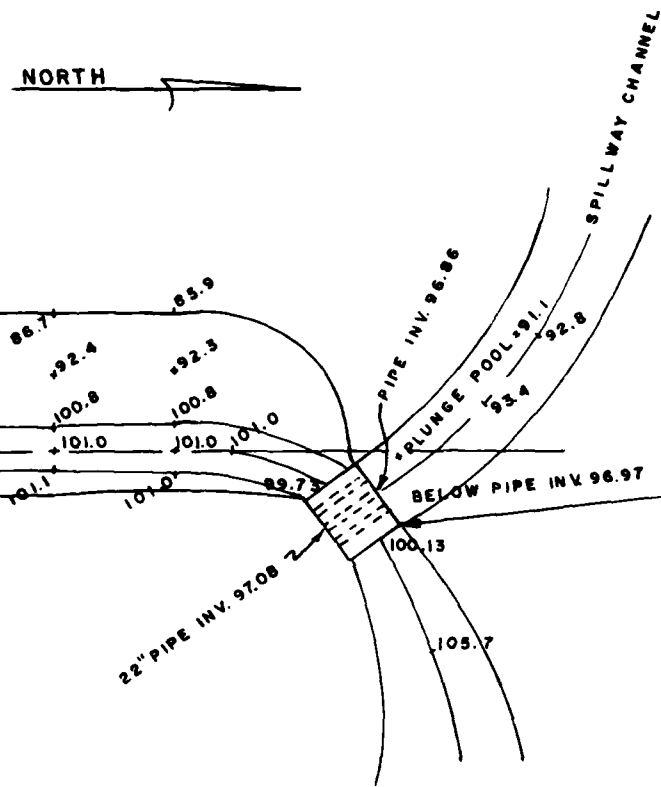
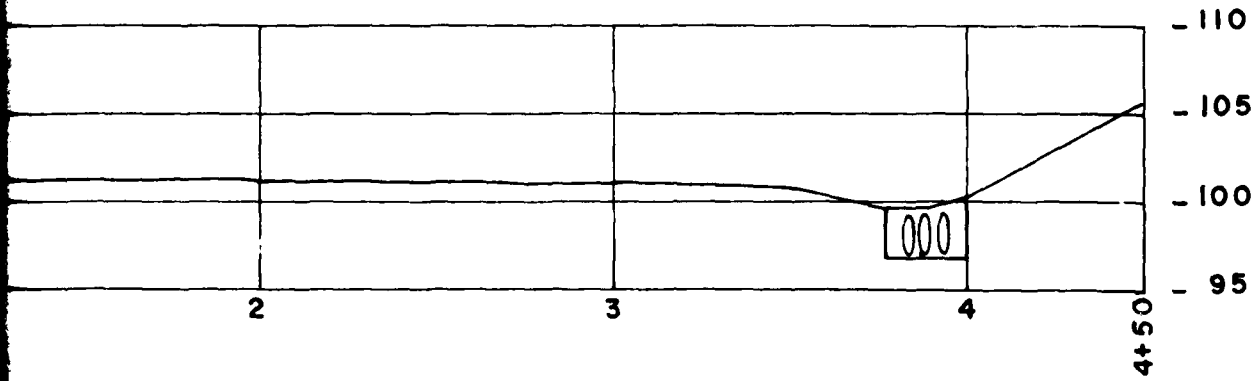
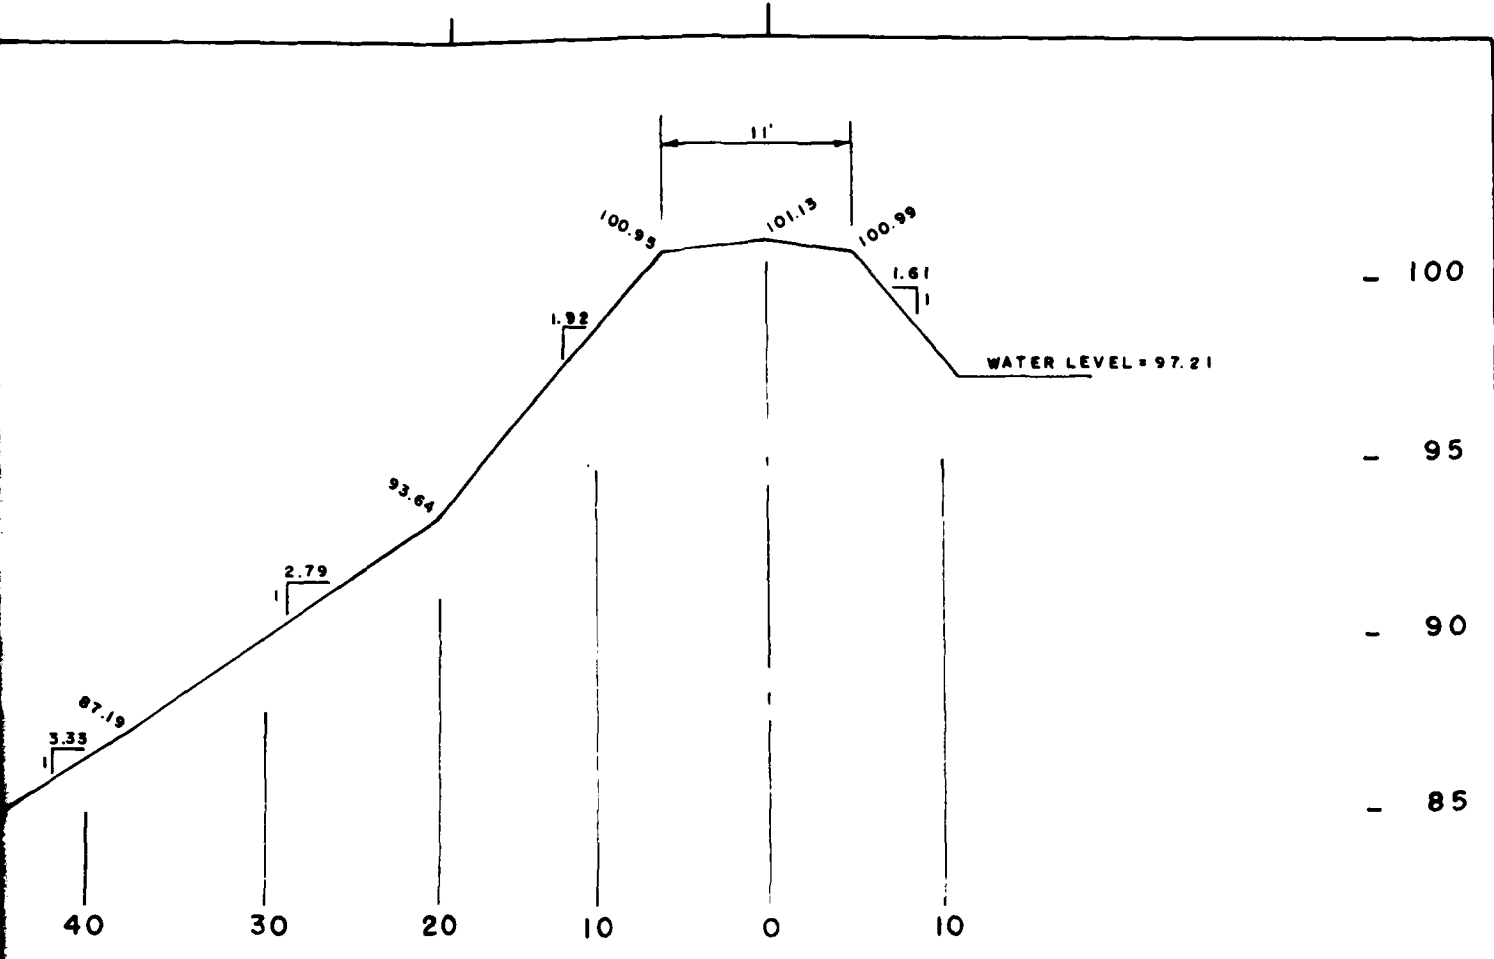
SHEET 3 APPENDIX A

R. Haas & A. Heck Lake Dam is an earth fill structure approximately 16 ft high and 360 ft long at the crest. The appurtenant works include: (1) a spillway consisting of a 2 ft-11 in. by 4 ft-10 in. concrete box culvert and a 22 in. diameter steel pipe located at the south end of the dam, and (2) a spillway located at the north end of the dam which consists of three 22 in. diameter steel pipes. These spillways, although located at opposite ends of the dam, are at nearly the same elevation. Therefore, neither can be considered an emergency spillway. In addition, an uncontrolled 2 in. diameter steel pipe passes through the dam and flows constantly. Sheet 3 of Appendix A shows a plan profile and typical section of the embankment.
