**NUWER LAKE DAM  
OREGON COUNTY, MISSOURI  
MO 30190**

**PHASE 1 INSPECTION REPORT  
NATIONAL DAM SAFETY PROGRAM**

PHASE I INSPECTION REPORT  
NATIONAL DAM SAFETY PROGRAM

Name of Dam: Nuwer Lake Dam  
State Located: Missouri  
County Located: Oregon  
Stream: Unnamed Tributary of Frederick Creek  
Date of Inspection: June 18, 1980

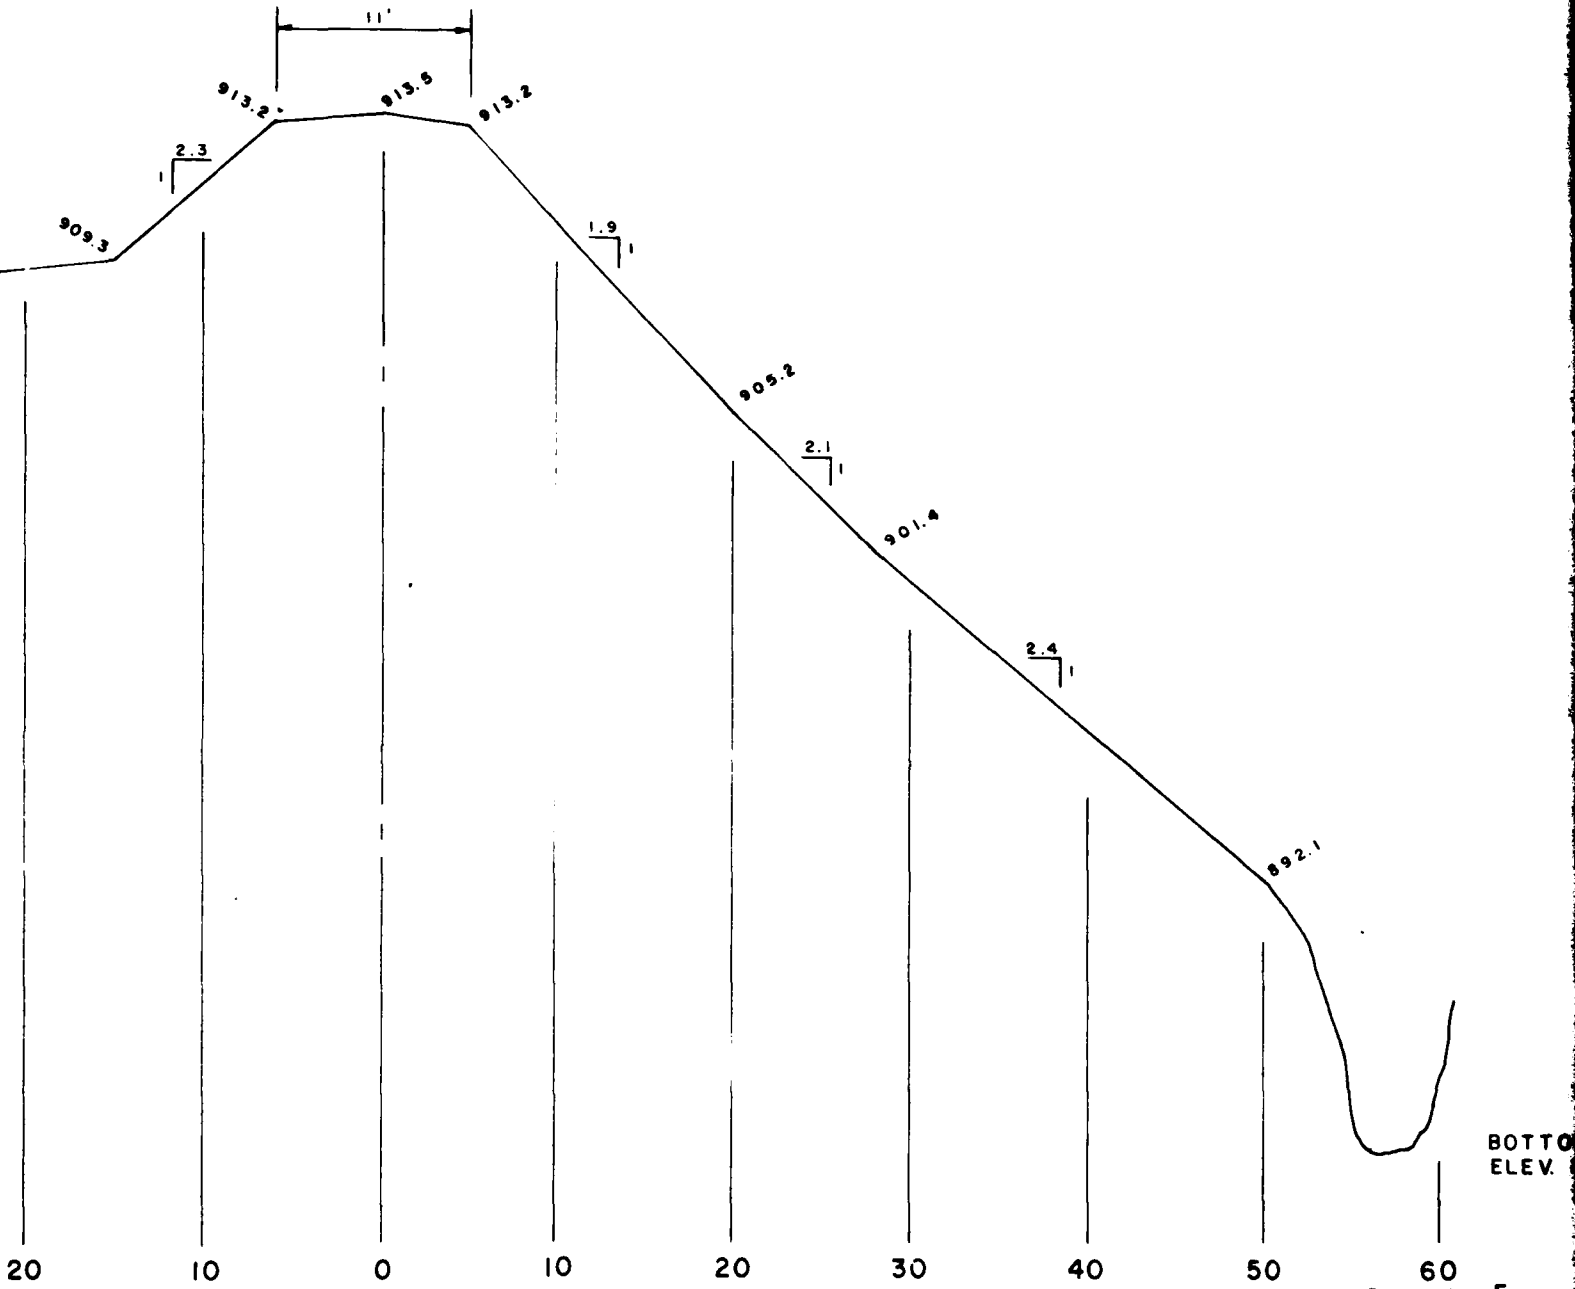
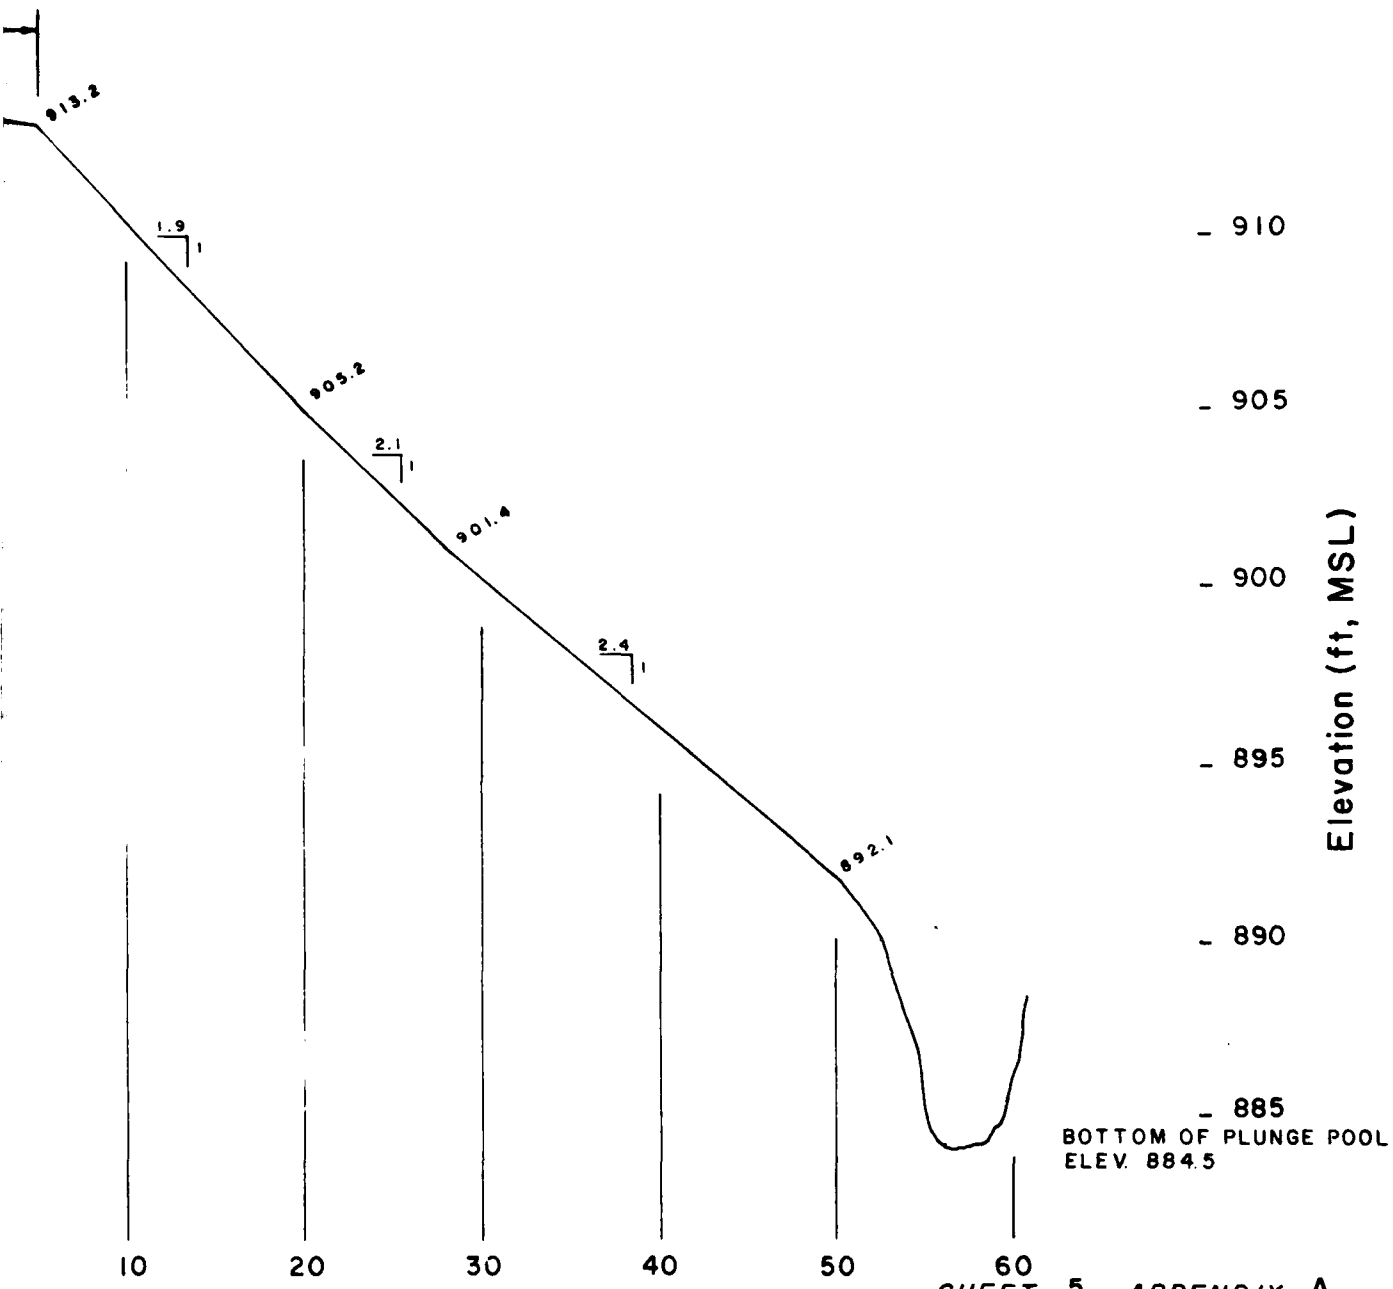
**SHEET 5 APPENDIX A**

The dam embankment appears to be in good condition. The downstream embankment face is heavily overgrown with briars, making inspection very difficult. The owner reported that he is currently spraying the briars to kill them. Small seepage areas were noted about 11 ft below the crest of the dam between Stations 1+50 and 2+00 and at Station 2+84. These areas were damp and soft, but no noticeable flows were noted. It did not appear that soil particles had been transported from these areas. The owner reported that this condition has been present since completion of the dam.

- (1) Seepage and stability analyses comparable to the requirements of the recommended guidelines should be performed by an engineer experienced in the construction of dams.
- (2) The briar growth should be removed from the downstream face, and the vegetation on the dam should be cut annually.
- (3) The seepage areas previously described should be investigated by an engineer experienced in the design and construction of dams. Remedial measures may be required. As a minimum, these areas should be monitored to determine if there is any increase in flow quantities and whether soil particles are being carried with the seepage water.
- (4) Wave protection should be provided for the upstream face of the dam.
- (5) A detailed inspection of the dam should be made periodically by an engineer experienced in the design and construction of dams.

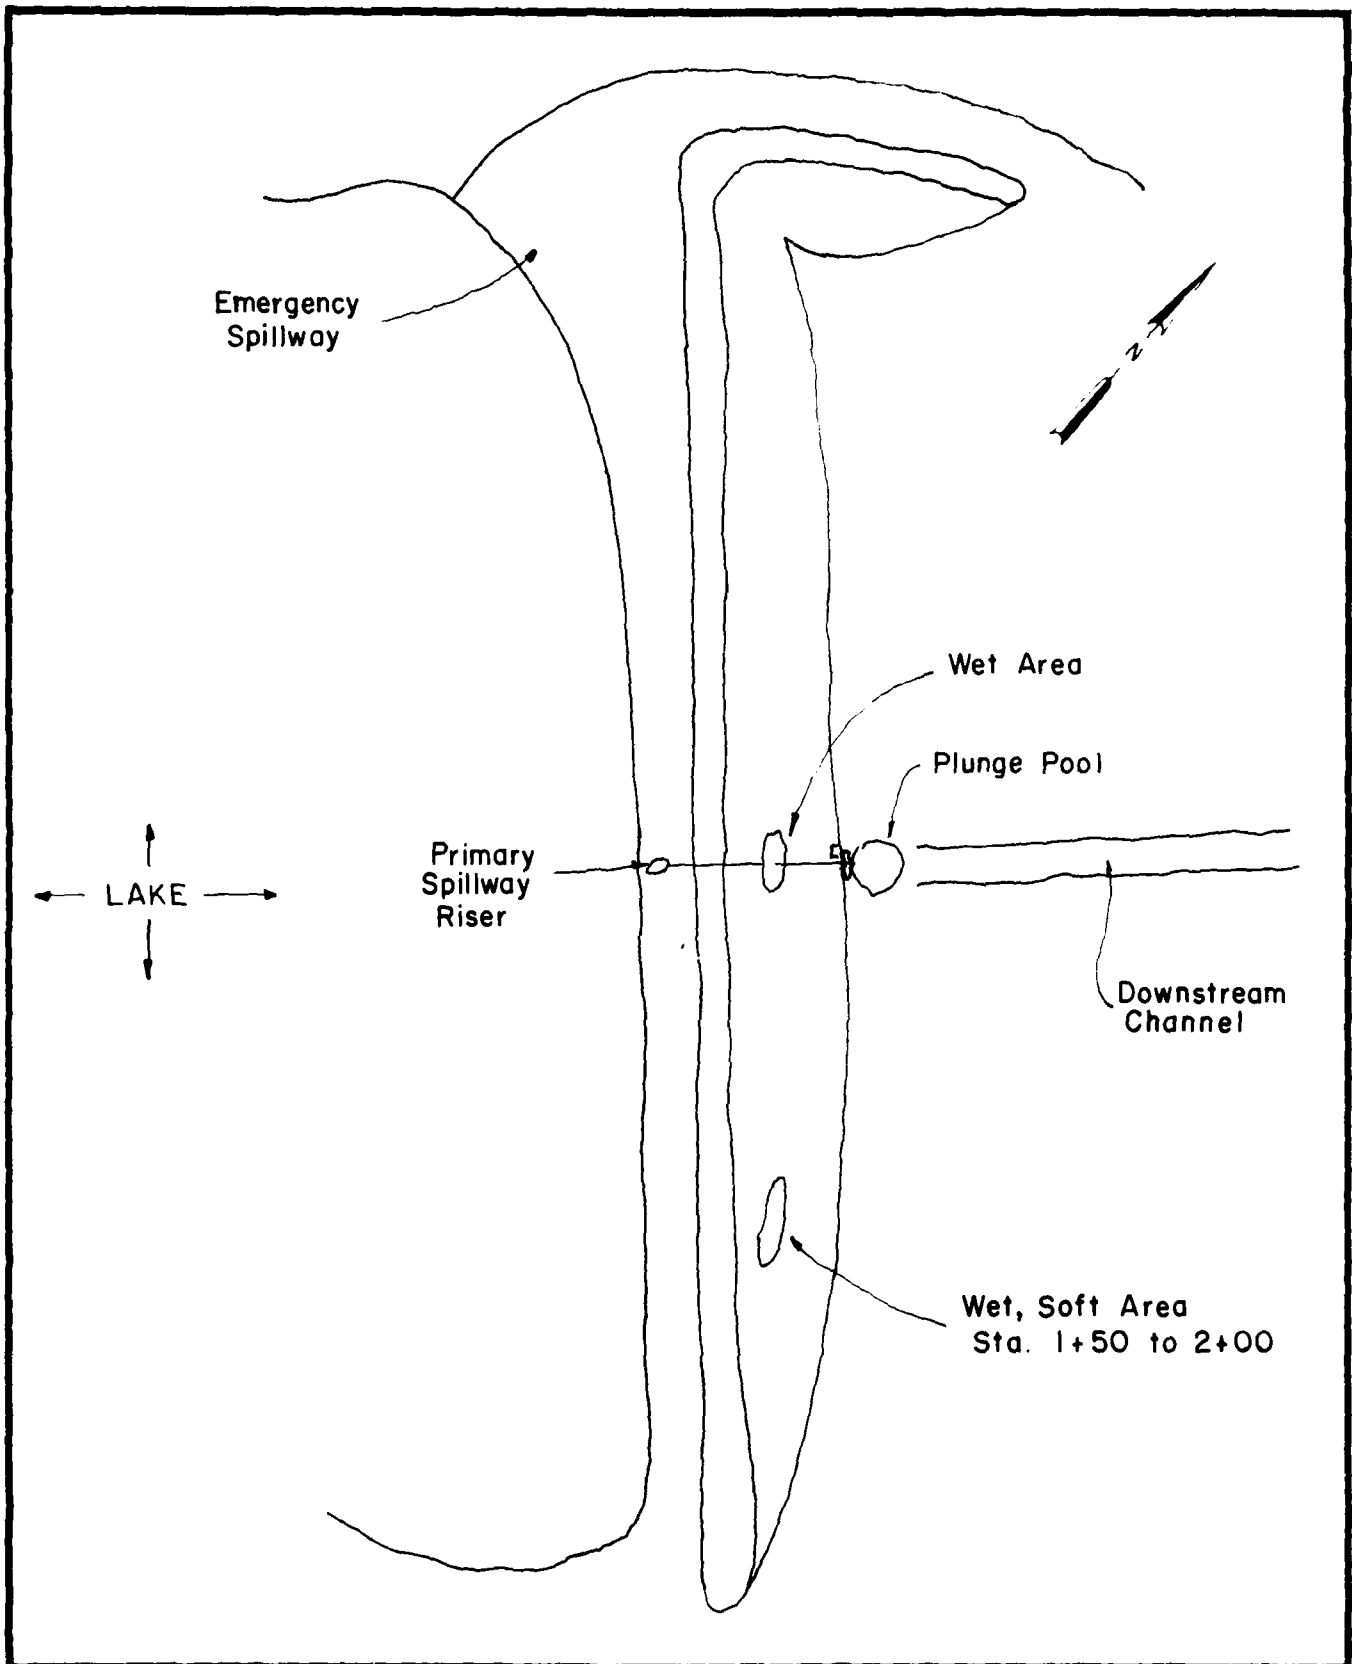
PLAN SKETCH OF FEATURES

Shallow auger probes into the embankment indicated the dam to consist of reddish brown clayey silt to silty clay with chert fragments (ML-CL). Information from the owner indicates that material for construction of the dam was obtained from a knob upstream of the dam on the left side, from the emergency spillway excavation, and from the lake area. Sheet 7 of Appendix A presents a plan sketch of the dam showing observed features.
