ROGERS LAKE DAM  
WARREN COUNTY, MISSOURI  
MO 31772

# PHASE 1 INSPECTION REPORT NATIONAL DAM SAFETY PROGRAM

ROGERS LAKE DAM  
MISSOURI INVENTORY NO. 31772  
WARREN COUNTY, MISSOURI

Name of Dam: Rogers Lake Dam  
State Located: Missouri  
County Located: Warren  
Stream: Sub-Tributary of Charrette Creek  
Date of Inspection: 4 December 1980

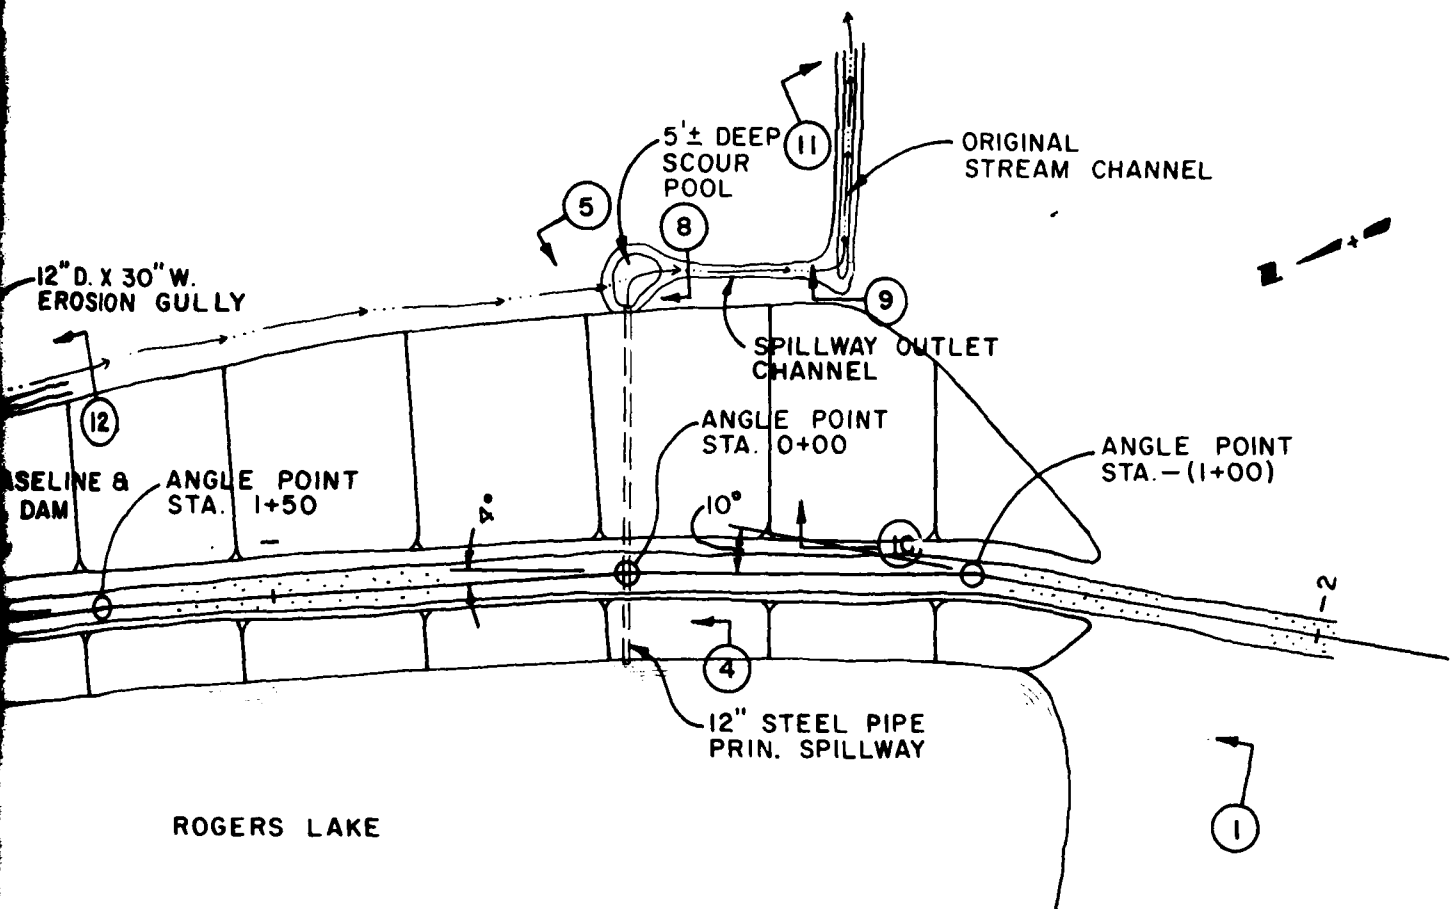
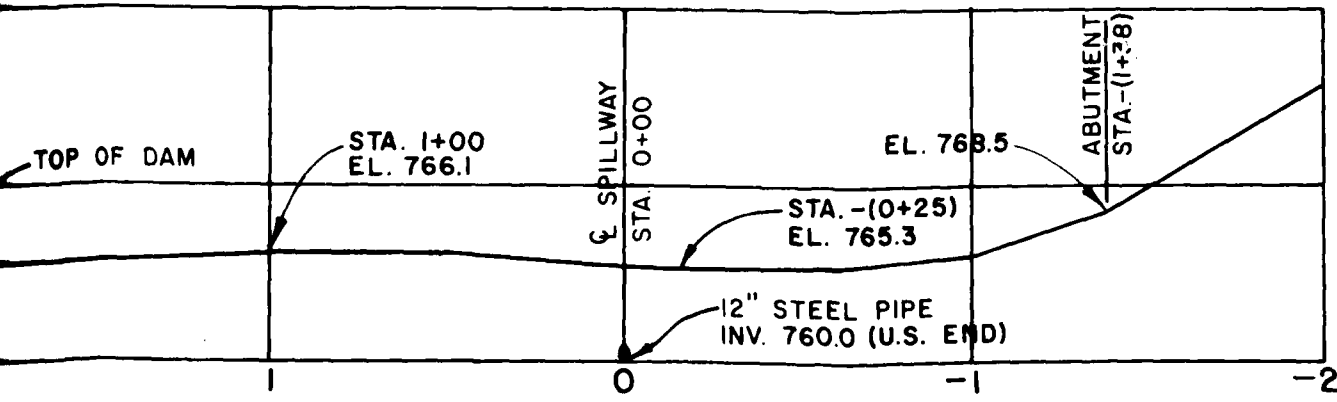
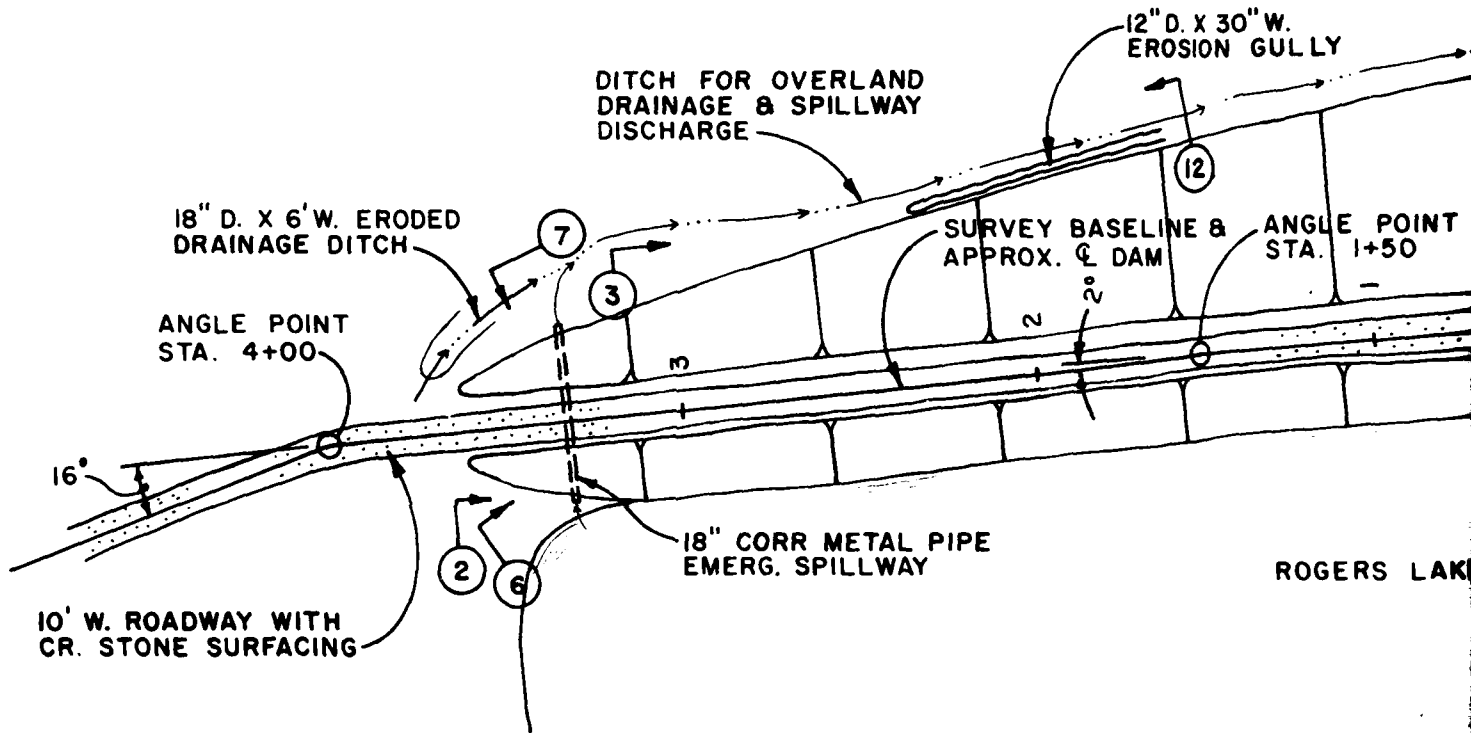
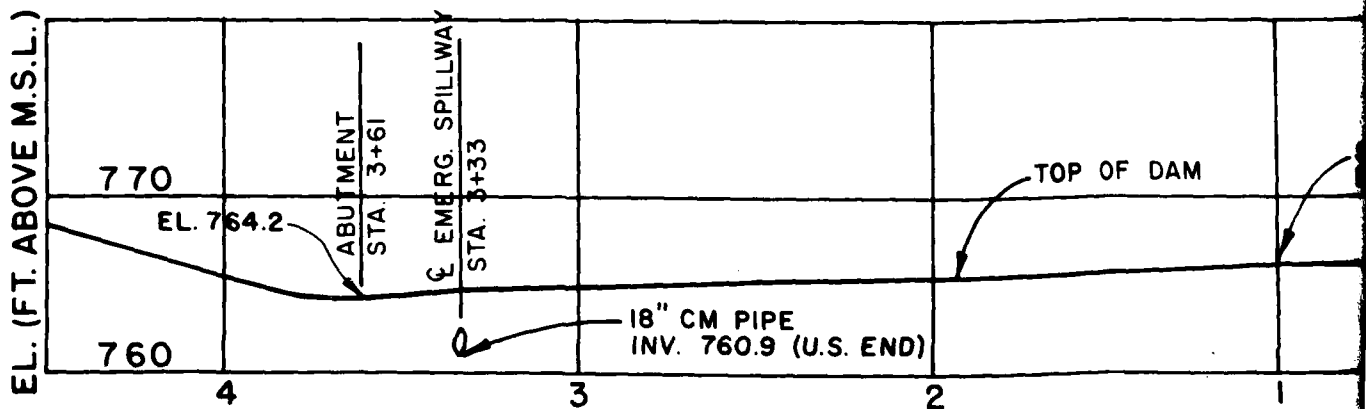
**ROGERS LAKE DAM-MO 31772**  
**DAM PLAN & PROFILE**  
Horner & Shifrin, Inc. March 1981

The dam has both a principal and an emergency spillway. The principal spillway, a 12-inch diameter steel pipe, passes through the dam at a point approximately 138 feet left, or north, of the right abutment. The normal level of the lake is governed by the invert elevation of the upstream end of this pipe. The downstream end of the 12-inch diameter pipe discharges lake outflow at a point near the toe of the dam, and pipe discharges have caused a scour pool approximately 5 feet deep and about 10 feet in diameter, to form in the original valley fill at the outlet end of the pipe. The principal spillway is shown in plan on Plate 3 and a profile of the 12-inch diameter pipe spillway is shown on Plate 5.
