**HARDECKE LAKE DAM
GREENE COUNTY, MISSOURI
MO 30148**

**PHASE 1 INSPECTION REPORT
NATIONAL DAM SAFETY PROGRAM**

HARDECKE LAKE DAM
GREENE COUNTY, MISSOURI
MISSOURI INVENTORY NO. 30148

PHASE I INSPECTION REPORT
NATIONAL DAM SAFETY PROGRAM

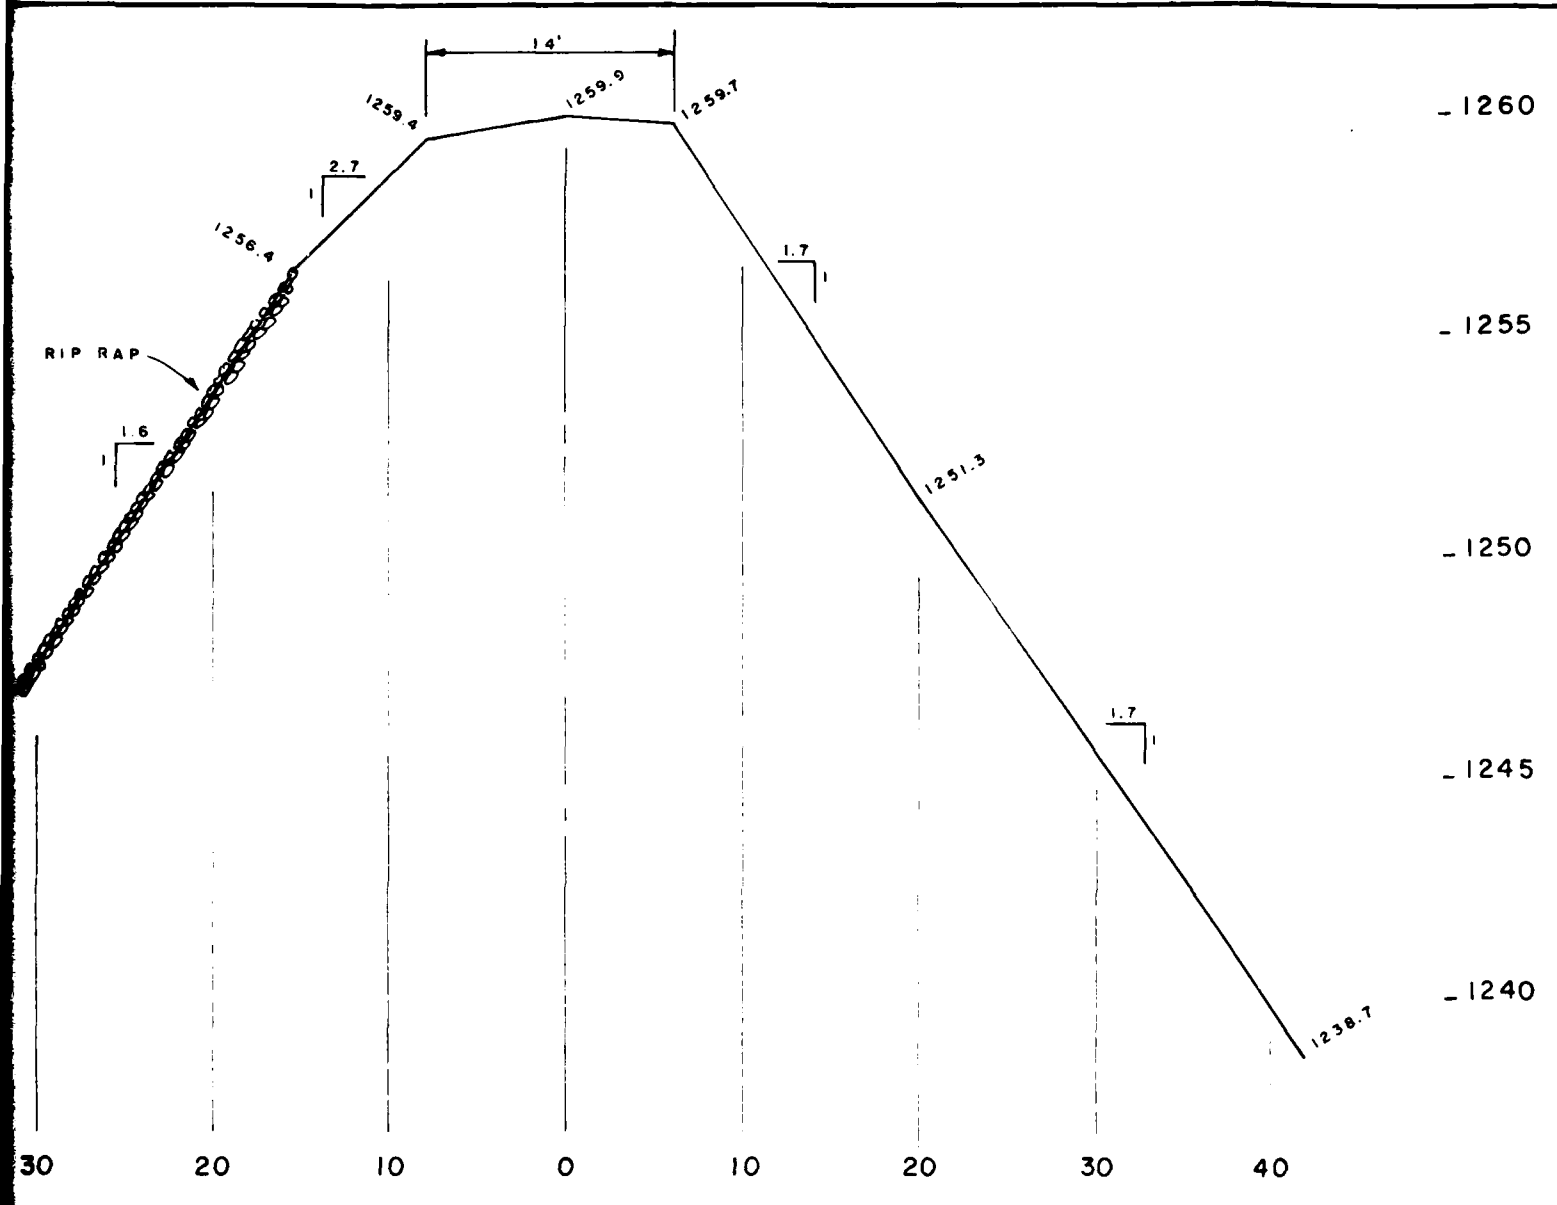
SECTION A-A STA 3+00

The vertical alignment of the crest appeared good. An apparent sag of the vertical alignment was observed near Station 2 + 00. The elevation at this point was approximately the same as the elevation of the spillway channel at the west abutment. The horizontal alignment was good.
