| REPORT DOCUMENTATION PAGE | | READ INSTRUCTIONS<br>BEFORE COMPLETING FORM |
|---|---|---|
| 4. TITLE (and Subtitle)<br>Phase I Dam Inspection Report<br>National Dam Safety Program<br>Lake Wauwanoka Dam (MO 30080)<br>Jefferson County, Missouri | | 5. TYPE OF REPORT & PERIOD COVERED<br>Final Report |
| 14. MONITORING AGENCY NAME & ADDRESS (if different from Controlling Office)<br><br>National Dam Safety Program, Lake<br>Wauwanoka Dam (MO 30080), Mississippi -<br>Kaskaskia - St. Louis Basin, Jefferson<br>County, Missouri. Phase I Inspection<br>Report. | | 12. REPORT DATE<br>December 1978 |
| 16. DISTRIBUTION STATEMENT<br>Approved for release; distribution unlimited. | | 13. NUMBER OF PAGES<br>Approximately 65 |

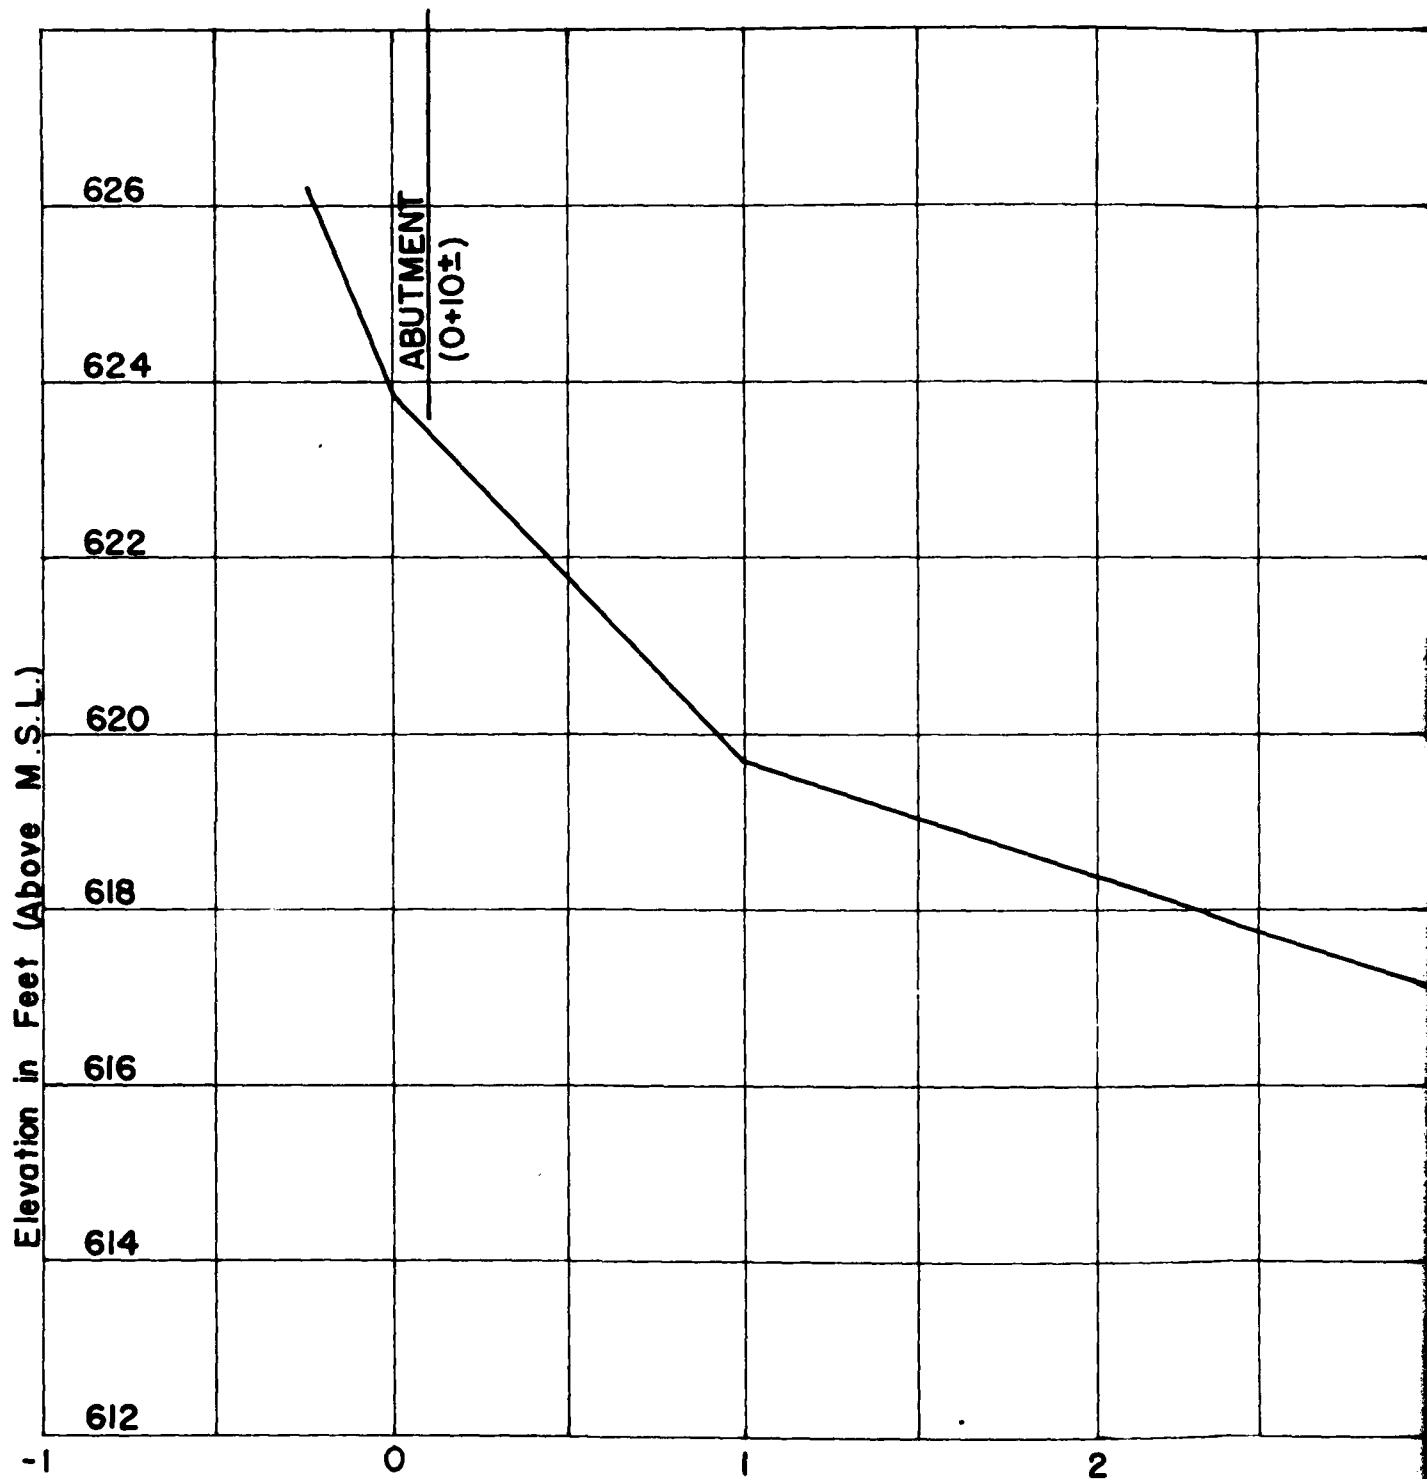
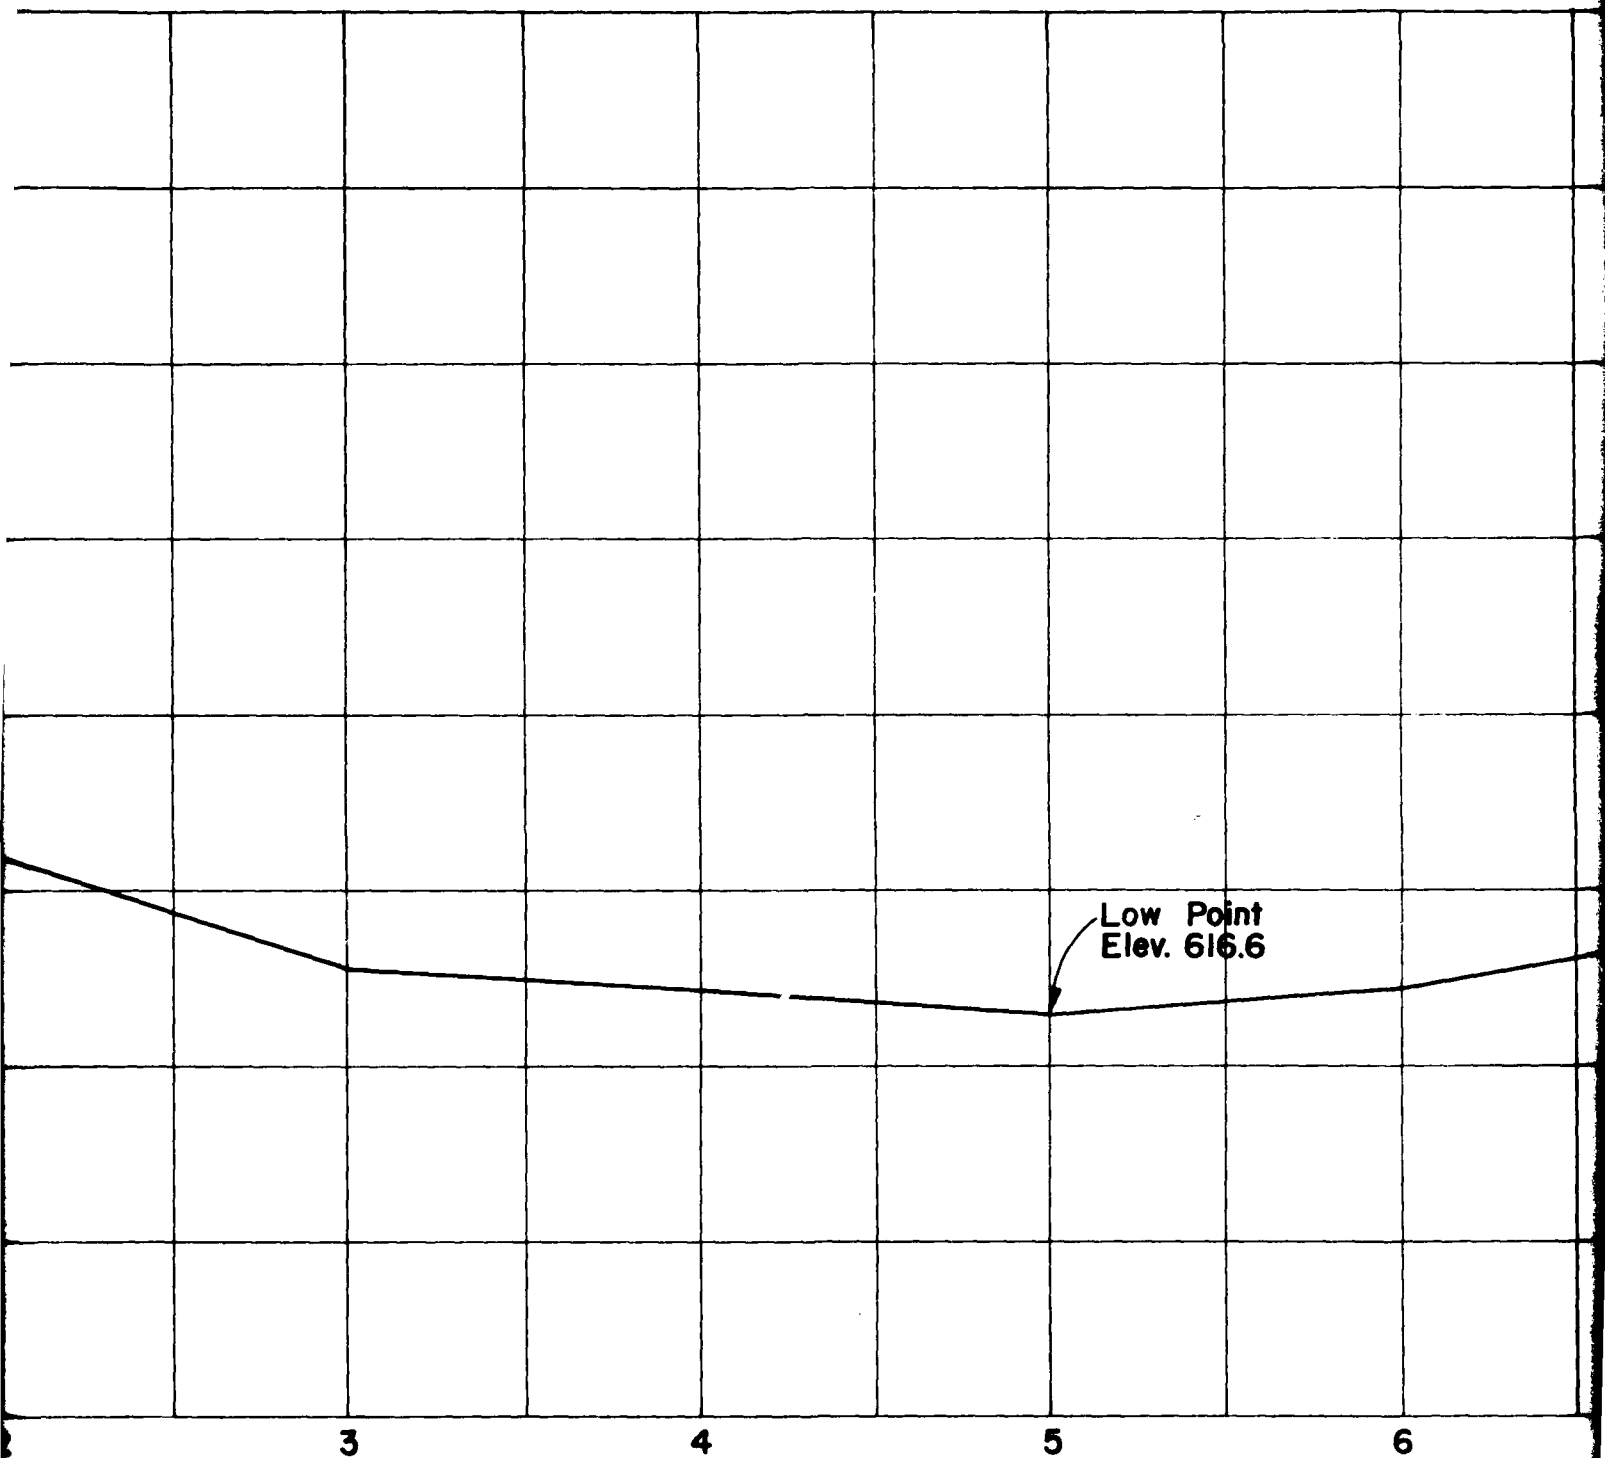
PROFILE DAM CREST

The crest of the dam was found to be approximately 1.5 feet lower at a location near the center of the dam than the crest of the dam in the area adjacent to the spillway. As a result of this low top of dam section, the capacity of the spillway to discharge lake outflow without overtopping the dam is reduced considerably. According to the criteria set forth in the recommended guidelines (see text) the minimum spillway design flood for this dam, which is classified as intermediate in size and of high hazard potential, is specified to be the Probable Maximum Flood (PMF). PMF is the flood that may be expected from the most severe combination of critical meteorologic and hydrologic conditions that are reasonably possible in the region. Results of a hydrologic/hydraulic analysis indicate that the existing spillway is inadequate to pass lake outflow resulting from a storm of PMF magnitude. The spillway is adequate to pass the lake outflow resulting from the 1 percent chance (100-year frequency) flood. The existing spillway is capable of

The elevation of the dam crest, as determined by survey, was found to be approximately 1.5 feet lower across the central area of the dam than the top of dam in the area adjacent to the spillway. A plot of the 1967 Brucker & Thacker survey data also indicated the top of the dam to be 1.5 feet lower at a location near the center than the top of the dam in the area near the spillway. Due to the fact that the two surveys (1967 and 1978) were made using different elevation datum, exact correlation of the top of dam levels, in order to determine interim settlement, could not be made. A profile of the dam crest centerline extending through the spillway section, based on survey data obtained during the inspection, is shown on Plate 9.

(1) Based upon criteria set forth in the recommended guidelines, alterations to the design of the dam should be made in order to pass lake outflow resulting from a storm of probable maximum flood magnitude. It is recommended, in any event, that the low area located near the center of the dam be raised so that it does not govern spillway capacity.
