TURNER LAKE DAM  
DENT COUNTY, MISSOURI

MISSOURI INVENTORY NO. 30266

PHASE I INSPECTION REPORT  
NATIONAL DAM SAFETY PROGRAM

SEPTEMBER 1978

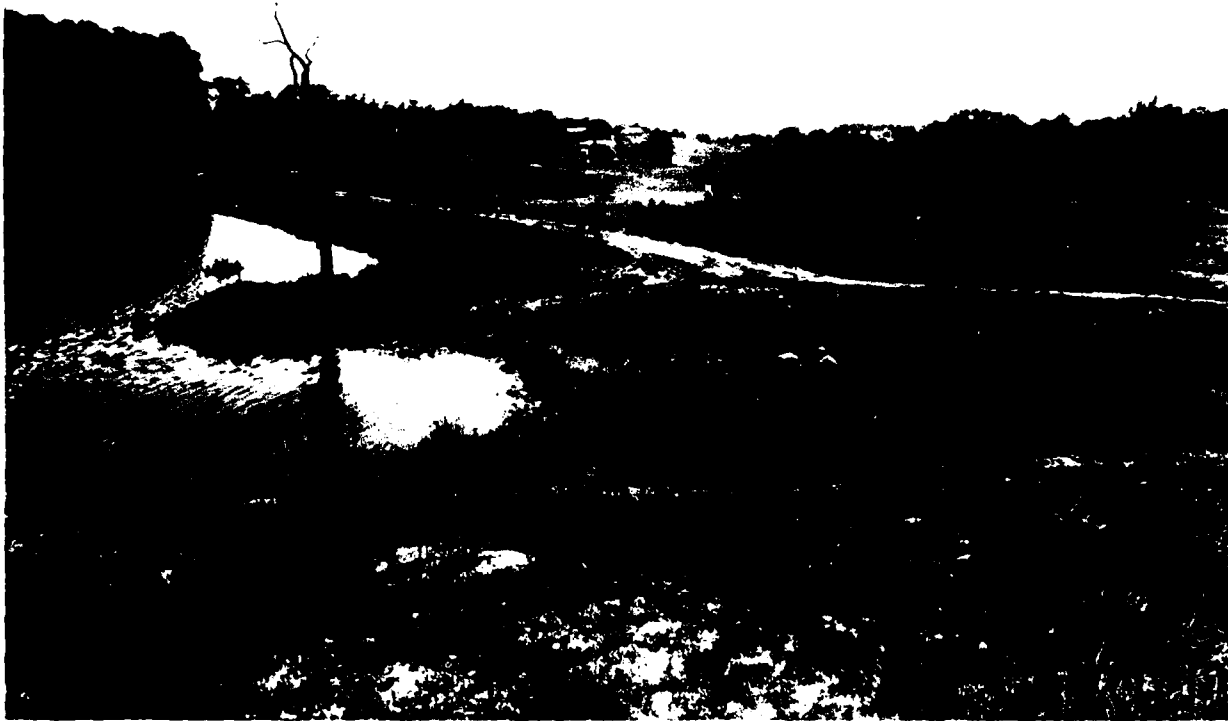
OVERVIEW OF LAKE AND DAM

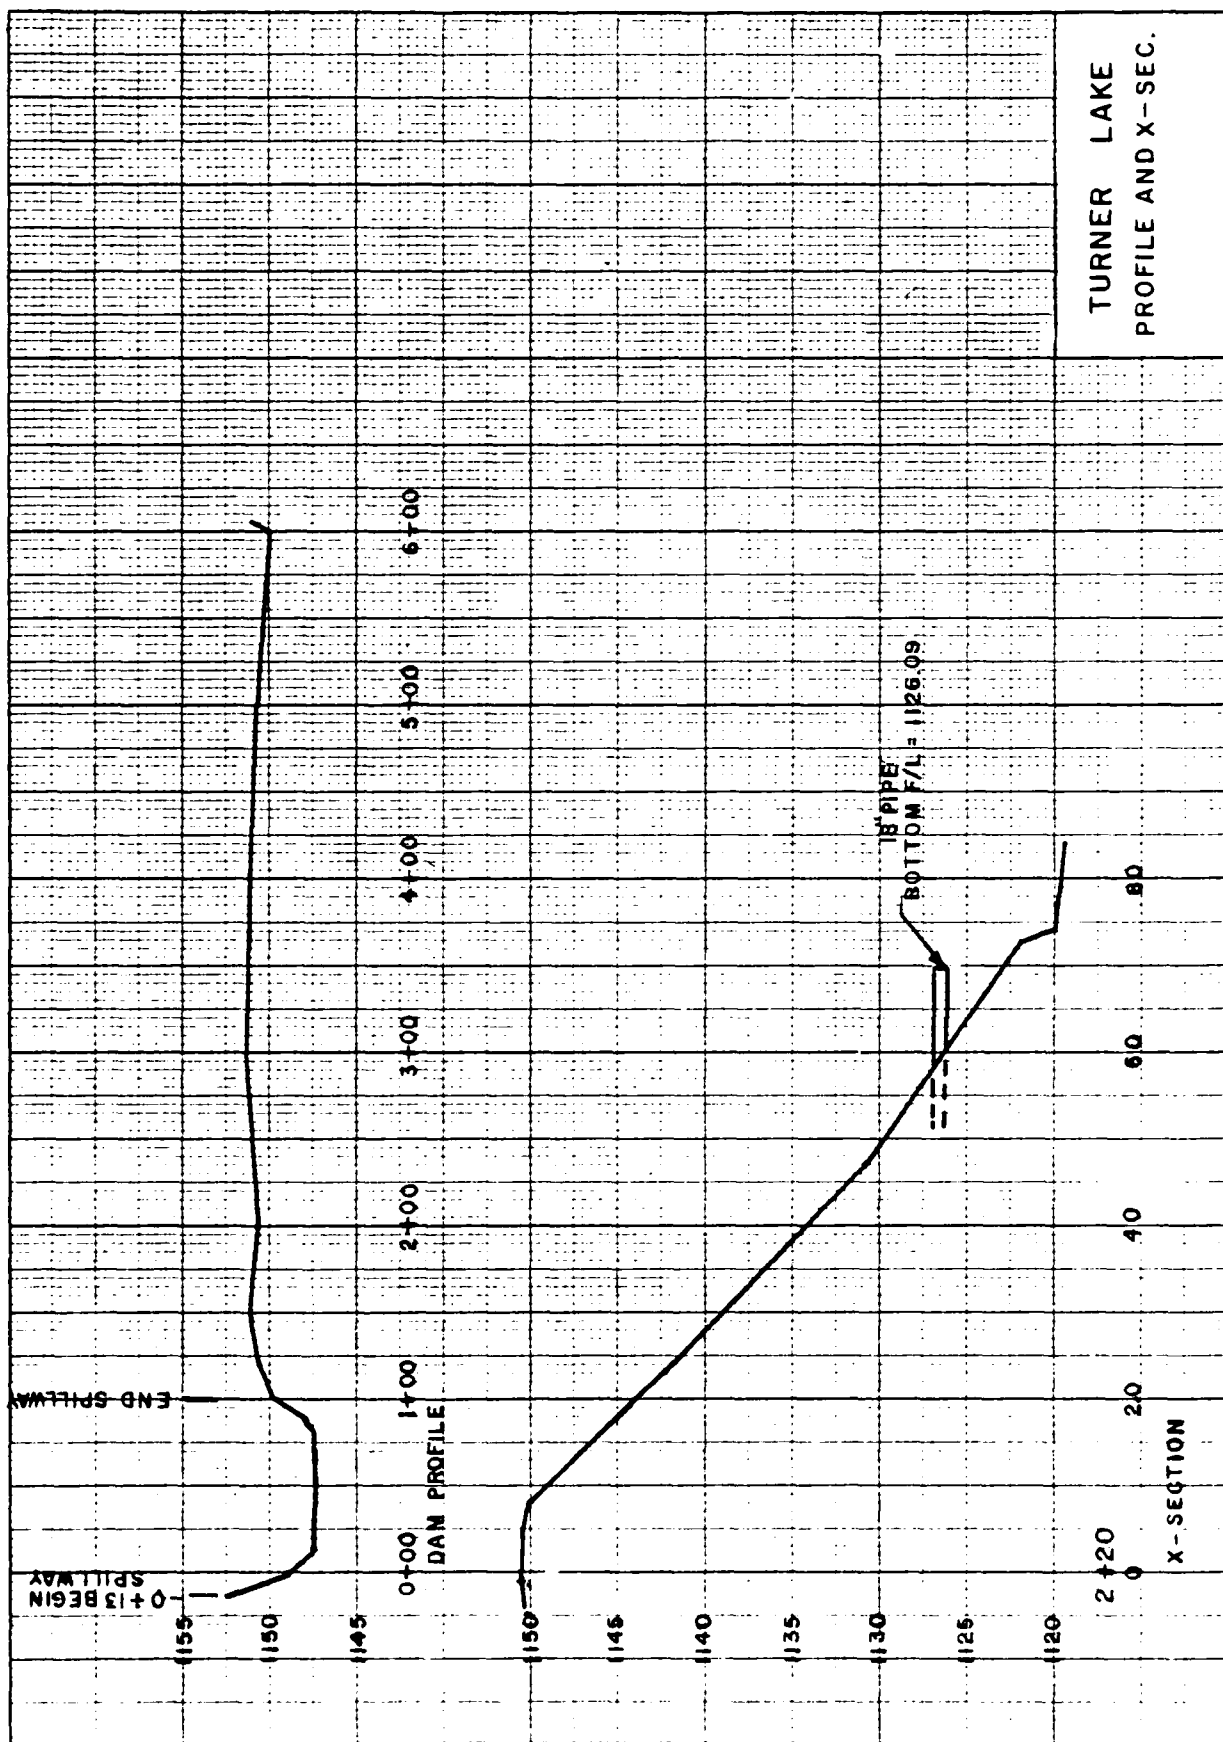
TURNER LAKE  
PROFILE AND X-SEC.

An embankment cross-section near the maximum height for the dam is shown on Plate 3. In a few areas, the embankment slopes are considerably steeper than the section shown. It is difficult to determine the reason for the irregular slopes especially since there was heavy vegetation on the slope but it appears that the slope has experienced some sliding. There is a slide scarp in the area adjacent to the outlet pipe up from the toe of the dam where seepage is exiting from the embankment. The slides are not large but they do pose a danger of progressive failure of the embankment. No burrows were noted but some could be present and masked by vegetation.

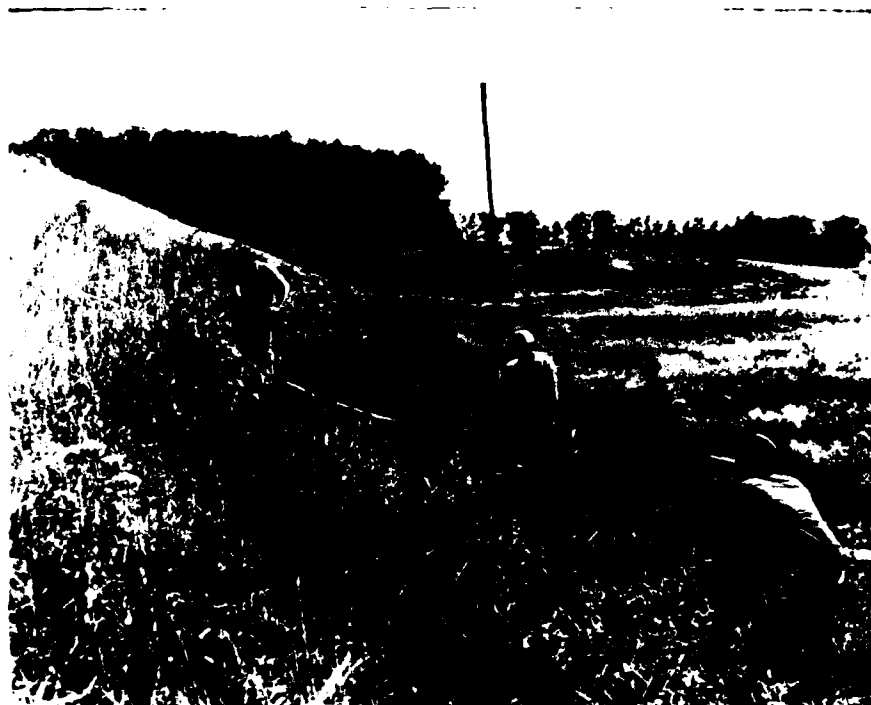
PHOTO 3    Downstream Slope of Dam Toward  
             Left Abutment

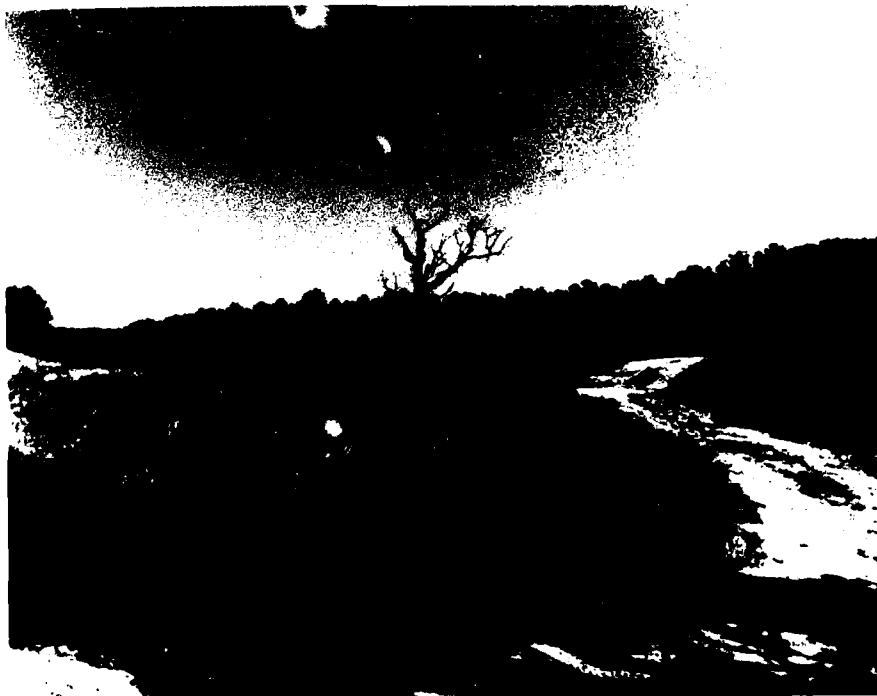
The spillway is approximately 16 feet wide. The spillway extends from the dam embankment down past the toe of the dam. It is composed of embankment or foundation material.

(4) A grassy spillway located at the right side of the dam serves as an emergency spillway (See Plates 2 and 3 and Photos 6 and 7). Any high and sustained flows through the emergency spillway could cause excessive erosions of the embankment. The excessive erosions could threaten the safety of the dam.

PHOTO 6 Spillway

PHOTO 7 Spillway
