2 SUGAR HOLLOW LAKE DAM,  
4 WARREN COUNTY, MISSOURI  
MO 30522

# PHASE 1 INSPECTION REPORT NATIONAL DAM SAFETY PROGRAM.

PHASE I INSPECTION REPORT  
NATIONAL DAM SAFETY PROGRAM

Name of Dam:	Sugar Hollow Lake Dam
State Located:	Missouri
County Located:	Warren
Stream:	Tributary of Wolf Creek
Date of Inspection:	20 May 1980

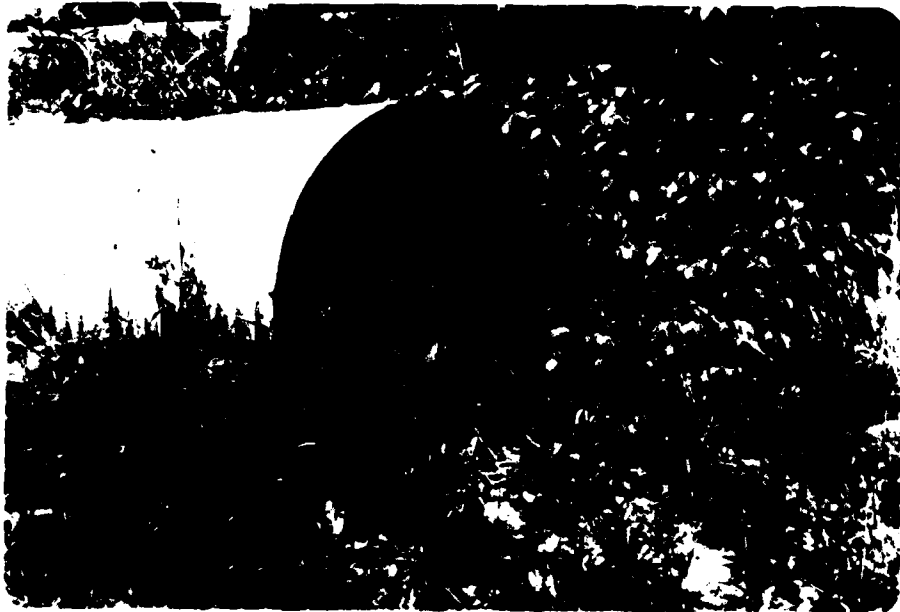
The upstream and downstream ends of the 42-inch diameter auxiliary spillway (see Photos 4 and 5) were examined and both appeared to be in good condition, although a small mound of earth on the order of 10 inches high partially blocked the pipe opening at the upstream end. The outlet channel for the auxiliary spillway (see Photo 6), with the exception of several small trees that were noticed near the downstream end of the channel, was also found to be in good condition.

NO. 4: UPSTREAM END OF AUXILIARY SPILLWAY LINE

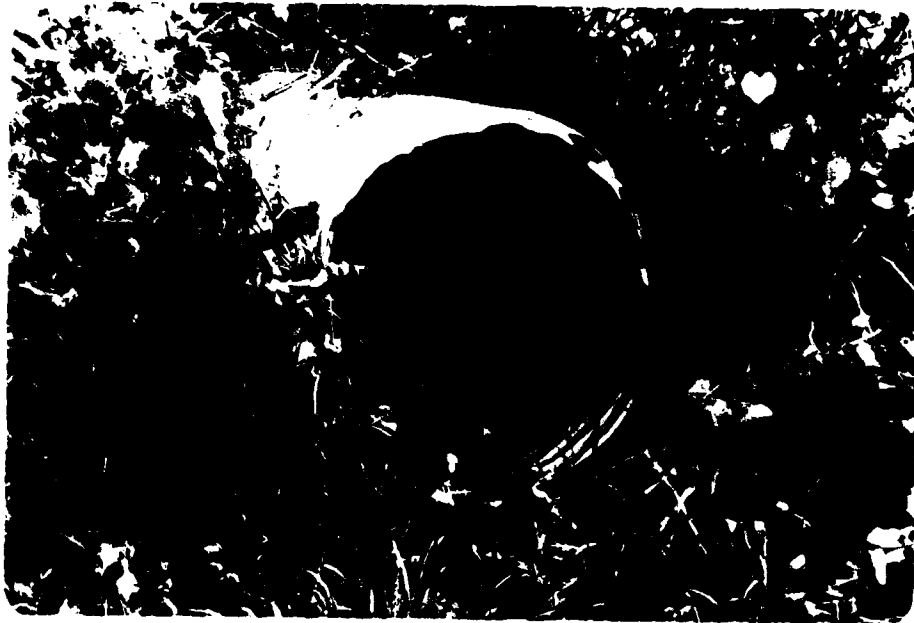
NO. 5: DOWNSTREAM END OF AUXILIARY SPILLWAY PIPE
