HORNER AND SHIFRIN INC ST LOUIS MO  
NATIONAL DAM SAFETY PROGRAM. UPPER LAKE MINNIE HA-HA DAM (MO-30--ETC(U)  
DEC 79

- UPPER LAKE MINNIE HA-HA DAM, MO 30643
- LOWER LAKE MINNIE HA-HA DAM, MO 30644
- LAKE MINNIE HA-HA DEVELOPMENT,
- STE. GENEVIEVE COUNTY, MISSOURI .

5 PHASE 1 INSPECTION REPORT.  
1 NATIONAL DAM SAFETY PROGRAM.

DECEMBER 1979

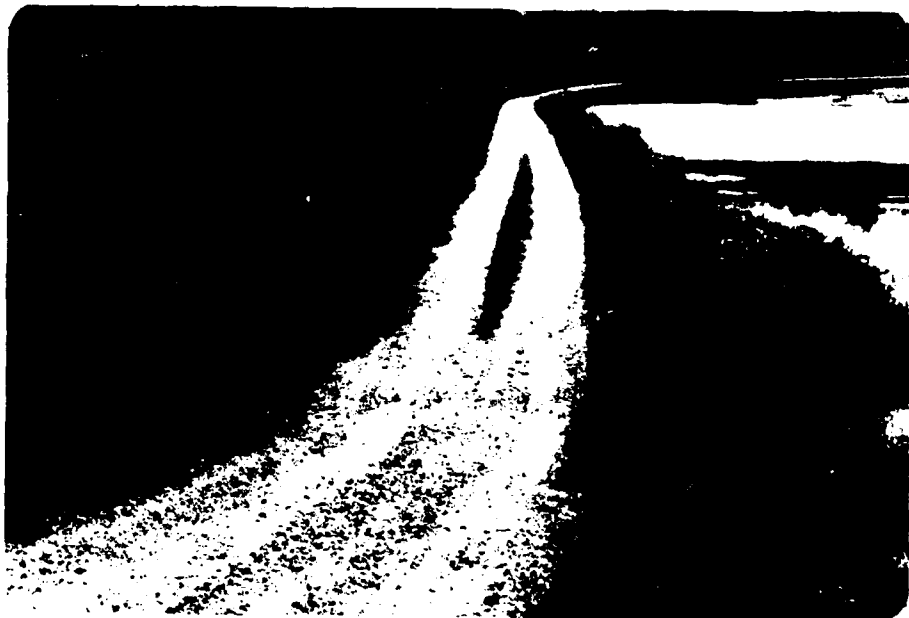
The gravel covered crest section of the earth spillway (see Photo 4) appeared to be in good condition, without signs of erosion. A line of metal fence posts without fence fabric (see Photo 3) crosses the spillway approach channel from the lake. The upper reach of the spillway discharge channel, a grass covered trapezoidal section excavated in the hillside (see Photo 5) was found to be in good condition. The lower reach of the outlet channel is steep and has been eroded (see Photo 6) to the underlying bedrock. Old tires and discarded machinery have been placed in this portion of the channel presumably in an attempt to control further erosion. The outlet channel flows into a natural draw which in turn joins Lower Lake Minnie Ha-Ha about 400 feet below the upper lake dam.

NO. 4: SPILLWAY CREST
