DUCK CREEK
 STATE WILDLIFE REFUGE - POND 1
 BOLLINGER AND STODDARD COUNTIES, MISSOURI
 MISSOURI INVENTORY NO. 40063

⑥ PHASE I INSPECTION REPORT ...
 NATIONAL DAM SAFETY PROGRAM,

PHASE I REPORT

Name of Dam	Duck Creek State Wildlife Refuge - Pond 1
State Located	Missouri
County Location	Bollinger and Stoddard Counties
Stream	Castor River
Date of Inspection	22 May 1979

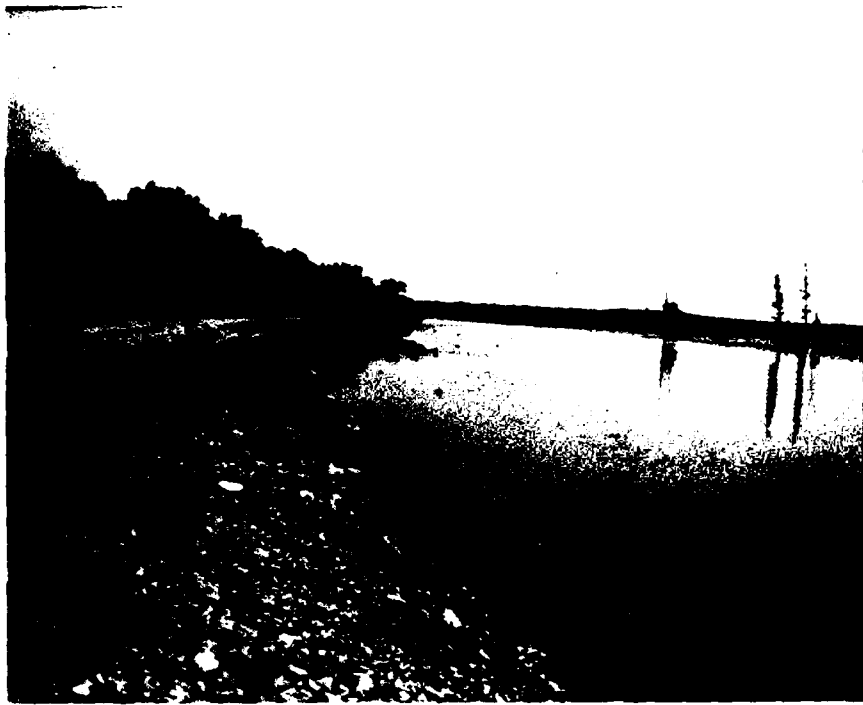
e. Reservoir Areas. No wave wash, excessive erosion, or slides were observed along the shoreline of the reservoir. Riprap had been placed along all portions of the lakeslope of the reservoir (see Photos 3 and 5) except for the northern boundary.

Photo 3: Lakeslope - Eastern Levee - Looking South from Section "Q"

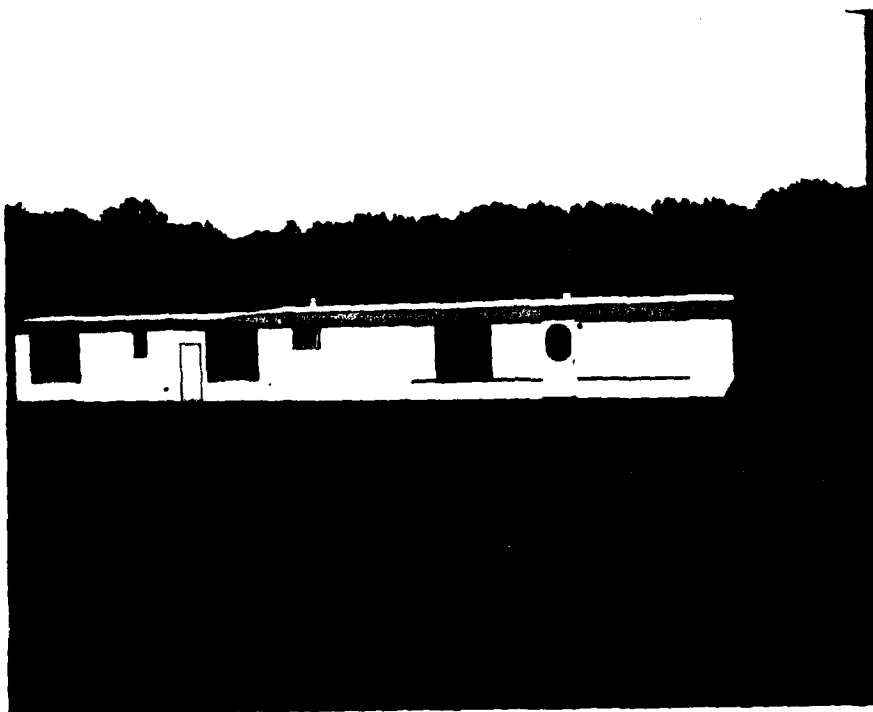
f. Downstream Channel. The downstream channels were satisfactorily maintained and in relatively good condition (see Photo 8). Photos 20-24 shows property and dwellings in the community of Idewild downstream of the reservoir.

Photo 22: Housetrailer Downstream of Duck Creek, Idlewild, MO

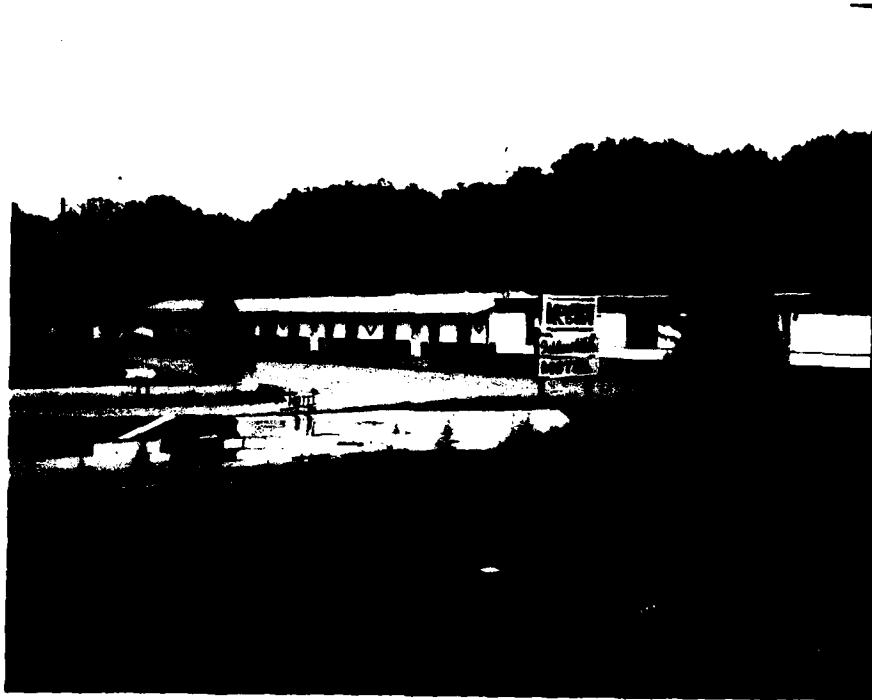
Photo 23: Motel Downstream of Duck Creek, Idlewild, MO
