MADDOX LAKE DAM
 WAYNE COUNTY, MISSOURI
 MISSOURI INVENTORY NO. 30024

⑥ ~~PHASE I INSPECTION REPORT~~
 NATIONAL DAM SAFETY PROGRAM

Maddox Lake Dam (MO 30024), Lower
 Mississippi - St. Francis Basin, Wayne
 County, Missouri. Phase I Inspection Report.

11 AUG 1978

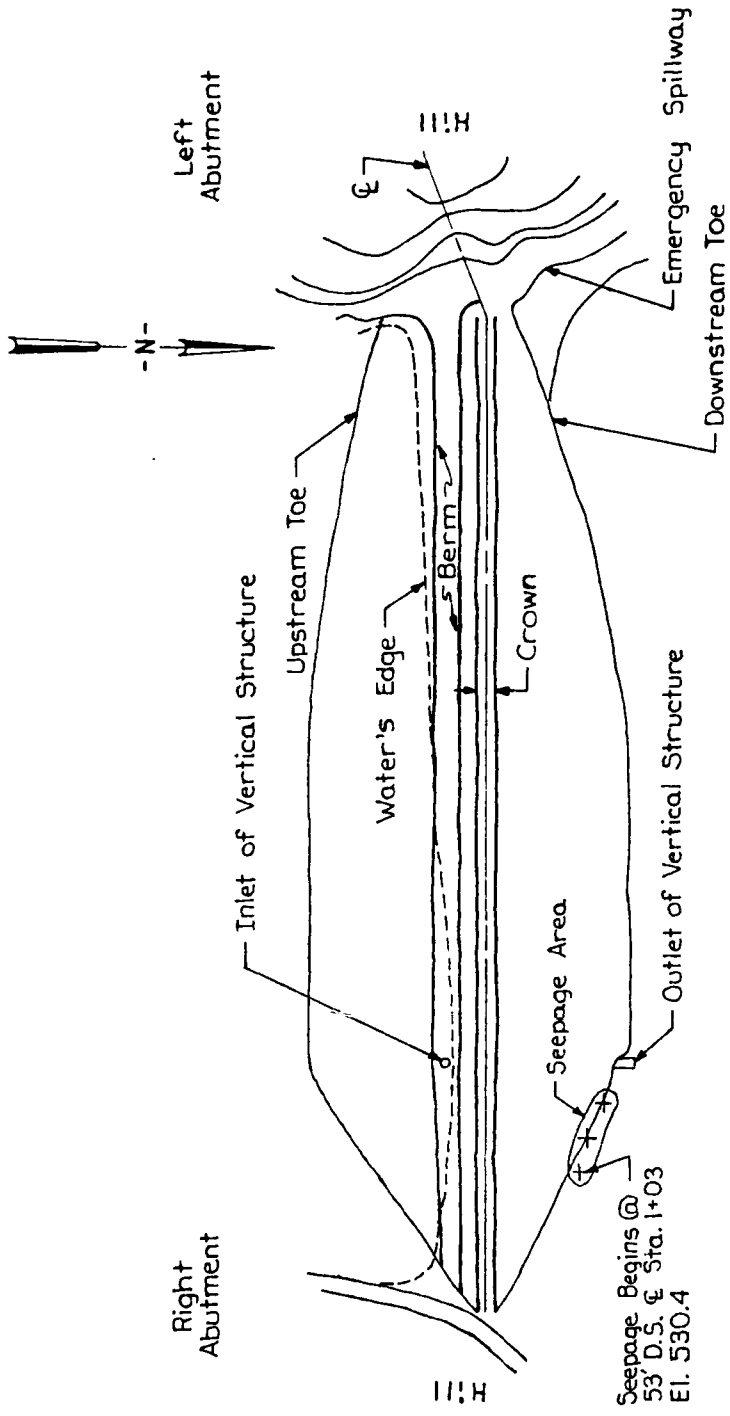
PLATE 3

Seepage was observed flowing at an estimated 5 gpm from the right abutment in the area shown on Plate 3. The seep water was reddish in color, indicating flow through a high iron content soil (see Photo 5) and had a temperature of 63°F. The owner of the dam stated that before the dam was constructed, a spring flowed from this area with reddish water and another spring flowed from an area approximately 500 feet downstream of the right abutment. He also stated that there are iron deposits in the hill which the right abutment adjoins. The downstream spring was located flowing from the hill with clear water having a temperature of 70°F. A temperature profile of the lake was performed with the following results:

Seepage Begins @
53' D.S. & Sta. 1+03
El. 530.4
