LOTTE DAM
WAYNE COUNTY, MISSOURI
MISSOURI INVENTORY NO. 30309

PHASE I INSPECTION REPORT
NATIONAL DAM SAFETY PROGRAM

PREPARED BY: ST. LOUIS DISTRICT CORPS OF ENGINEERS
FOR: GOVERNOR OF MISSOURI

AUGUST 1979

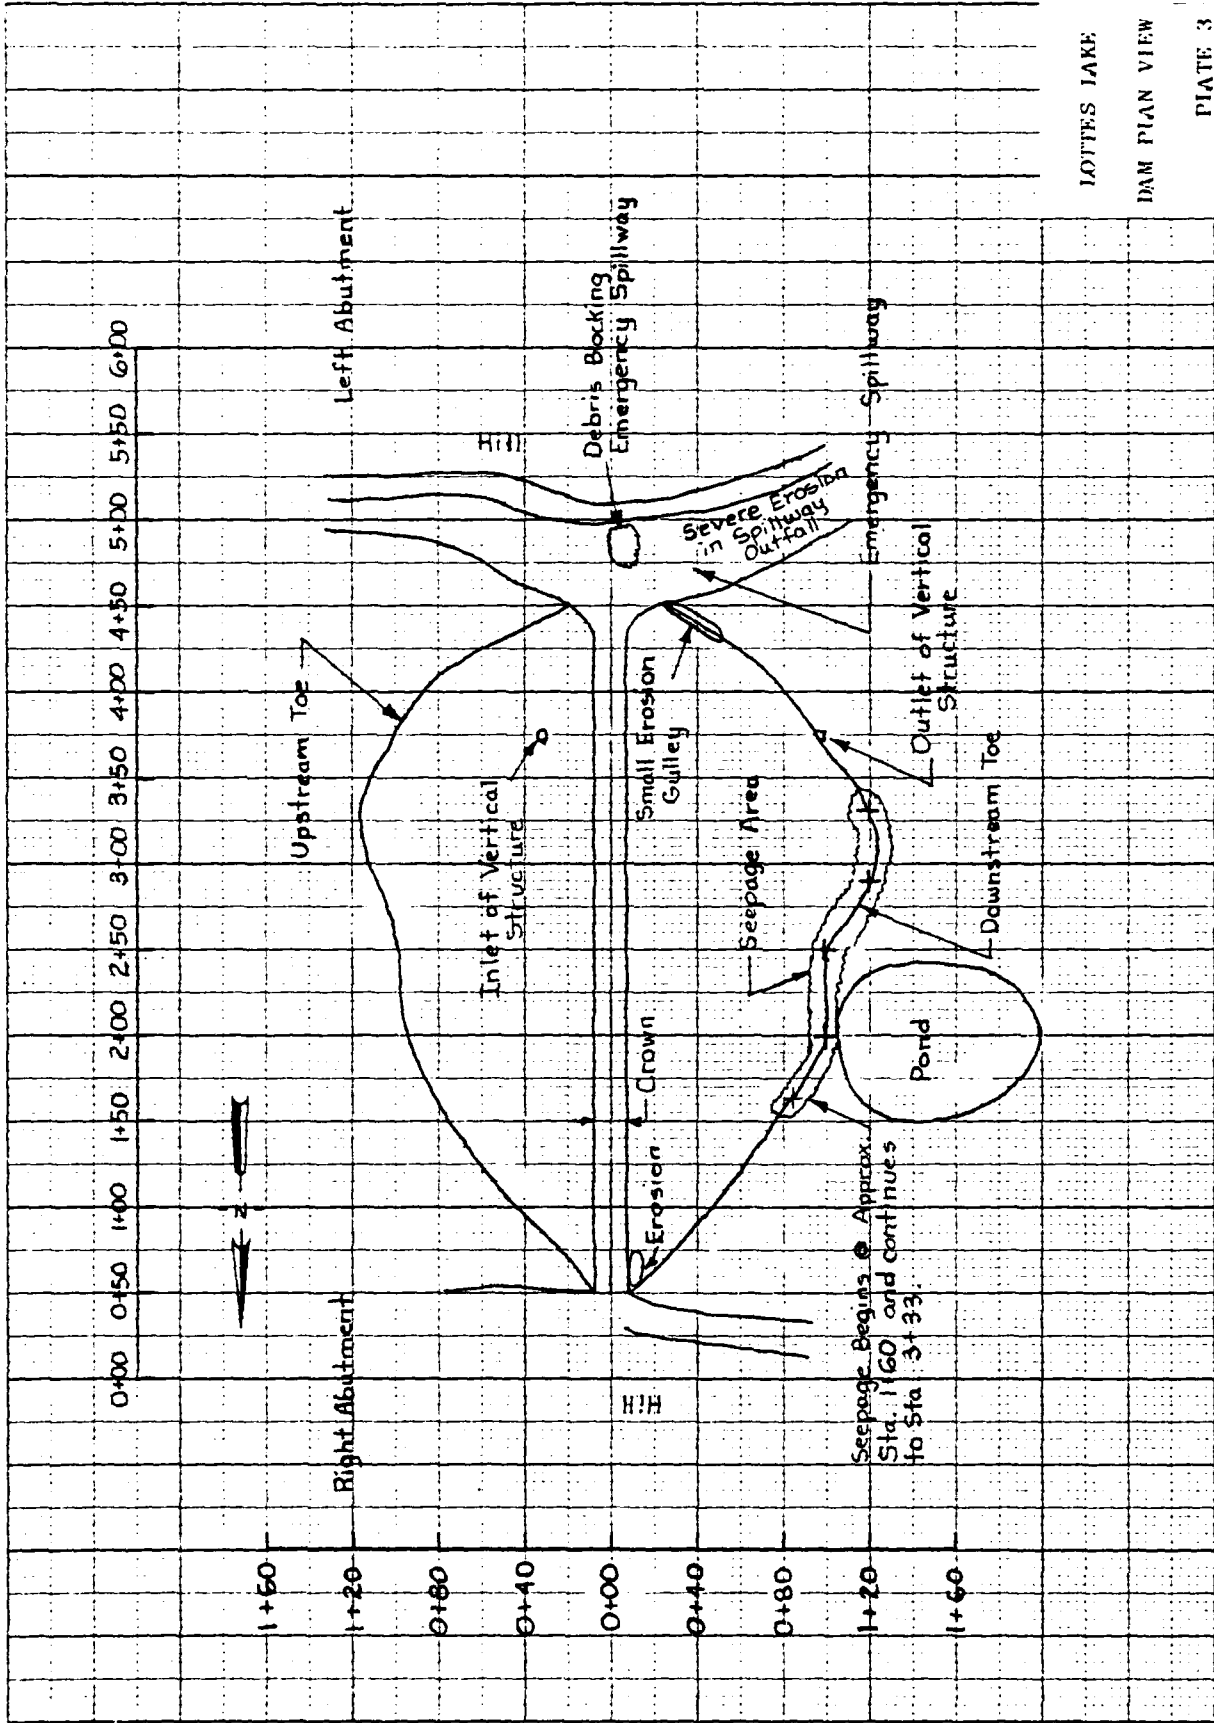
LOTTER'S LAKE
 DAM PLAN VIEW
 PLATE 3

Seepage was observed flowing from several locations at the toe of the dam from Sta. 1+60 to Sta. 3+33 (see Plate 3). There was also slight seepage flowing from the right abutment. Seepage was estimated to be approximately 5 gpm from each of the locations except at Sta. 2+90 where the seepage was estimated to be 20 gpm. All of the seep water, except that flowing from the right abutment, was reddish in color, indicating flow through a high iron content soil. None of the seepage appeared to be piping any material from the embankment or foundation. Seepage from the right abutment and at approximate Sta. 2+00 was used to feed a pond constructed at the toe of the dam near the right abutment (see Plate 3 and Photo 14). The pond is used to water stock and as a minnow pond. The pond follows the toe of the dam for approximately 75 feet and extended approximately 100 feet perpendicular to the dam. According to the owner the seepage began after the construction of the dam, but it has decreased approximately 80% during the life of the dam.

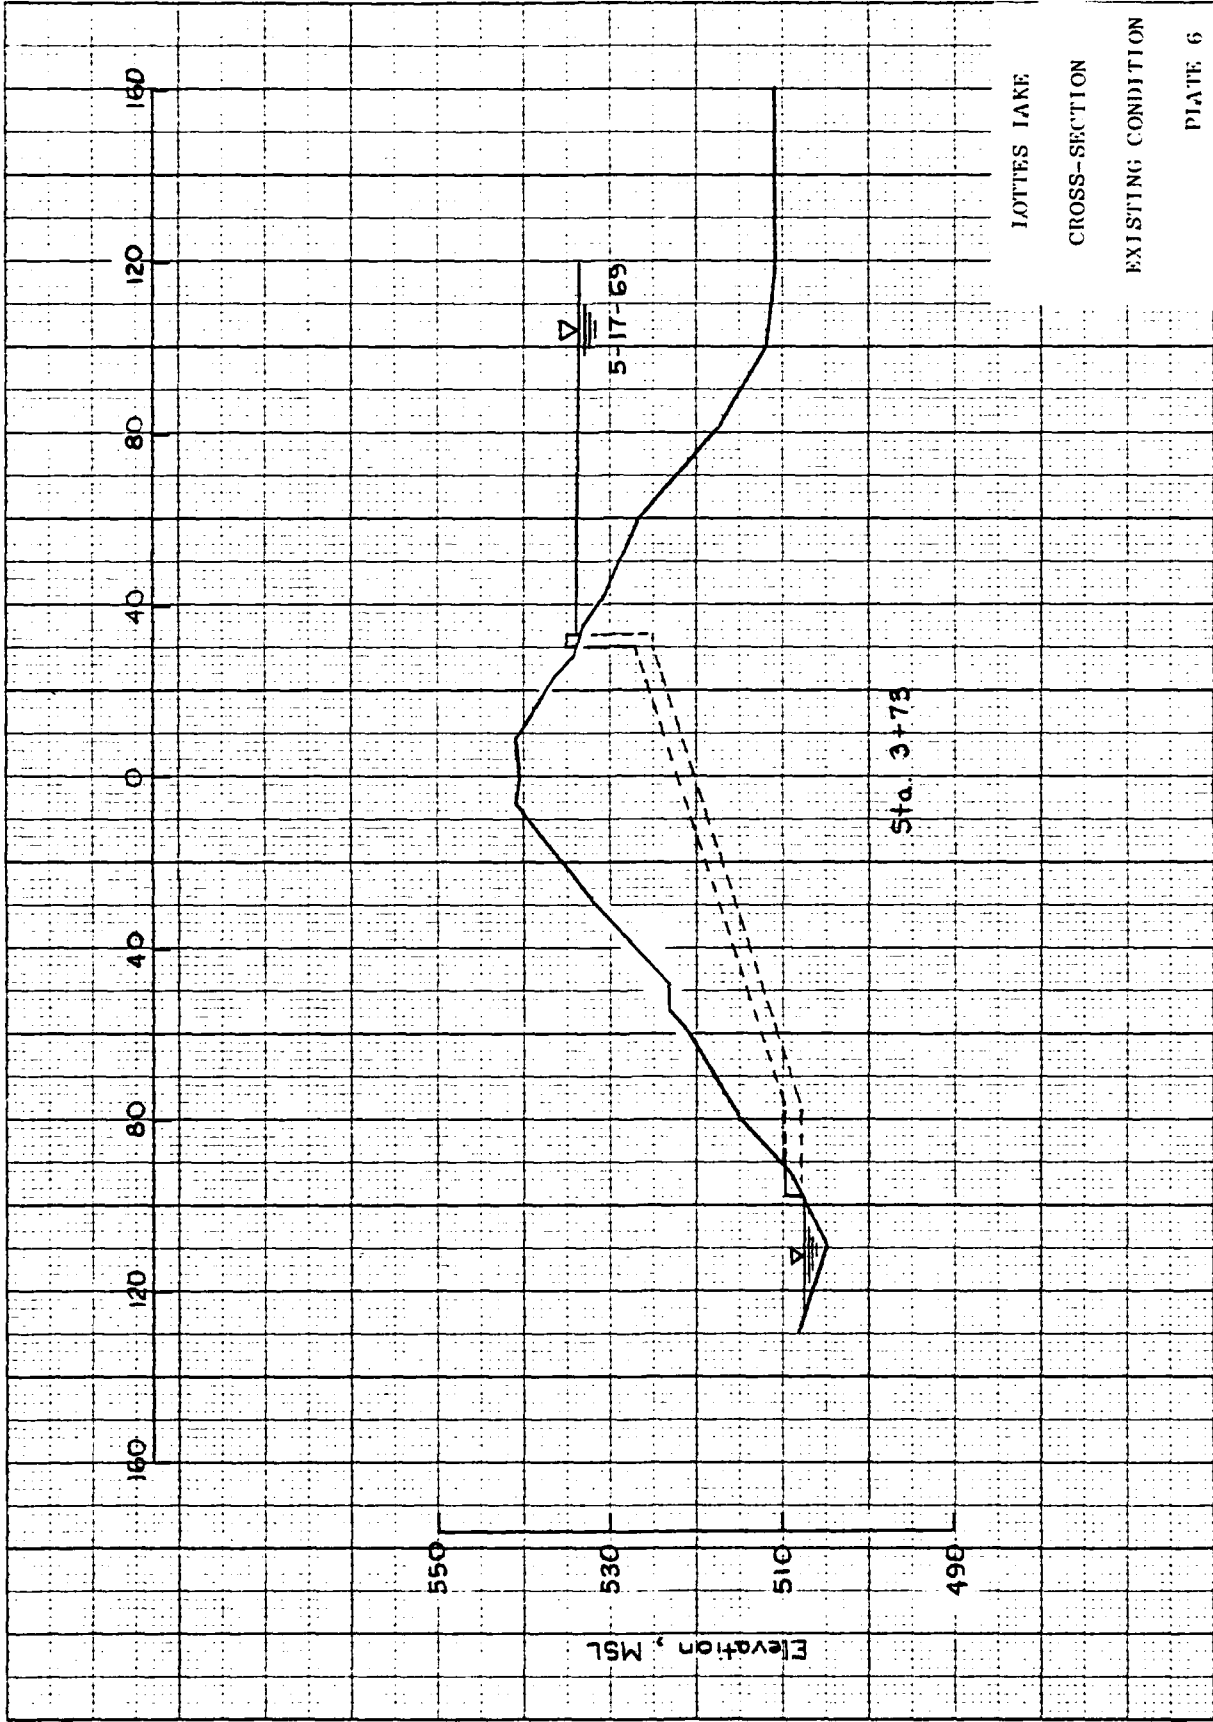
PLATE 6

b. Dam. No detrimental settlement, cracking, slides or animal burrows were observed in or near the earth embankment. A typical existing cross-section of the embankment is shown on Plate 6. This section is consistent with the cross-section presented in the Soils Conservation Service 1967 drawings (see Plate 5) except the downstream embankment slope is 1V on 2.75 H. Also, the elevations and sizes of the existing upstream and downstream berms differ slightly from those shown on the 1967 contract drawings. The existing upstream berm is at El. 534 m.s.l. instead of El. 535.5 m.s.l. as shown on the contract drawings. The existing downstream berm is at El. 523 m.s.l. and is 7 feet wide as compared to El. 521 m.s.l. and 8 feet wide as shown on the contract drawings. The crest and upstream dam embankment appear to be well maintained. The upstream slope had recently been cleared of small brush growth (see Photo 3). The entire downstream dam embankment is overgrown with trees and bushes (see Photos 4 and 6). The trees were planted after the construction of the dam in 1967.
