MOUNTAIN LAKE DAM
WAYNE COUNTY, MISSOURI

MISSOURI INVENTORY NO. 30044

PHASE I INSPECTION REPORT
NATIONAL DAM SAFETY PROGRAM

AUGUST 1978

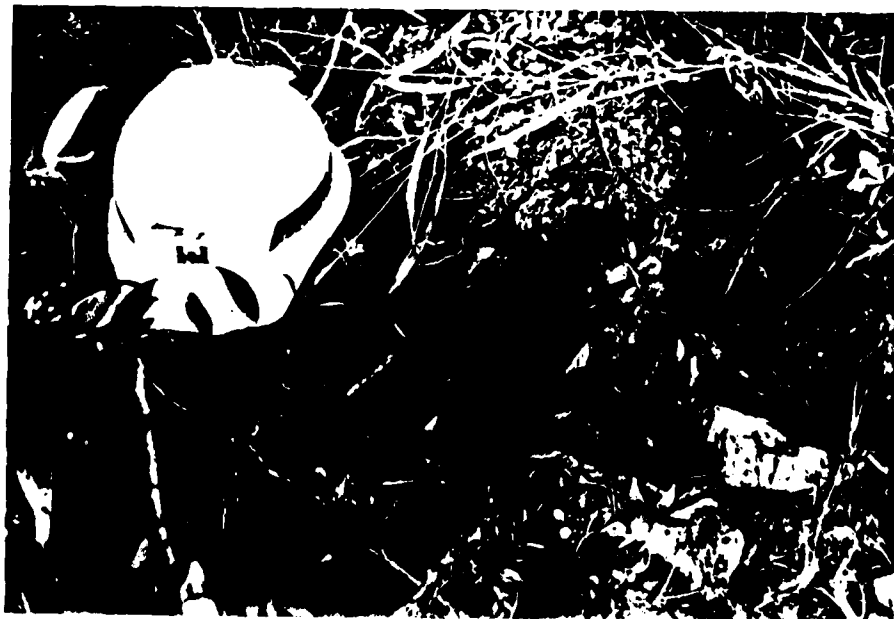
PHOTO 4: Animal Burrow on Crown of Dam

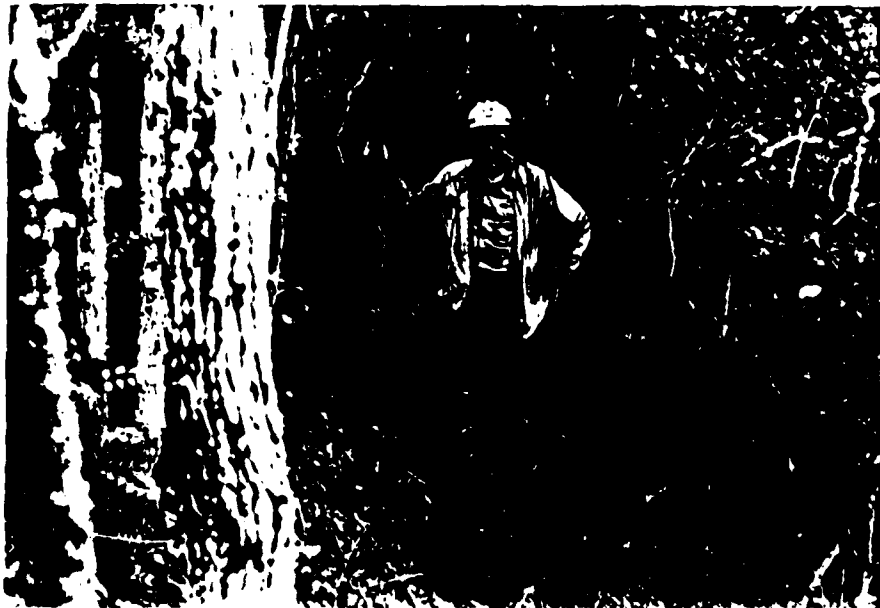
PHOTO 5: Downstream Slope

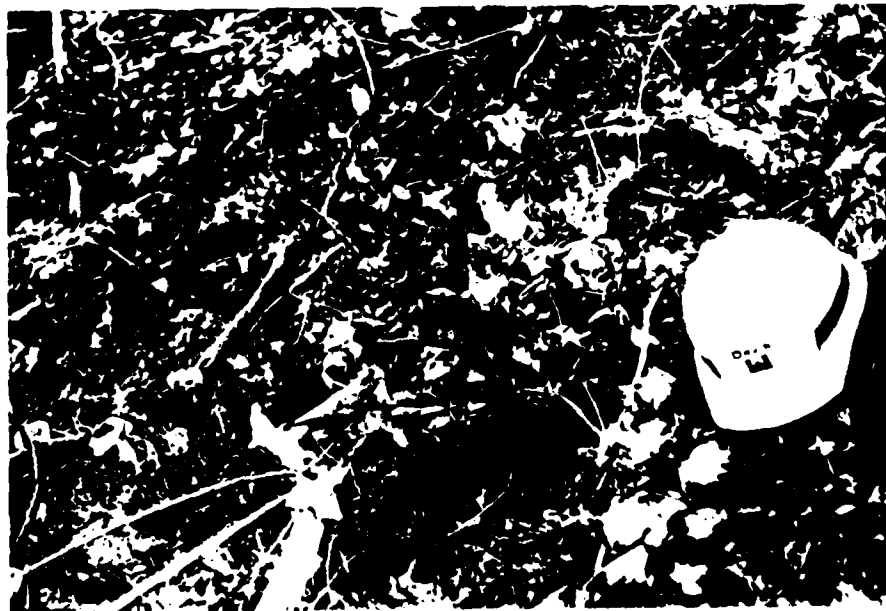
Light seepage was observed in three areas downstream of the embankment. Two of the areas were approximately 50 feet long and 10 feet wide located at baseline stations 6+00 + and 3+50 + about 10 feet from the downstream toe of the embankment. The other area of seepage is adjacent to the downstream embankment toe between baseline stations 2+00 and 3+00. Approximately 5 gpm was flowing from this area (see Photo 10).

PHOTO 8: Saturated Area on Downstream Slope

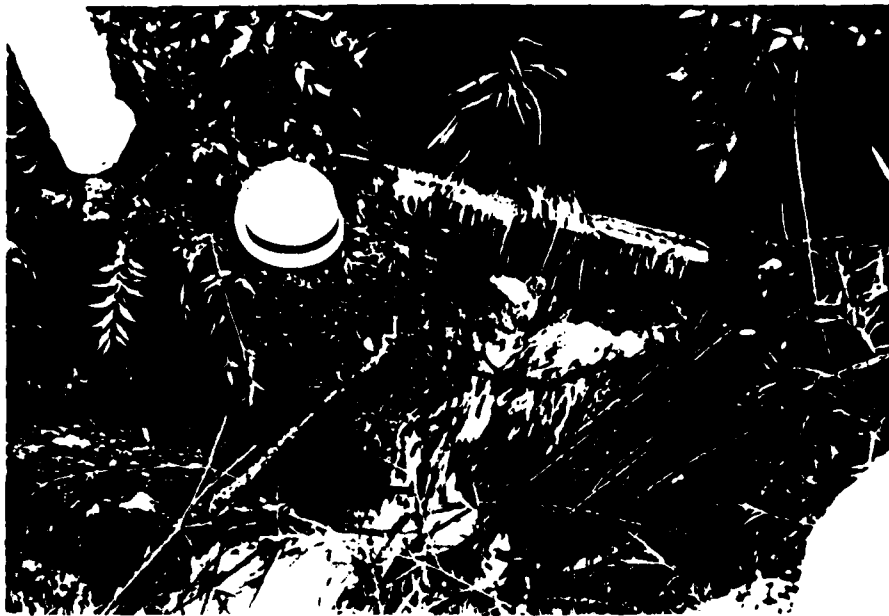
PHOTO 15: Notch in Spillway Weir
