CLAYMONT WOODS LAKE DAM  
ST. LOUIS COUNTY, MISSOURI

MISSOURI INVENTORY NO. 10489

PHASE I INSPECTION REPORT  
NATIONAL DAM SAFETY PROGRAM

SEPTEMBER 1978

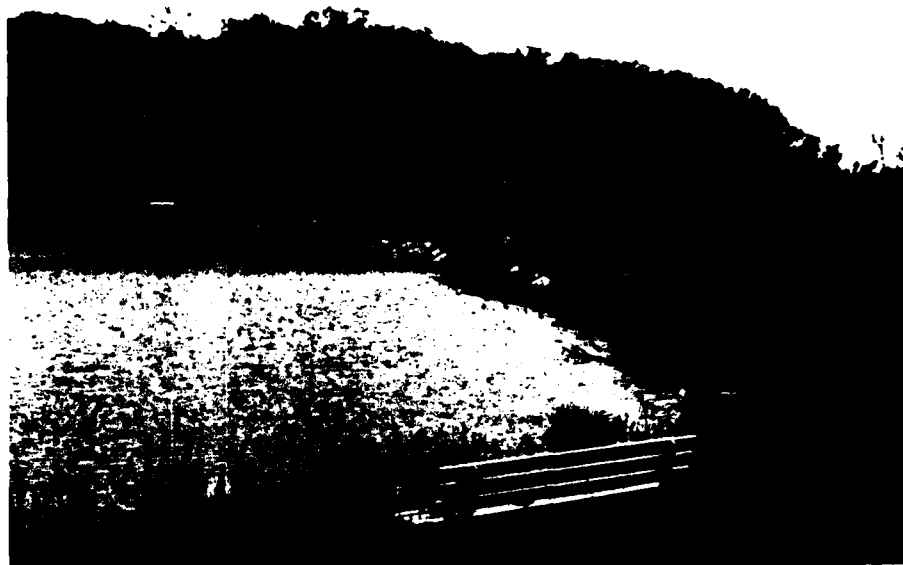
b. Dam and Auxiliary Spillway. The upstream and downstream slopes of the dam (see Photos 1 and 2) and auxiliary spillway sections were found to be in good condition with the exception of some minor erosion due to surface storm runoff. Both the crest and upstream side slopes of the embankment to the right (looking downstream) of the concrete spillway, which were intended to be protected by grass, were found for the most part to be sparsely covered. No evidence of lake seepage was noticed along the backslope or drainage ditch paralleling the dam. Trees and brush were present on the backslope at and in the drainage ditch (see Photo 2).

NO. 1: UPSTREAM FACE OF DAM

(4) Fill eroded areas and reseed the crest and upstream slopes of the dam and other areas where the existing grass cover is missing or sparse in order to provide protection against erosion by storm water drainage and subsequent loss of section.

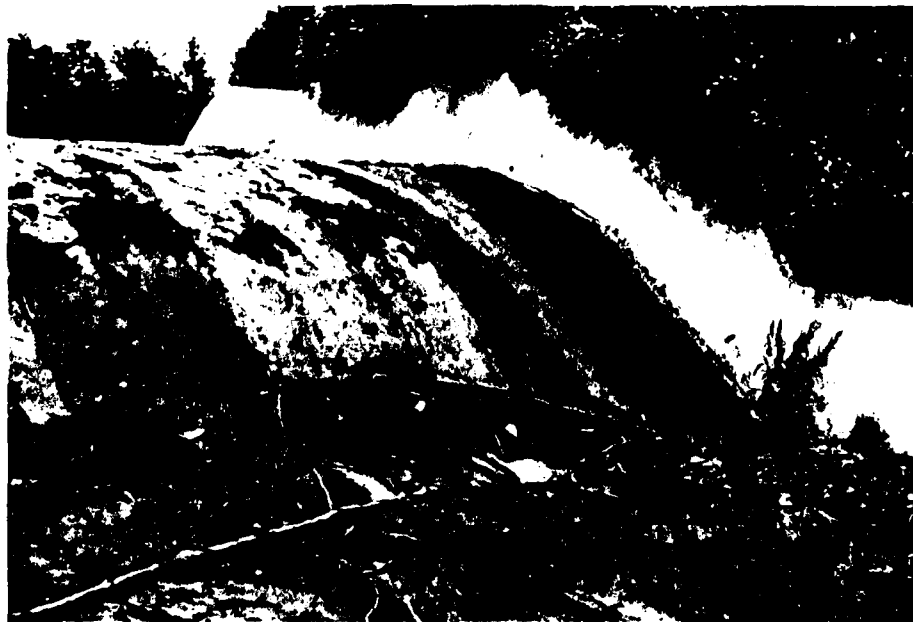
c. Principal Spillway. The fixed crest concrete spillway (see Photos 3 and 4) appeared to be in good condition. No significant deterioration of the concrete due to weathering or damage from ice was observed. Several vertical construction joints, mainly at the junction of the walkway walls with the spillway training walls, showed a joint separation of as much as 1/2-inch (see Photo 8) at the top. This separation is apparently due to differential settlement of adjacent structural sections. No loss of backfill material through these joint openings was apparent.

NO. 4: SPILLWAY OGEE
