SHERMAN LAKE DAM
BOLLINGER COUNTY, MISSOURI
MISSOURI INVENTORY NO. 30839

PHASE I INSPECTION REPORT
NATIONAL DAM SAFETY PROGRAM

PREPARED BY: ST. LOUIS DISTRICT CORPS OF ENGINEERS
FOR: GOVERNOR OF MISSOURI
AUGUST 1979

Name of Dam	Sherman Lake Dam
State Located	Missouri
County Located	Bollinger County
Stream	Castor River
Date of Inspection	23 May 1979

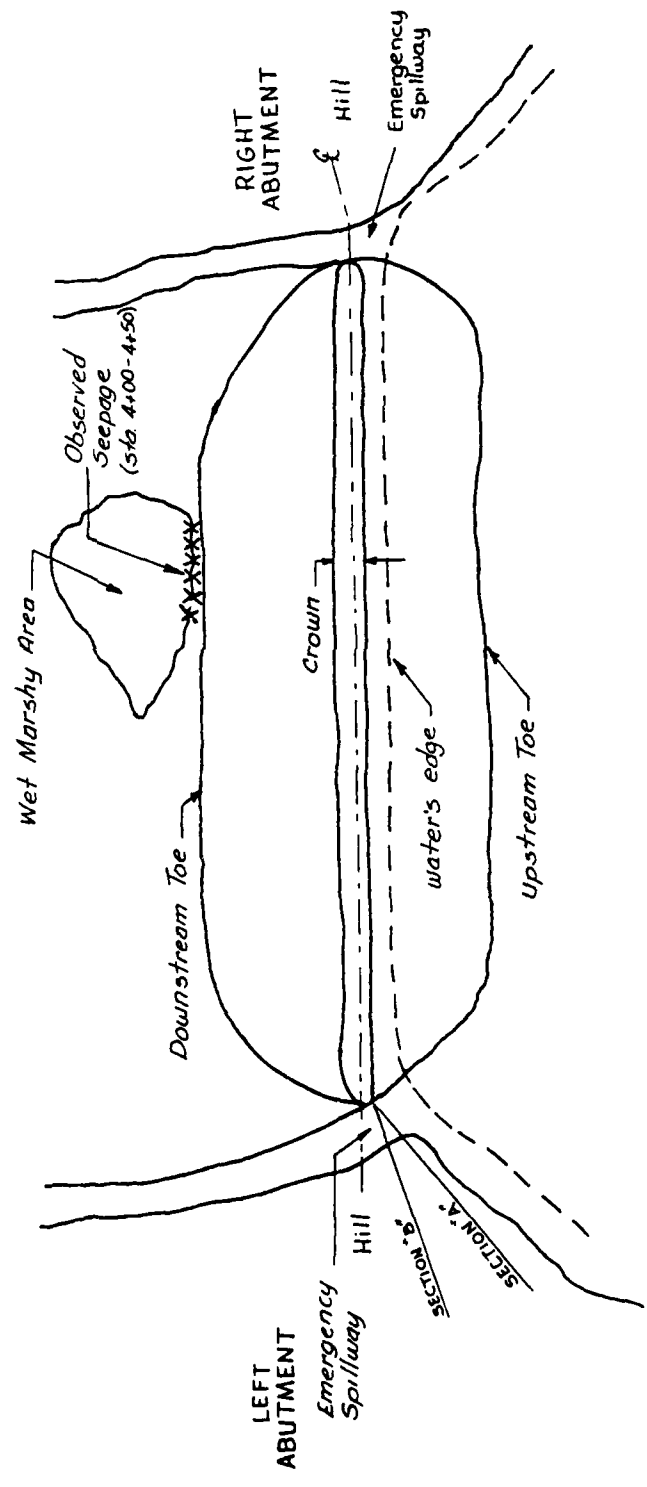
SIERMAN LAKE
DAM PLAN VIEW
PLATE 6

A large wet area was observed at the downstream toe of the dam from baseline 3+00⁺ to station 4+50⁺ (see Plate 6). The area was soft and spongy and was covered with trees, cattails, and other vegetation (see Photos 10 and 11). Crawfish holes were also observed in the area. Portions of the area appeared to be just trapped water, but evidence of seepage was apparent at several locations (see Photos 12 and 13). The majority of the seepage seemed to be concentrated in an area from stations 4+00 to 4+50. Seepage flows were estimated to be 50 gpm. No material was observed being piped by the seepage flows.
