**SAYERSBROOK LAKE DAM  
WASHINGTON COUNTY, MISSOURI  
MO 30112**

**PHASE 1 INSPECTION REPORT  
NATIONAL DAM SAFETY PROGRAM**

**SAYERSBROOK LAKE DAM  
WASHINGTON COUNTY, MISSOURI  
MISSOURI INVENTORY NO. 30112**

Name of Dam: Sayersbrook Lake Dam  
State Located: Missouri  
County Located: Washington  
Stream: Ashley Branch Fourche a Renault  
Date of Inspection: 22 August 1978

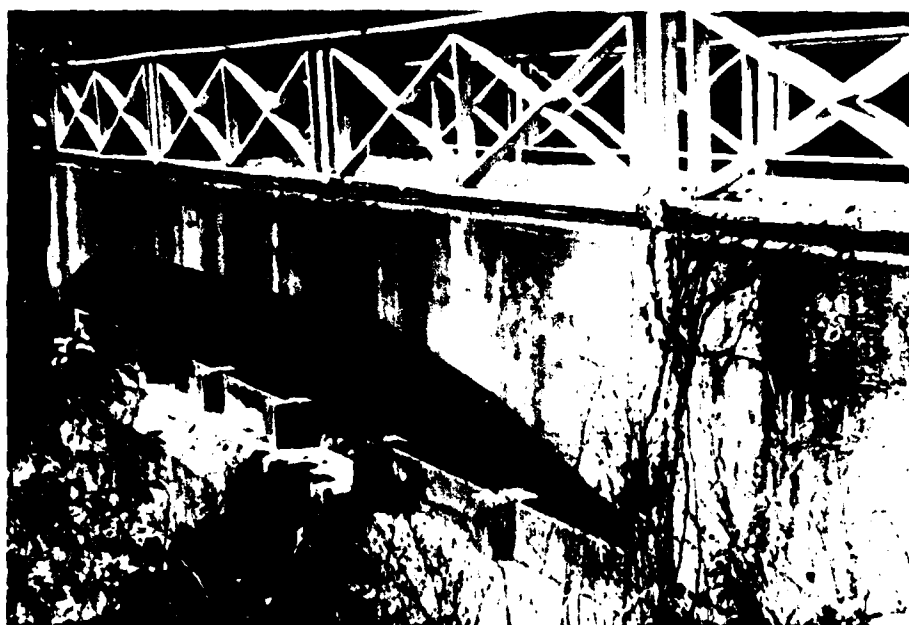
4. Lake water was noticed emerging in the bottom of the spillway channel at a point approximately 10 feet downstream of the concrete weir. It appears that a seepage path may have developed beneath the spillway wall. Seepage at this location could develop into a piping condition that could affect the operation of the lake.

c. Principal Spillway. The concrete weir at the principal spillway, including the 12-inch high piers for support of the wood planks and the concrete bridge crossing the spillway approach channel (see Photo 5), appeared to be in sound condition. The clear distance between the concrete weir and the underside of the bridge was measured to be approximately 3.5 feet. Water, believed to be from the lake, was emerging in the bottom of the spillway channel at a point approximately 10 feet downstream of the concrete weir. A heavy growth of small willows and brush was noticed in the exit channel (see Photo 6) between the spillway crest and the downstream channel.

NO. 5: SPILLWAY WEIR AND BRIDGE

(5) The possibility exists that flow emerging in the channel near the spillway weir could develop into a piping condition that would affect the operation of the lake. The Owner should investigate this condition and determine the corrective measures to be taken.
