LAKE OF THE HILLS DAM
BOLLINGER COUNTY, MISSOURI
MISSOURI INVENTORY NO. 30077

PHASE I INSPECTION REPORT
NATIONAL DAM SAFETY PROGRAM

PREPARED BY: ST. LOUIS DISTRICT CORPS OF ENGINEERS
FOR: GOVERNOR OF MISSOURI

AUGUST 1979

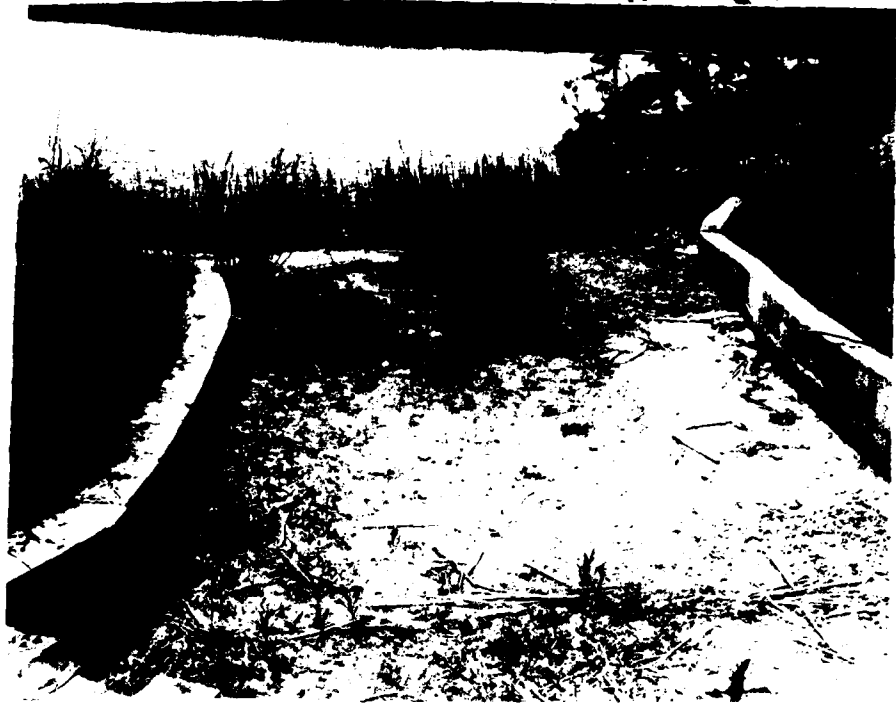
PHOTO 13: Emergency Spillway - Upstream View
