| REPORT DOCUMENTATION PAGE | | READ INSTRUCTIONS<br>BEFORE COMPLETING FORM |
|---|---|---|
| 4. TITLE (and Subtitle)<br>Phase I Dam Inspection Report<br>National Dam Safety Program<br>Indian Rock Lake Dam (MO 31033)<br>Franklin County, Missouri | | 5. TYPE OF REPORT & PERIOD COVERED<br>Final Report |

INDIAN ROCK LAKE  
FRANKLIN COUNTY, MISSOURI  
MISSOURI INVENTORY NUMBER 31033

PHASE I INSPECTION REPORT  
NATIONAL DAM SAFETY INSPECTION

PREPARED BY: ST. LOUIS DISTRICT CORPS OF ENGINEERS  
FOR: GOVERNOR OF MISSOURI  
JULY 1978

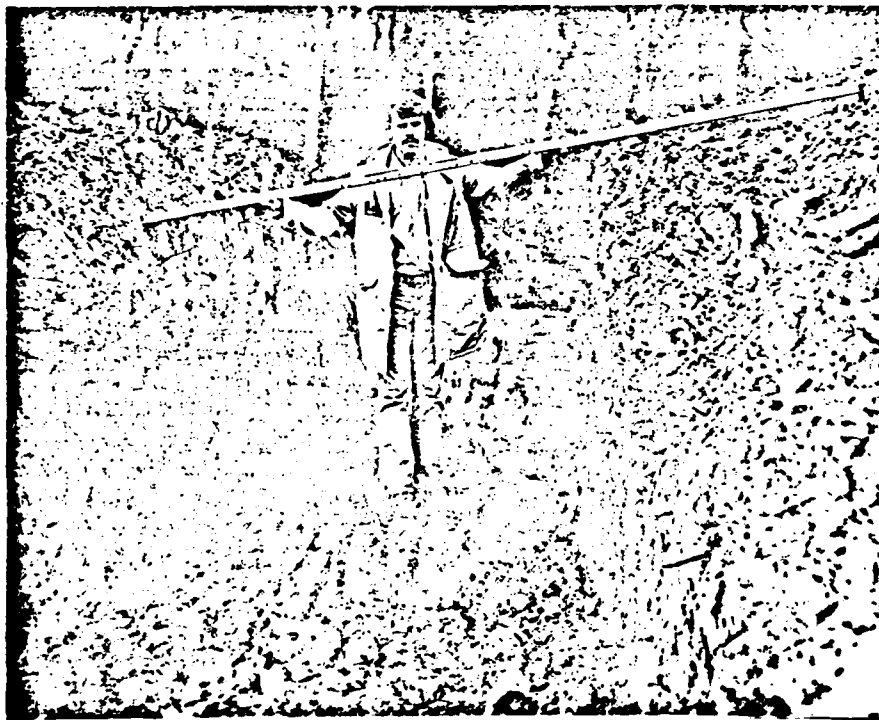
An unprotected 6-foot by 6-foot outlet cut through the embankment as an emergency spillway indicated the dam is unzoned, or of homogeneous construction in the area exposed. Numerous roots were found in the fill material (see photo 2). These roots constitute a potential seepage hazard as they decay. Sidewalls of the cut were firm but the bottom was soft from flowing water. No erosion protection was provided. This earth cut could not be expected to remain intact during any prolonged flow. Significant embankment erosion, and possible failure, would likely occur.

(3) An unprotected 6 feet by 6 feet notch had recently been cut through the embankment near the left abutment to serve as an emergency spillway. The water flowing through the notch was cutting its own exit channel parallel to the toe of the dam to the creek. (See photos 2 and 3).

PHOTO 2      Spillway cut through embankment

d. Provide an adequately sized and erosion resistant spillway and exit channel with proper energy dissipators.
