MONROE CITY DAM  
RALLS COUNTY, MISSOURI  
MO. 10542

## PHASE I INSPECTION REPORT NATIONAL DAM SAFETY PROGRAM.

Monroe City Dam (MO-10542), Mississippi  
Salt - Quincy River Basin, Ralls County,  
Missouri. Phase I Inspection Report.

JANUARY 1979

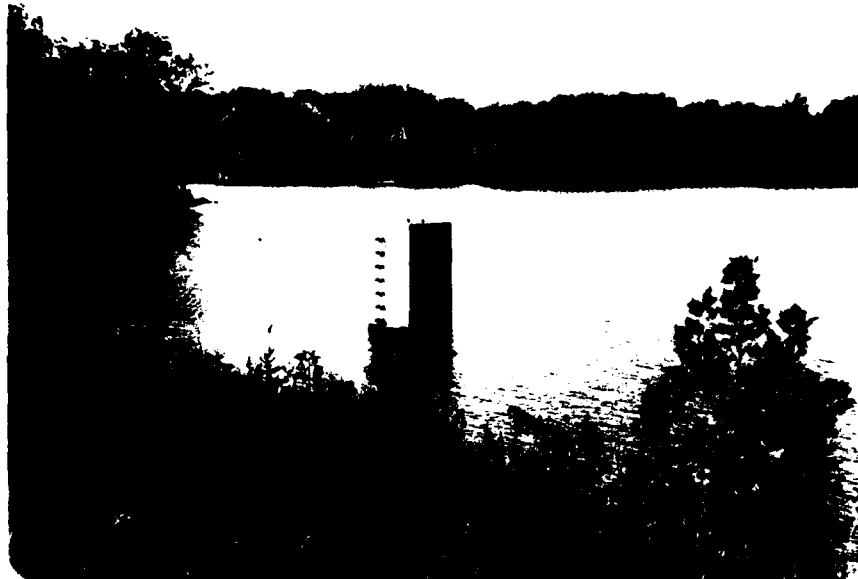
The observed portions of concrete in the intake tower and headwall were seen to be in good, sound condition. The closure flange on the outlet pipe is firmly bolted in place, but has a light coating of rust. The pump station was locked and its interior could not be inspected.

Photo 7 - Picture of intake structure for water supply piping.
