NEW LA BELLE LAKE DAM  
LEWIS COUNTY, MISSOURI  
MO 10372

## PHASE I INSPECTION REPORT NATIONAL DAM SAFETY PROGRAM

Name of Dam: New Labelle Lake Dam, Missouri Inv. No. 10372  
State Located: Missouri  
County Located: Lewis  
Stream: Unnamed Tributary of Troublesome Creek  
Date of Inspection: September 27 and October 6, 1978

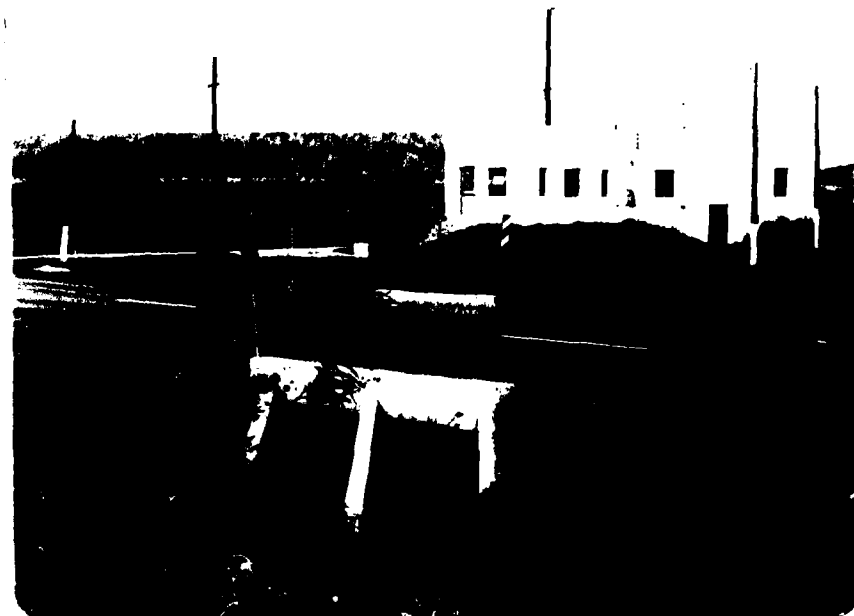
Photo 6 - Picture of water supply pumping house. Note downstream slope of dam in background.

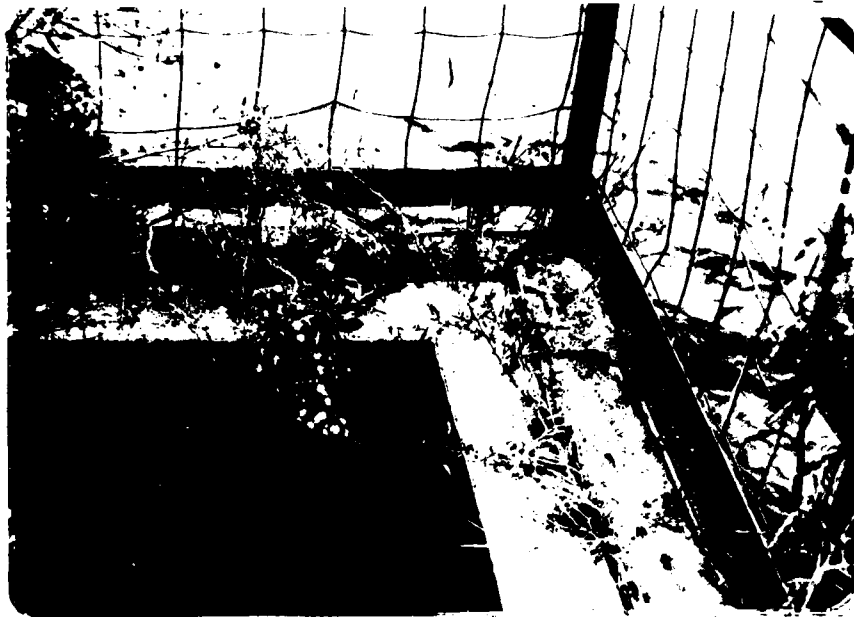
The concrete drop inlet structure is in a deteriorated condition. Several major vertical cracks, minor erosion and moderate spalling on the concrete were observed.

Photo 9 - Close-up of inlet structure for service spillway.  
Note cracked concrete on outside concrete wall.

The service spillway drop inlet structure should be repaired to prevent continuous flow through the pipe. This condition is especially critical due to the likely leakage in the C.M.P. pipe and the poor condition of the service spillway discharge channel.
