AD-A104 784

PRC CONSOER TOWNSEND INC ST LOUIS MO  
NATIONAL DAM SAFETY PROGRAM. WYACONDA CITY DAM (NO 10009), MISS--ETC(U)  
DEC 78

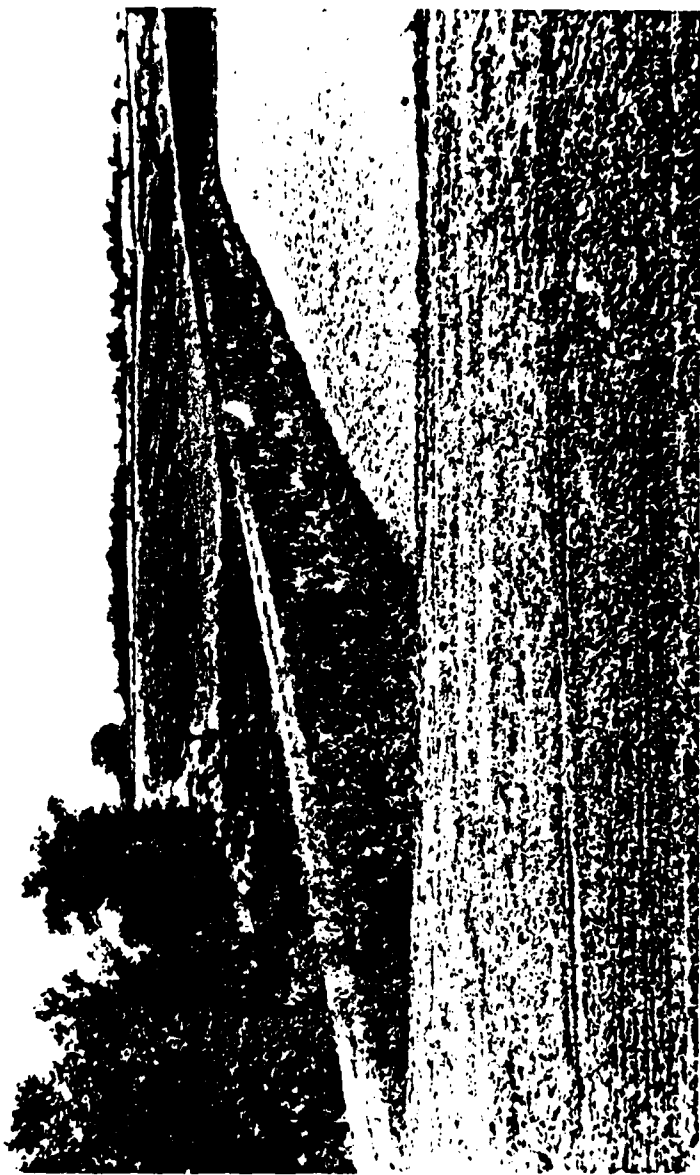
It is recommended that the owner take action to correct or control the deficiencies described above.

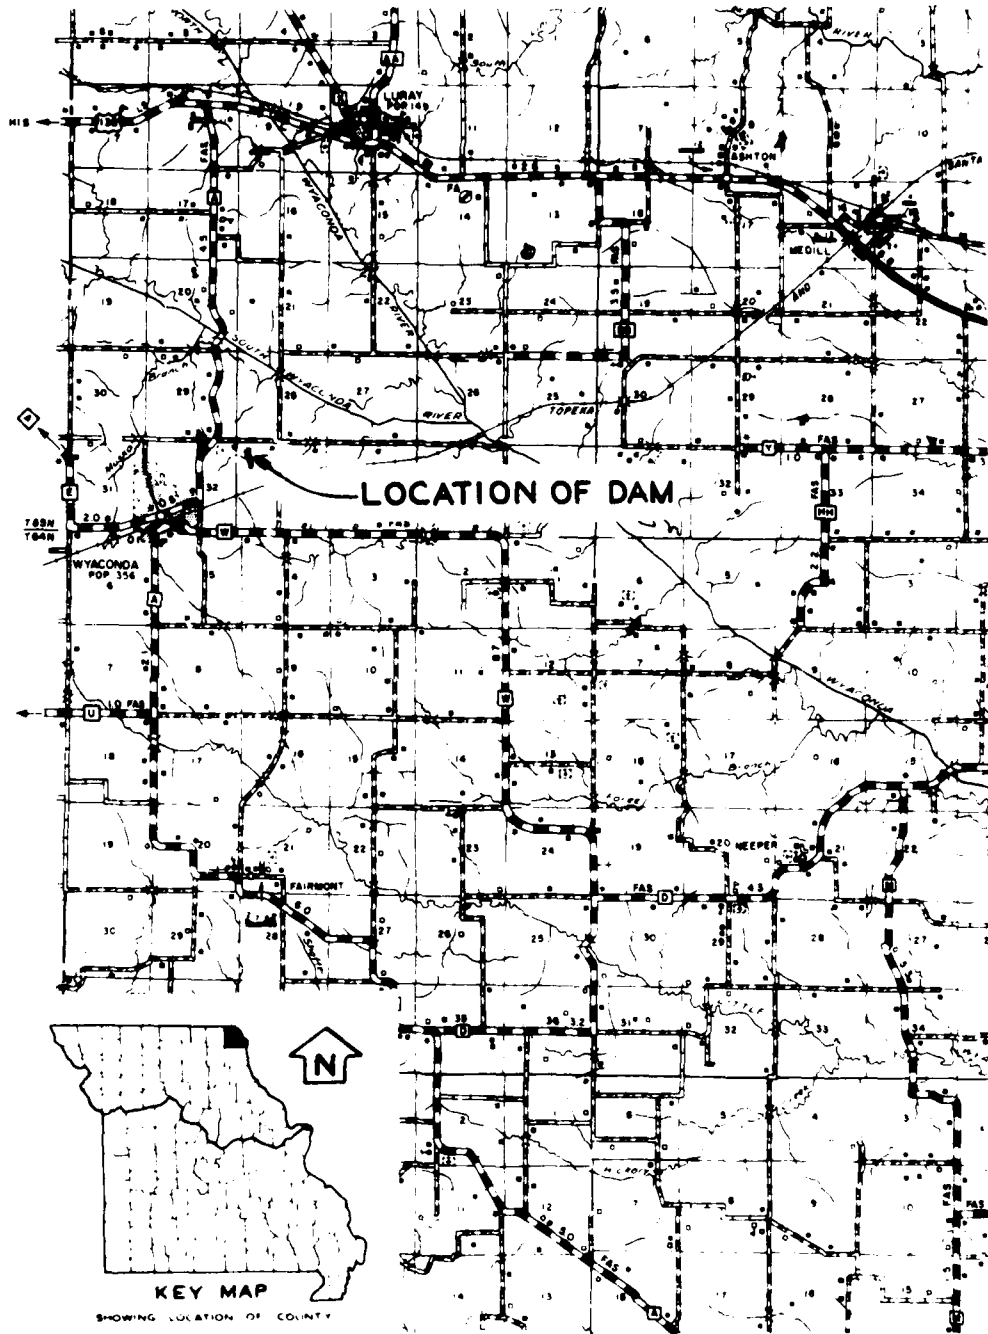
LOCATION MAP  
 WYACONDA CITY DAM  
 CLARK COUNTY, MISSOURI

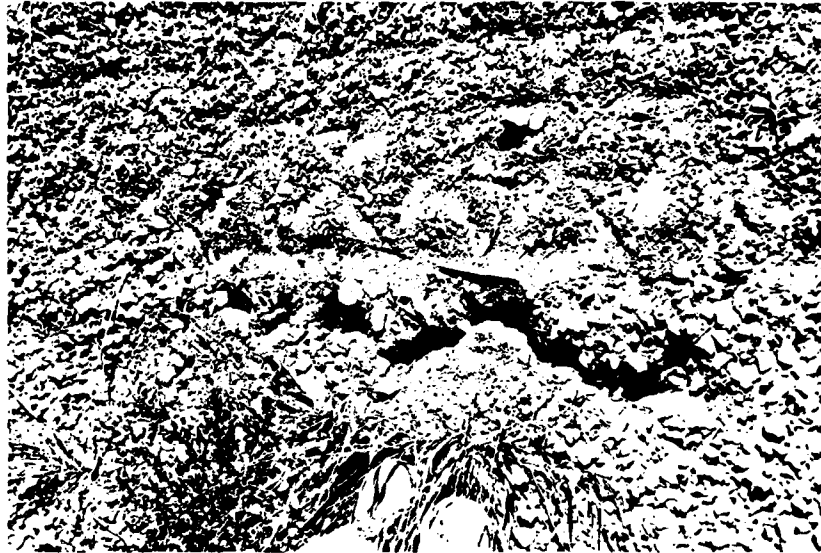
Photo 7 - Close-up of cracking near downstream edge of crest.

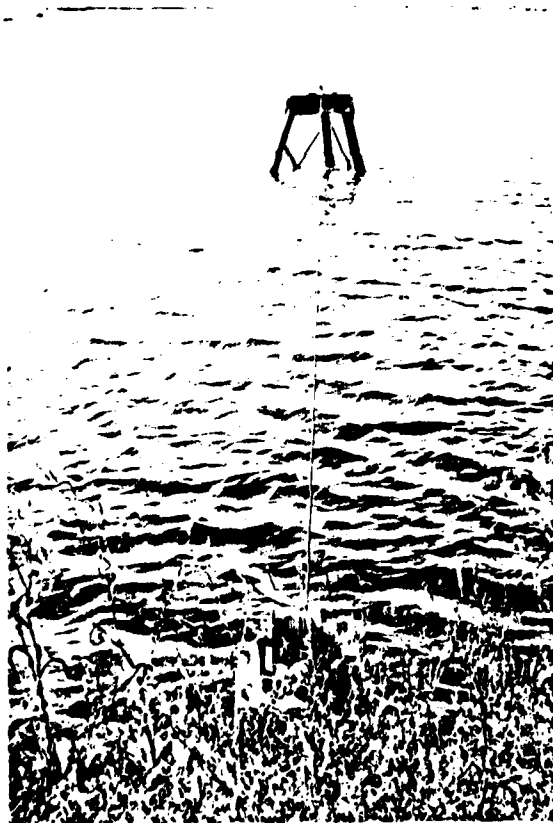
Photo 8 - Picture of hoist arrangement for the water supply intake.
