**MEMPHIS LAKE AND PARK DAM  
SCOTLAND COUNTY, MISSOURI  
MO 10217**

**PHASE I INSPECTION REPORT  
NATIONAL DAM SAFETY PROGRAM**

**DECEMBER 1978**

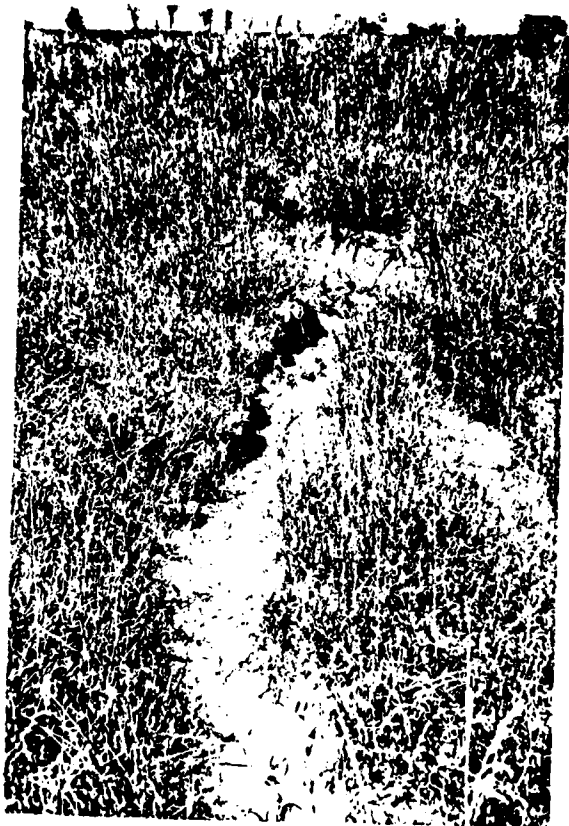
The downstream embankment slope is covered with heavy grass vegetation. Along each abutment contact are relatively large surface erosion gullies. Some of these gullies are 3 to 4 feet deep by 2 feet wide. These gullies are very large for a dam as new as this structure, and repairs should be made to reduce the erosion.

Photo 5 - Picture of erosion gullies in downstream slope along left abutment contact.

The surface erosion gullies should be repaired within a reasonable period of time to prevent the removal of large amounts of embankment material.

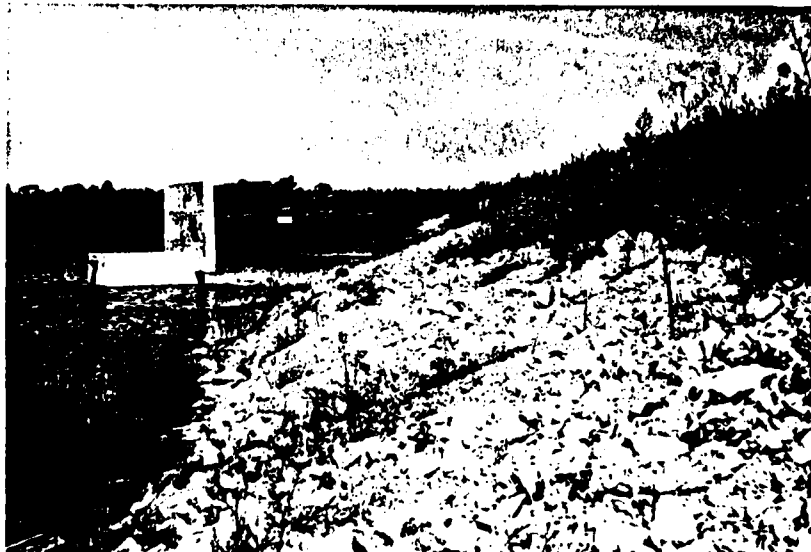
The concrete drop inlet structure is in excellent condition with the exception that there are no provisions for trashracks on the concrete crest. No evidence of structural cracking or spalling could be found. No leakage in the 60-inch C.M.P. was detected. The stilling basin at the end of the 60-inch C.M.P. is also in a good condition, with adequate riprap protection.

Photo 8 - Picture of drop inlet structure for service spillway.

5. Provide a trashrack over the drop inlet of the service spillway.
6. Uncover the buried discharge ends of the low level outlet and the water supply outlet.
7. Seepage and stability analyses should be performed by a professional engineer experienced in the design and construction of dams.
