EWING DAM
LEWIS COUNTY, MISSOURI
MO 10218

**PHASE I INSPECTION REPORT
NATIONAL DAM SAFETY PROGRAM**

DECEMBER 1978

Name of Dam: Ewing Dam, Missouri Inv. No. 10218
State Located: Missouri
County Located: Lewis
Stream: Unnamed Tributary of the Middle Fabius River
Date of Inspection: September 26, and October 6, 1978

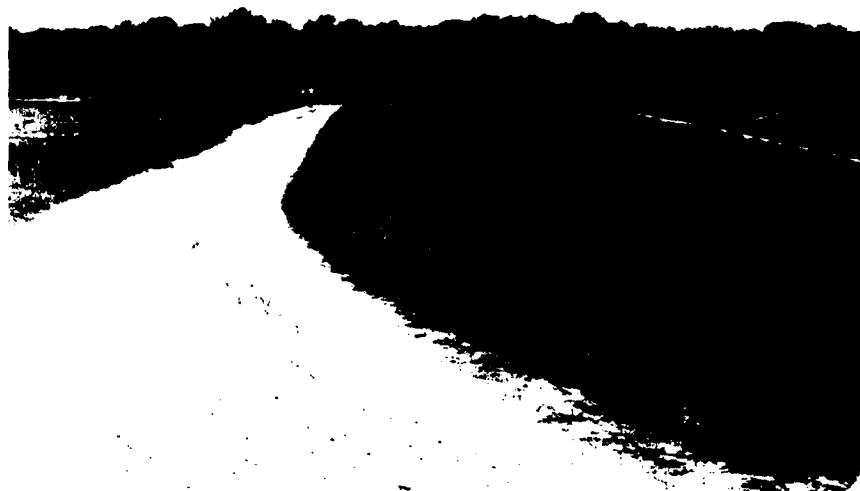
Photo 1 - View along crest of dam taken at right abutment.

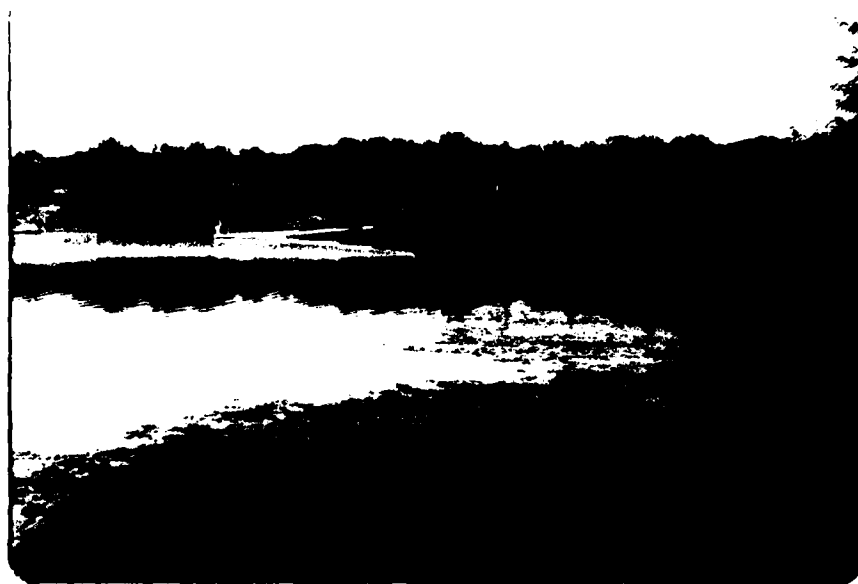
Photo 2 - View of upstream slope of dam taken from right side of dam.

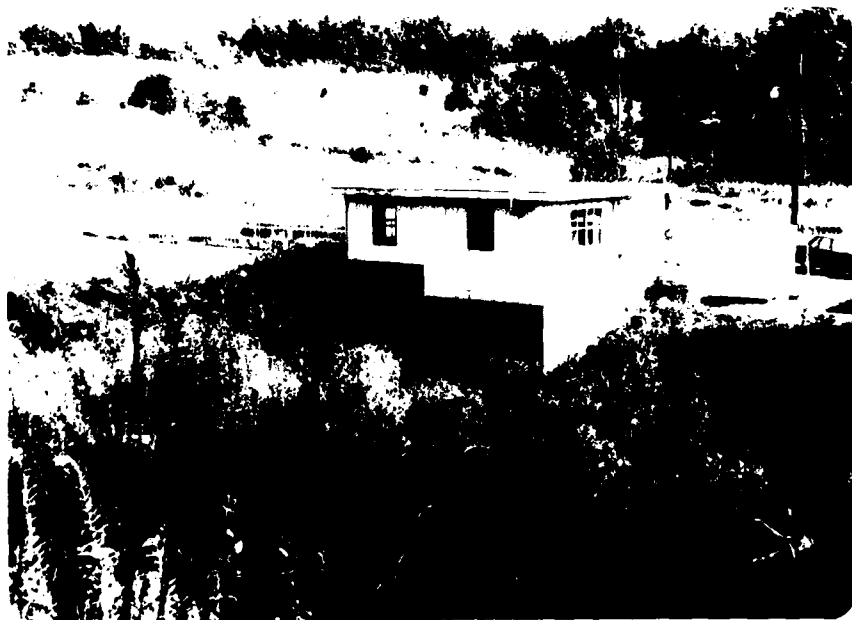
Photo 8 - Picture of water supply pump house.
