MEMPHIS RESERVOIR DAM
SCOTLAND COUNTY, MISSOURI
MO 10163

**PHASE I INSPECTION REPORT
NATIONAL DAM SAFETY PROGRAM**

Name of Dam: Memphis Reservoir Dam, Missouri Inv. No. 10163
State Located: Missouri
County Located: Scotland
Stream: Unnamed Tributary of the North Fabius River
Date of Inspection: October 4, 1978

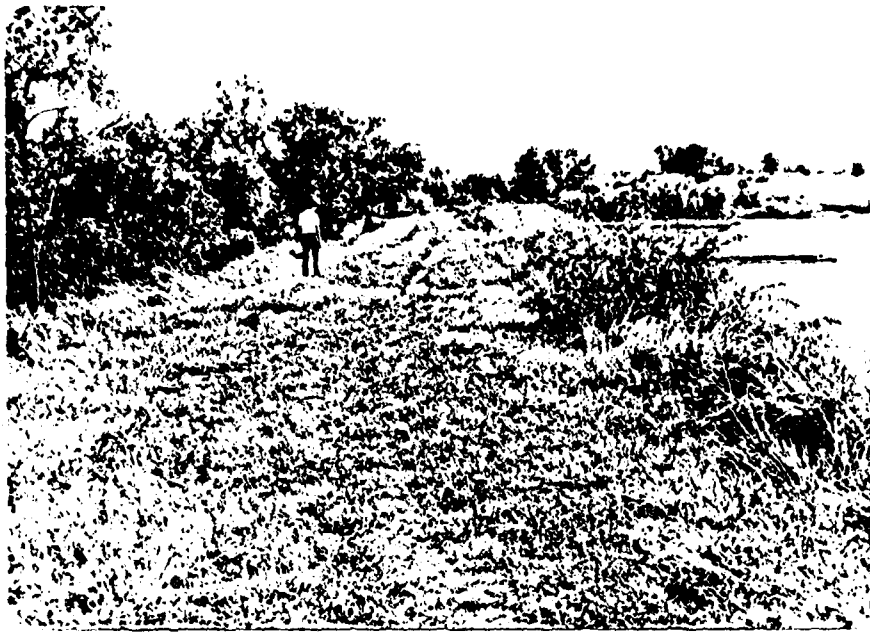
Photo 1 - View along crest of dam taken from near left abutment.

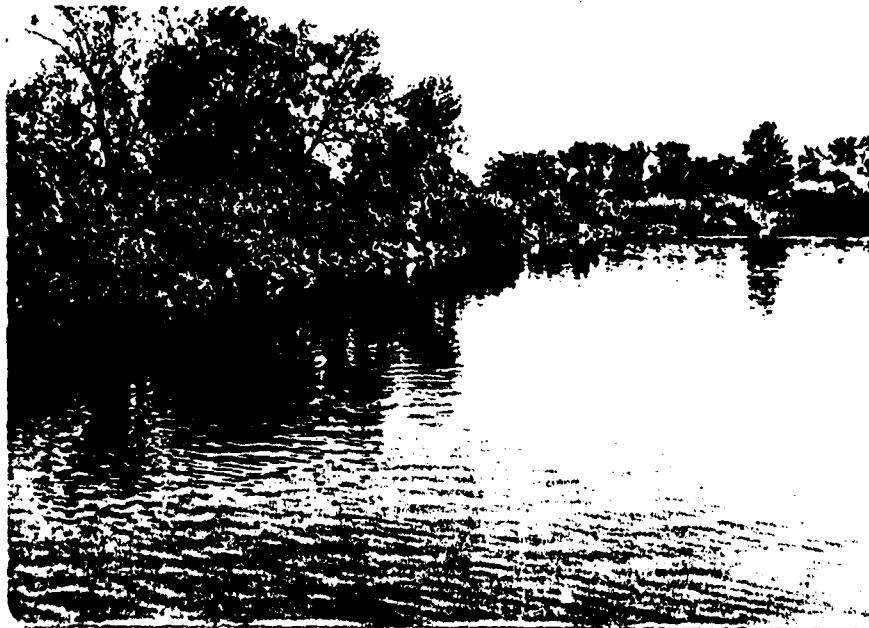
1. The trees and brush beginning to grow on the upstream embankment slope.
2. The vegetation growing in the approach channel for the service spillway and the slotted spillway.
3. The deteriorated concrete and leakage observed in the concrete channel of the service spillway.

Photo 2 - Picture of upstream slope of embankment taken from left side of dam.

The trees starting to grow on the upstream embankment slope should be cut before they become a hazard to the embankment. The downstream embankment slope should be maintained in its present condition.

3. The dam should be surveyed and an as-built set of plans and drawings should be completed.
4. Cut the small trees and brush on the upstream embankment slope.
5. Clear the vegetation from the approach channels of the spillways.
6. Patch the eroded and spalled concrete on the spillway structure as it becomes necessary.
7. Seepage and stability analyses should be performed by a professional engineer experienced in the design and construction of dams.

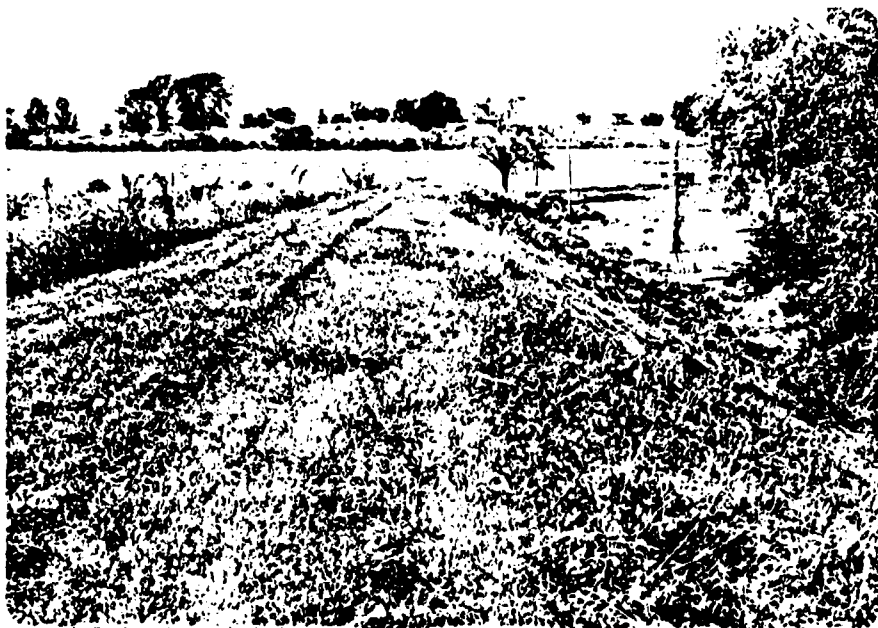
Photo 3 - Picture of crest and downstream embankment slope taken from near center of dam looking toward left abutment.

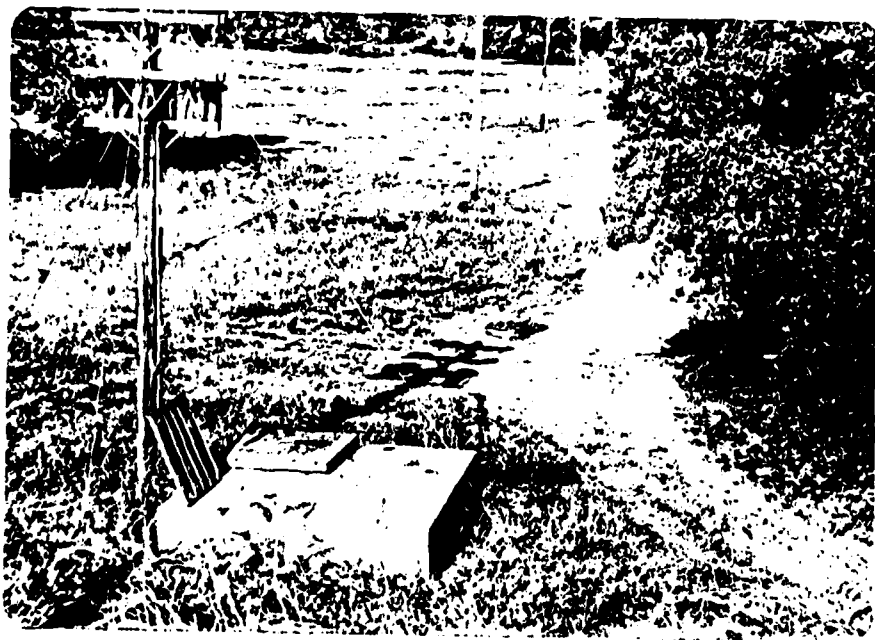
The cover of the pump vault was removed and the vault was entered for inspection. The appearance of the pumping and piping equipment was satisfactory, except there was several inches of standing water over the vault floor, and the electrical control boxes were open and the exposed wiring was in disarray. It was obvious from the condition of the wiring that the pumps were not operational.

connected in parallel to a 6-inch discharge line. The appearance of the pumping and piping equipment in the vault was satisfactory, except there was several inches of standing water over the vault floor and the electrical control boxes were open, with the exposed wiring in disarray. It was obvious from the condition of the wiring that the pumps were not operational, due to a lack of maintenance.

Photo 6 - Picture of pump house vault for water supply.

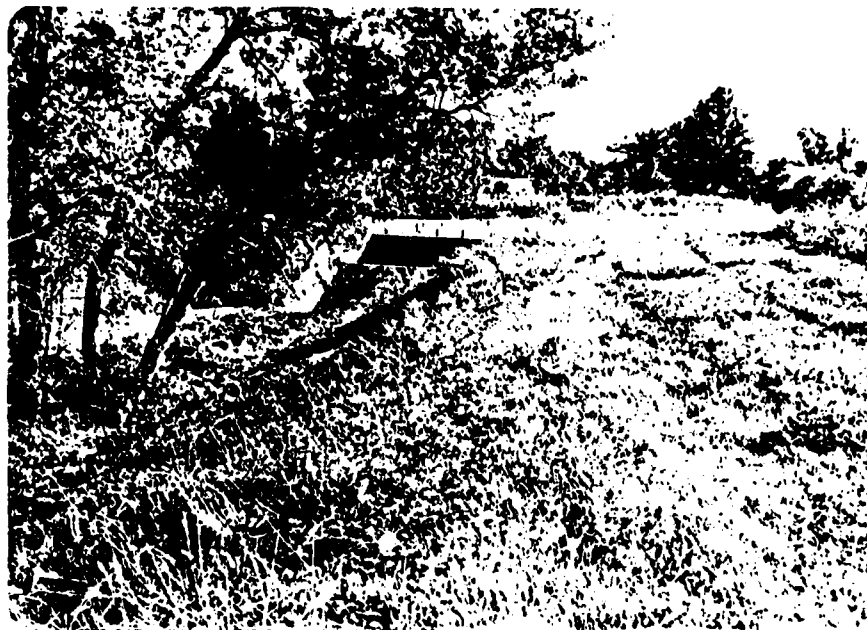
Spillway discharge from all the spillways merge into the natural channel at approximately 70 feet downstream of the embankment toe. The downstream channel is an unlined trapezoidal channel which was sparsely covered with fallen tree trunks and debris at the time of inspection. However, this minor obstruction in the channel does not seem to pose serious restrictions to the spillway capacity. Signs of moderate erosion and sloughing on the right bank of the channel were observed.

Photo 7 - Picture of downstream channel of spillway taken from near center of dam toward right side of dam.

The downstream channel may require remedial work following discharges through the spillway during flood conditions, but no immediate remedial work is required at this time.

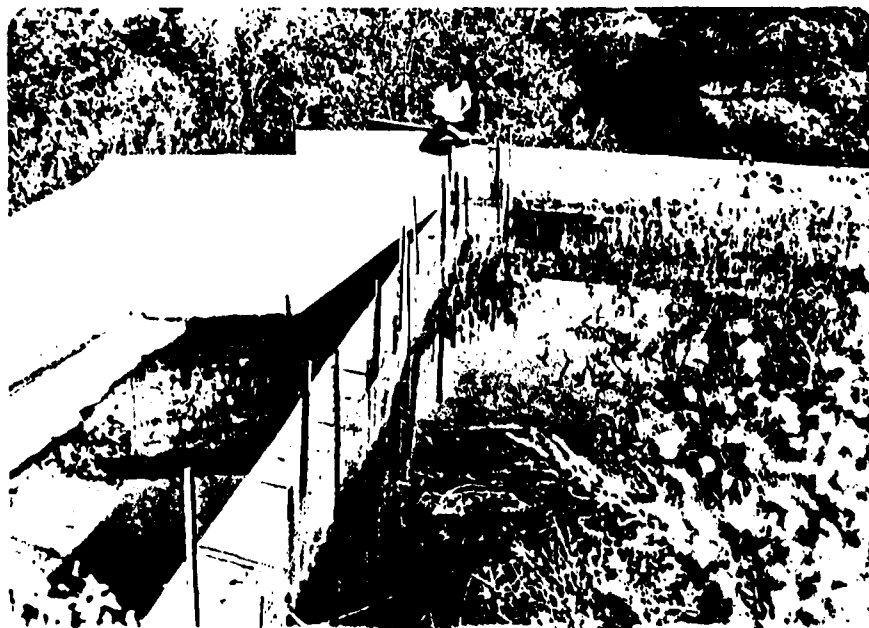
Mostly due to the old age of the structure, the service spillway shows signs of deterioration. Some leakage is occurring through the vertical concrete weir. In addition, vertical and horizontal cracking, and concrete spalling and erosion was observed throughout the concrete channel. Dense grasses are growing in the spillway approach areas.

Photo 8 - Picture of concrete overflow crest of service spillway taken at left side of spillway.

The concrete spillway structures, although old and deteriorating, are in satisfactory structural condition. Some grouting to stop the leakage should be performed, and patching of badly spalled areas should be done as it becomes necessary.

The general physical condition of the dam and appurtenant structures is fair. The leakage through the service spillway crest should be stopped, and patchwork to the deteriorating concrete should be done as it becomes necessary.

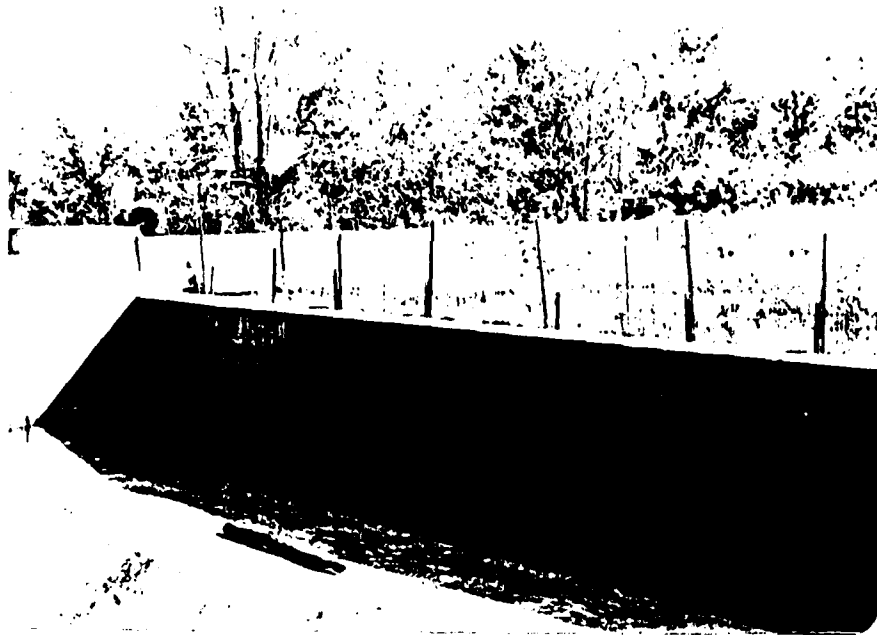
The service spillway structure is deteriorating. Vertical cracks, moderate erosion and spalling on the concrete were apparent. The right bank of the exit channel shows signs of a moderate degree of erosion and sloughing. There is grass growing in front of the spillway entrance of both the service spillway and the No. 2 spillway.

Photo 9 - Picture of concrete overflow of service spillway taken from downstream of spillway.

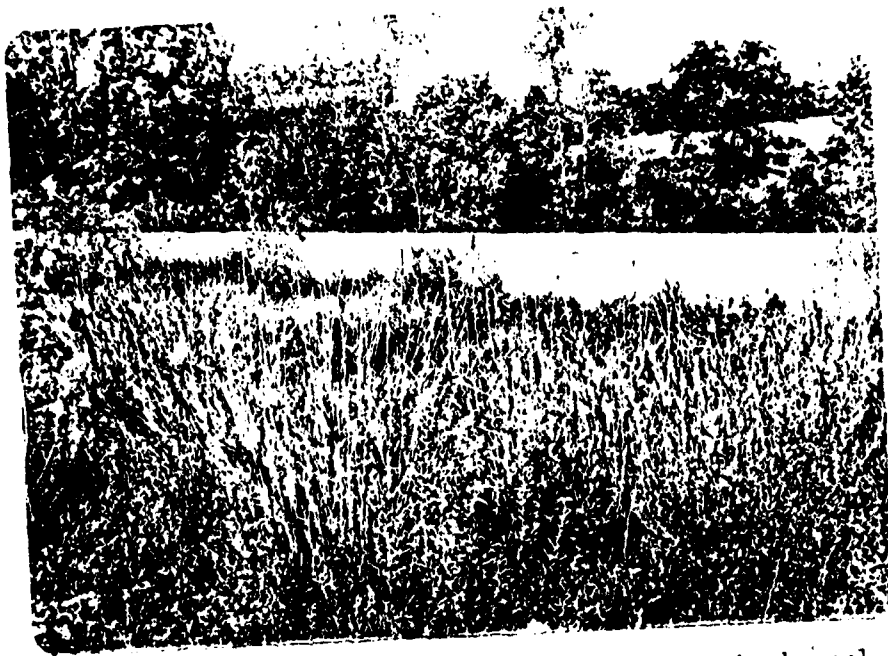
Photo 11 - Picture of emergency spillway approach channel and crest.

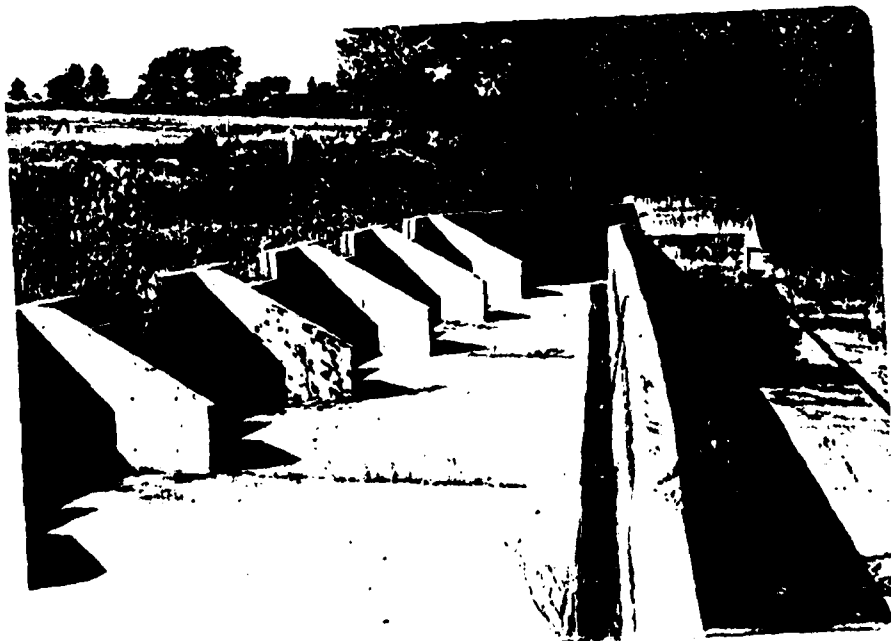
No post construction changes exist which will affect the structural stability of the dam. At spillway No. 2, the new spillway wall replaced an old wall which had failed.

Photo 12 - Picture of crest of emergency spillway and failed downstream wall taken from right abutment of spillway.
