Lake Adelle Dam (MO 30411). Mississippi -
Kaskaskia - St. Louis River Basin.
Jefferson County, Missouri. Phase I
Inspection Report.

SUBJECT: Lake Adelle Dam Phase I Inspection Report
Jefferson County, Missouri
Missouri Inventory No. 30411

LAKE ADELLE DAM
JEFFERSON COUNTY, MISSOURI
MISSOURI INVENTORY NO. 30411

PHASE I INSPECTION REPORT
NATIONAL DAM SAFETY PROGRAM

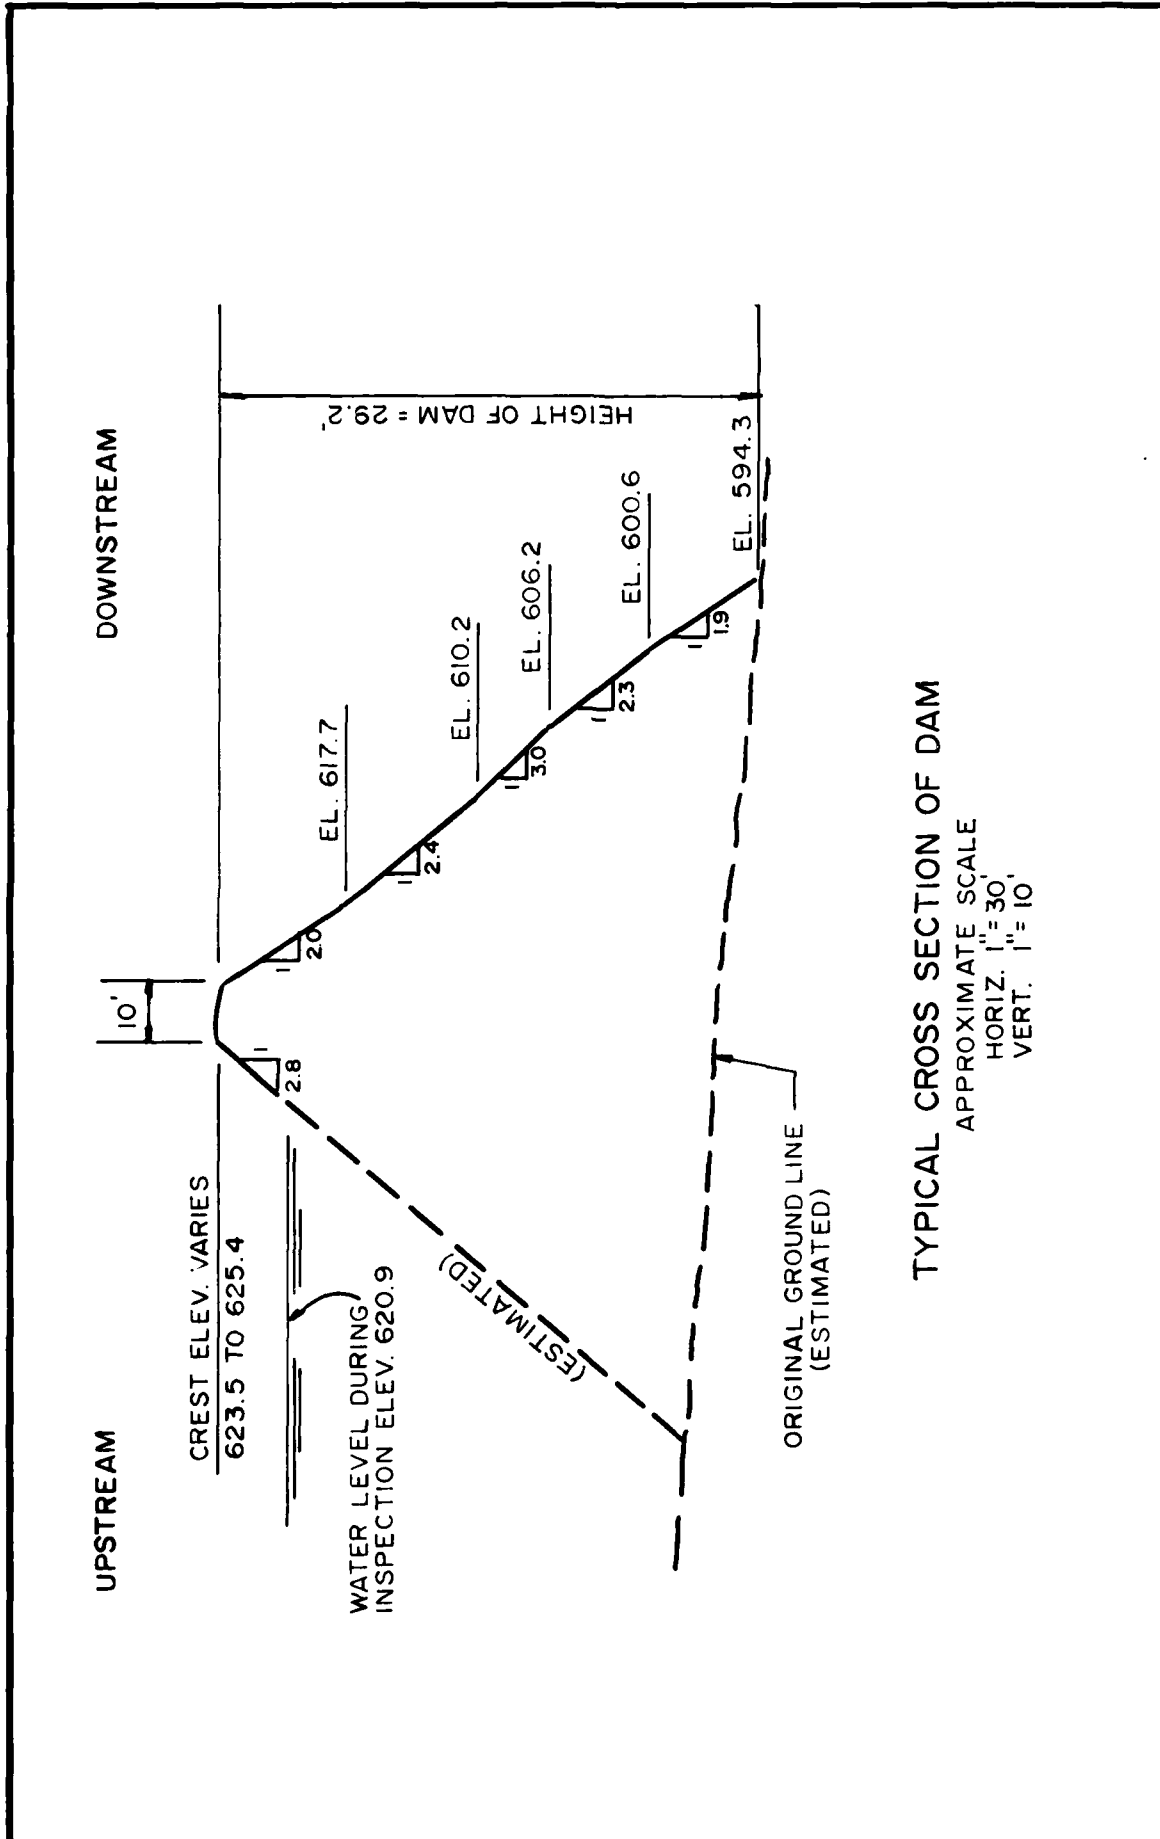
TYPICAL CROSS SECTION OF DAM

The steep and irregular slopes of the downstream face present a condition that may contribute to instability. It should be noted that Lake Adelle Dam is located in Seismic Zone 2 as shown on Plate 3 of Appendix A. A Seismic Zone 2 delineates areas in which moderate damage would result from the expected seismic activity in the area. The lack of seepage and stability analyses is a deficiency which should be corrected. Seepage and stability analyses should include an allowance for seismic loadings.
