LITTLE LAKE DAM
JEFFERSON COUNTY, MISSOURI
MO. 30456

**PHASE I INSPECTION REPORT
NATIONAL DAM SAFETY PROGRAM**

PHASE I INSPECTION REPORT
NATIONAL DAM SAFETY PROGRAM

LITTLE LAKE DAM, Missouri Inv. No. 30456

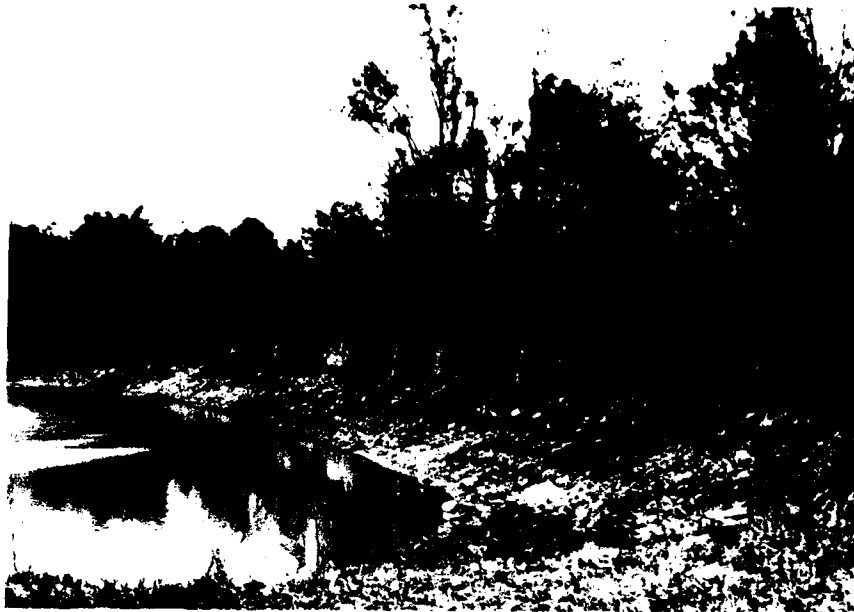
The entire embankment, except for the upstream slope below the normal water surface, is covered by a dense unmaintained vegetative growth ranging from tall grass to large trees (see Photos 1 and 2). A comprehensive inspection of the dam was hampered due to the vegetative cover; however, no bulges, depressions or cracks indicative of an instability of the embankment or foundation were apparent on the dam.

Photo 1 - View of the upstream slope from the right abutment.

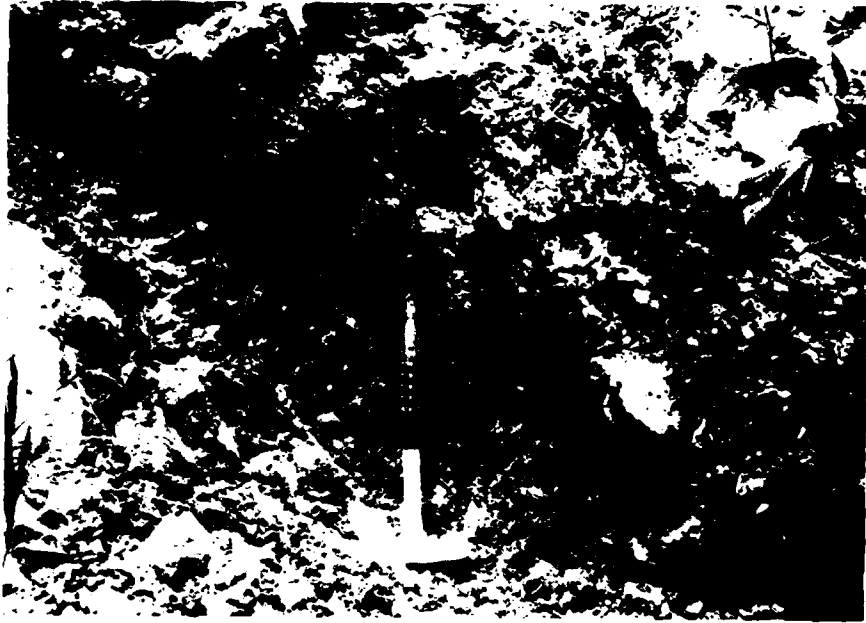
No active faults have been identified at the damsite. The closest geologic fault to the damsite is the Ste. Genevieve fault system nearly 0.5 miles northeast of the damsite. The Ste. Genevieve fault had its last movement in the post - Pennsylvanian time and consists of several fault sets that were formed at the same geologic time. Reconnaissance geologic evidence (a possible shear zone in the highly weathered dolomite foundation bedrock, see Photo 9) suggests that there is a possibility that one of these fault sets crosses the dam reservoir, which could be the cause of the leakage at this damsite.

Photo 9 - Close-up view of a possible shear zone in the highly weathered dolomite bedrock in the spillway discharge channel.

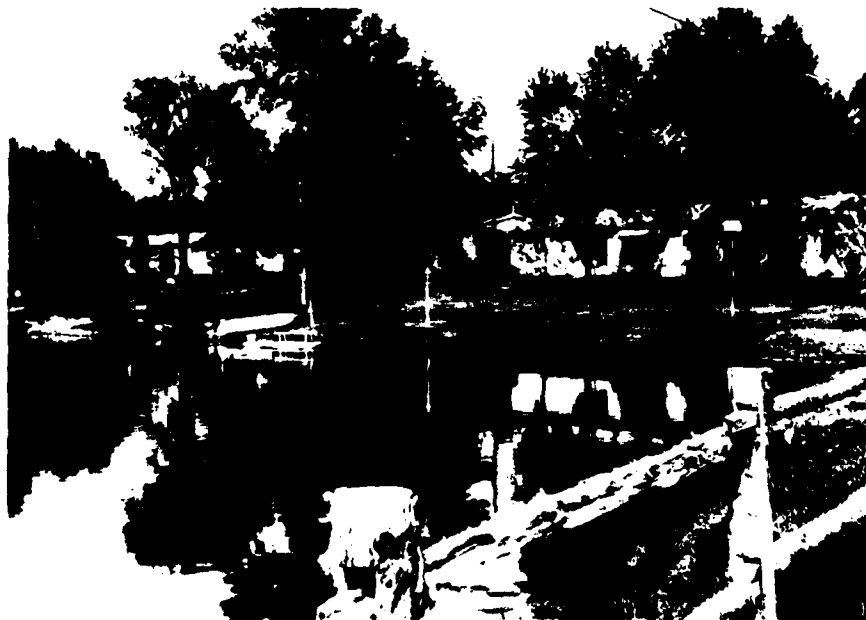
The failure of the dam could cause extensive damage to the property downstream of the dam and possible loss of life. The estimated damage zone extends less than one mile downstream of the dam. Located within the damage zone are one downstream reservoir (Sunrise Lake, Mo. 31190) and at least four dwellings located at the upper end of Sunrise Lake.

Photo 10 - View of dwellings in the downstream hazard zone at the upper end of Sunrise Lake.
