CLEAR LAKE DAM
JEFFERSON COUNTY, MISSOURI
MO. 30437

**PHASE I INSPECTION REPORT
NATIONAL DAM SAFETY PROGRAM**

JULY 1981

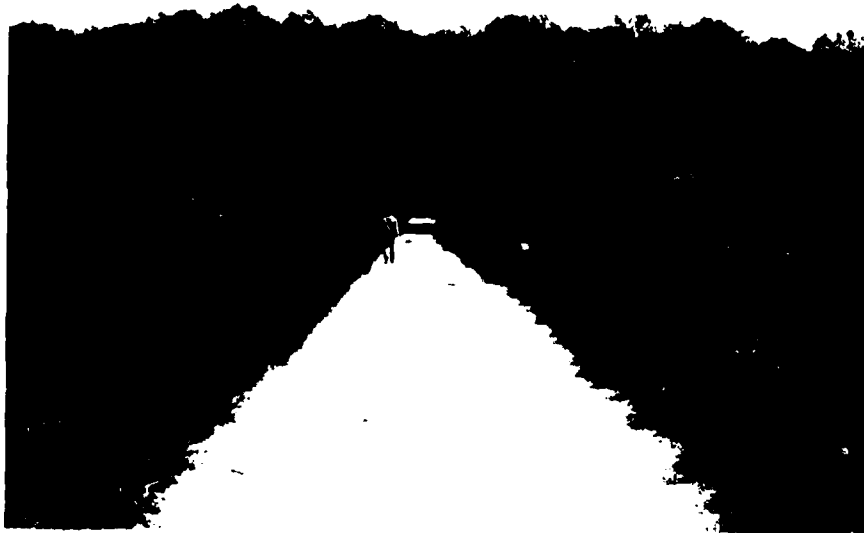
The top of dam supports a gravel access road used by local residents to gain access to their homes (see Photo 2). Outside of the access road, the top of dam has a vegetative covering. The gravel surfacing and vegetative covering appear to provide adequate erosion protection against surface runoff, for no erosion was evident. No damage due to vehicular traffic across the dam was seen; however, in a few areas, patches of asphalt, which appeared to have been used to fill in potholes, were observed. No depressions or cracks indicating a settlement of the embankment were apparent. The variation in elevation across the top of dam did not appear to be due to an instability of the embankment. No significant deviation in the horizontal alignment was apparent. According to Mr. Shy, the dam has never been overtopped and no evidence indicating the contrary was observed.

Photo 2 - View of the top of dam from the left end of the dam.

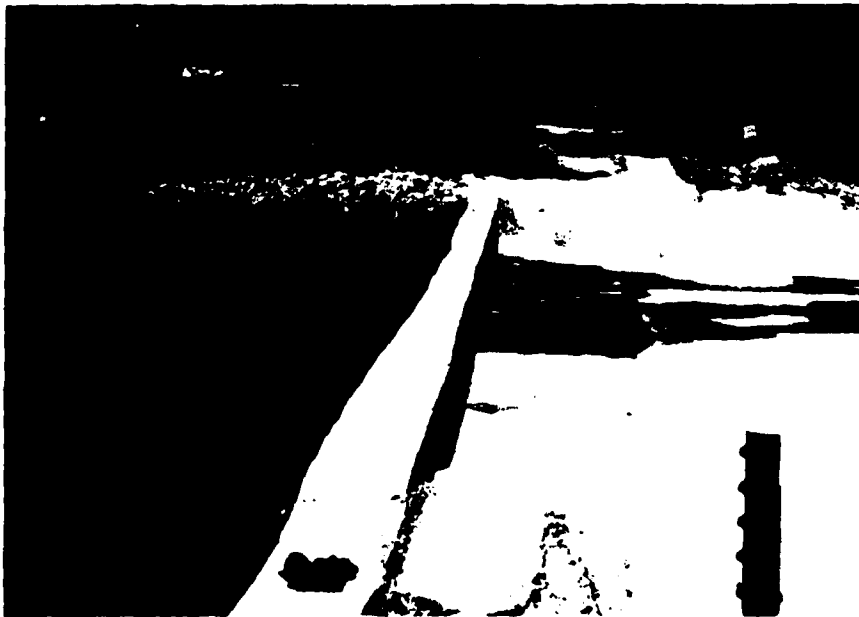
An addition was made to the concrete weir, one or two years ago, increasing the thickness from eight inches to the existing 1.8 to 2.3 feet thickness. As described in Section 1.2g, the purpose of the addition was to extend the cutoff wall further below the spillway slab in order to stop seepage under the slab. The new cutoff wall did not stop the seepage, but did reduce the flow, according to Mr. Sells. Water was observed flowing between the spillway slab/natural ground interface at the outfall of the spillway channel. The flow rate was estimated to be less than five gallons per minute. The discharge was clear and no undermining along the length of the spillway slab due to the seepage was evident. The placement of the addition was done in an unprofessional manner evidenced by the variable thickness of the resultant structure (see Photo 6). Although the newer concrete appeared undamaged and sound, water was flowing through cracks in the weir near the channel invert at the centerline of the spillway (see Photo 6).

1. The leakage through the spillway system will only hasten the demise of the spillway channel. It appears that flow is following the spillway slab/natural ground interface and exiting at the top of the vertical face of the undermined area of the spillway outfall, which could be contributing to the erosion there.

Photo 6 - View of the weir at the spillway control section and seepage into the spillway channel.

4. The leakage of water under the spillway slab should be stopped.
5. The cracks in the spillway channel slab should be repaired.
6. The erosion due to wave action on the upstream slope should be properly repaired and the slope protected from further damage.

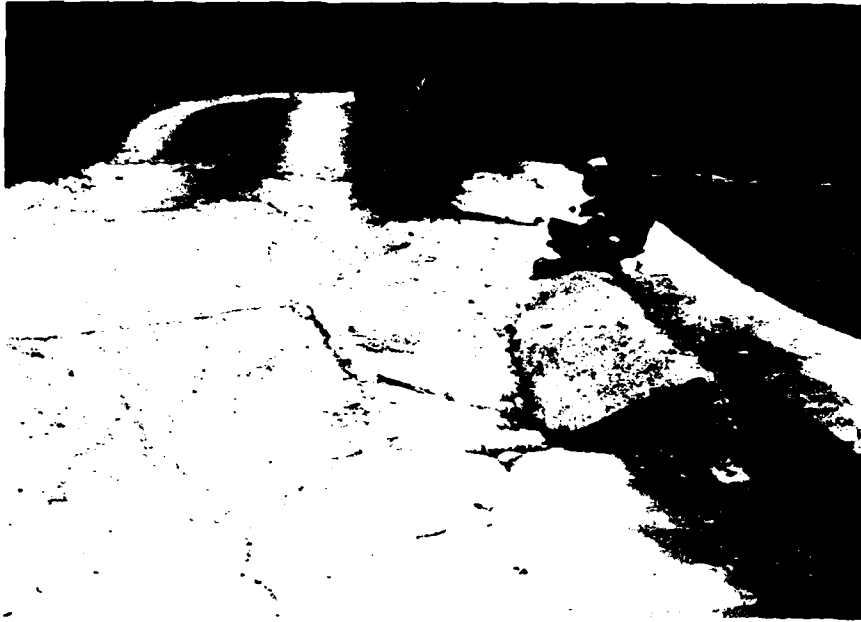
The concrete of the spillway channel has numerous cracks particularly in the area where vehicles cross the spillway (see Photo 7). Patches of lighter colored concrete were evident in this area indicating some repair work has been done to the spillway channel. Downstream of this area, the surface of the concrete appeared sound with no noticeable sign of weathering. This stable condition ends at the spillway outfall where a roughly triangular shaped piece of concrete, eight feet at the base and extending five feet back into the spillway, has broken off and fallen into the

2. The cracks in the spillway channel did not appear to indicate an unsafe condition; however, the cracks do provide an avenue by which water can flow under the spillway slab. Water flowing under the spillway slab could undermine it, resulting in an unsafe condition.

Photo 7 - Close-up view of the spillway channel showing cracking in the concrete slab.

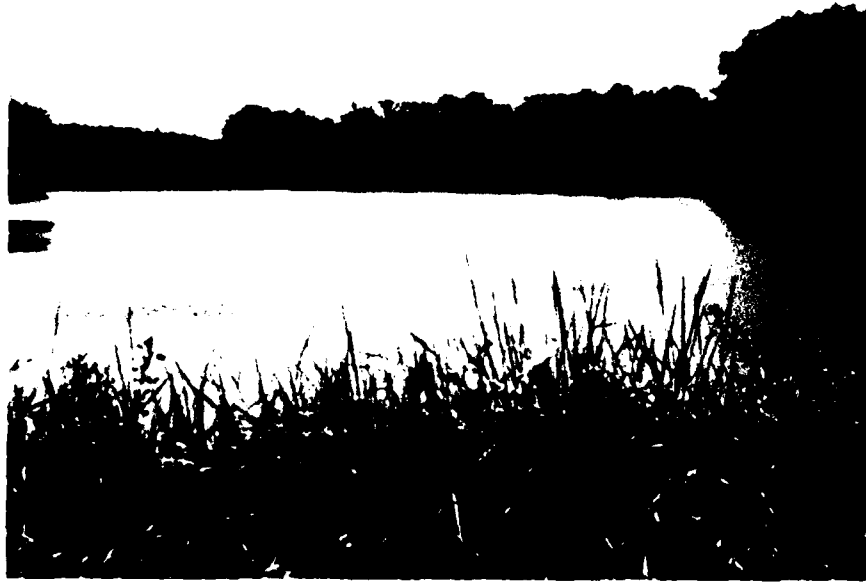
The rim appeared to be stable with no erosional or stability problems observed (see Photo 13). The land around the reservoir slopes gently to moderately upward from the reservoir rim and is mostly wooded with grass-covered slopes. Several houses are built around the reservoir rim. No evidence of excessive siltation was observed in the reservoir on the day of the inspection.

Photo 13 - View of the reservoir and rim. Note Sunrise Lake Dam in the background.

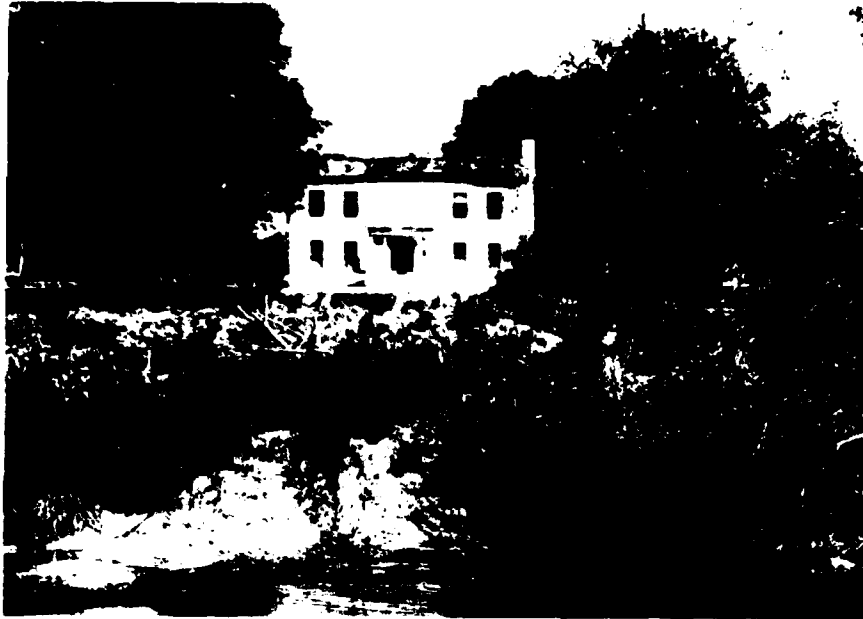
The dam has been classified as having a "high" hazard potential in the National Inventory of Dams, on the basis that in the event of failure of the dam or its appurtenances, excessive damage could occur to downstream property, together with the possibility of the loss of life. From a visual inspection of the downstream area, our findings concur with this classification. Located within the estimated damage zone, which extends approximately two miles downstream of the dam, are at least three dwellings, one building, and a county highway (Highway V), which parallels Joachim Creek (see Photos 15 and 16).

Photo 15 - View of a dwelling in the downstream hazard zone looking across Joachim Creek.
