LAKE JEANO DAM  
WAYNE COUNTY, MISSOURI  
MO 30018

**PHASE 1 INSPECTION REPORT  
NATIONAL DAM SAFETY PROGRAM**

LAKE JEANO DAM  
WAYNE COUNTY, MISSOURI  
MISSOURI INVENTORY NO. 30018

PHASE I INSPECTION REPORT  
NATIONAL DAM SAFETY PROGRAM

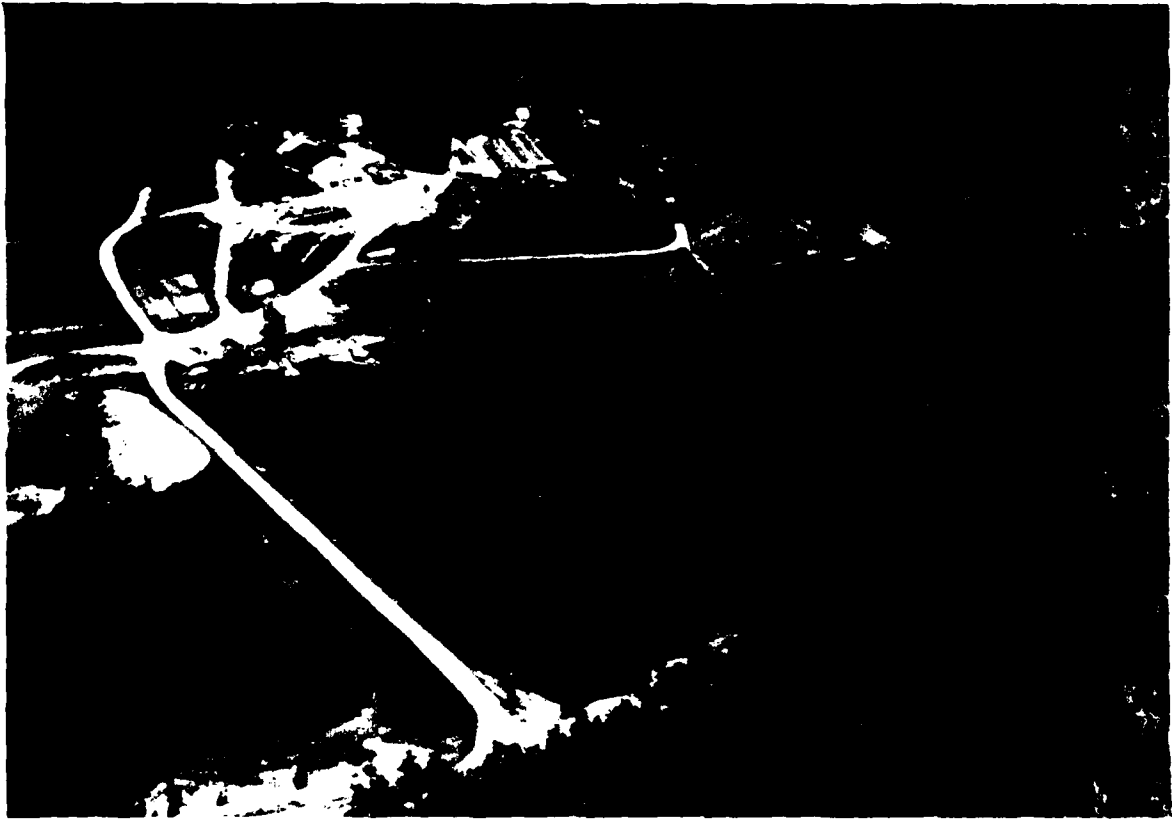
AERIAL VIEW OF LAKE AND DAM
