B & K LAKE NO. 2 DAM  
WARREN COUNTY, MISSOURI  
MO. 11002

**PHASE I INSPECTION REPORT  
NATIONAL DAM SAFETY PROGRAM**

Name of Dam: B & K Lake No. 2 Dam, Missouri Inv. No. 11002  
State Located: Missouri  
County Located: Warren  
Stream: An Unnamed Tributary of Lost Creek  
Date of Inspection: August 20, 1979

B & K LAKE NO. 2 DAM, I.D. No. 11002

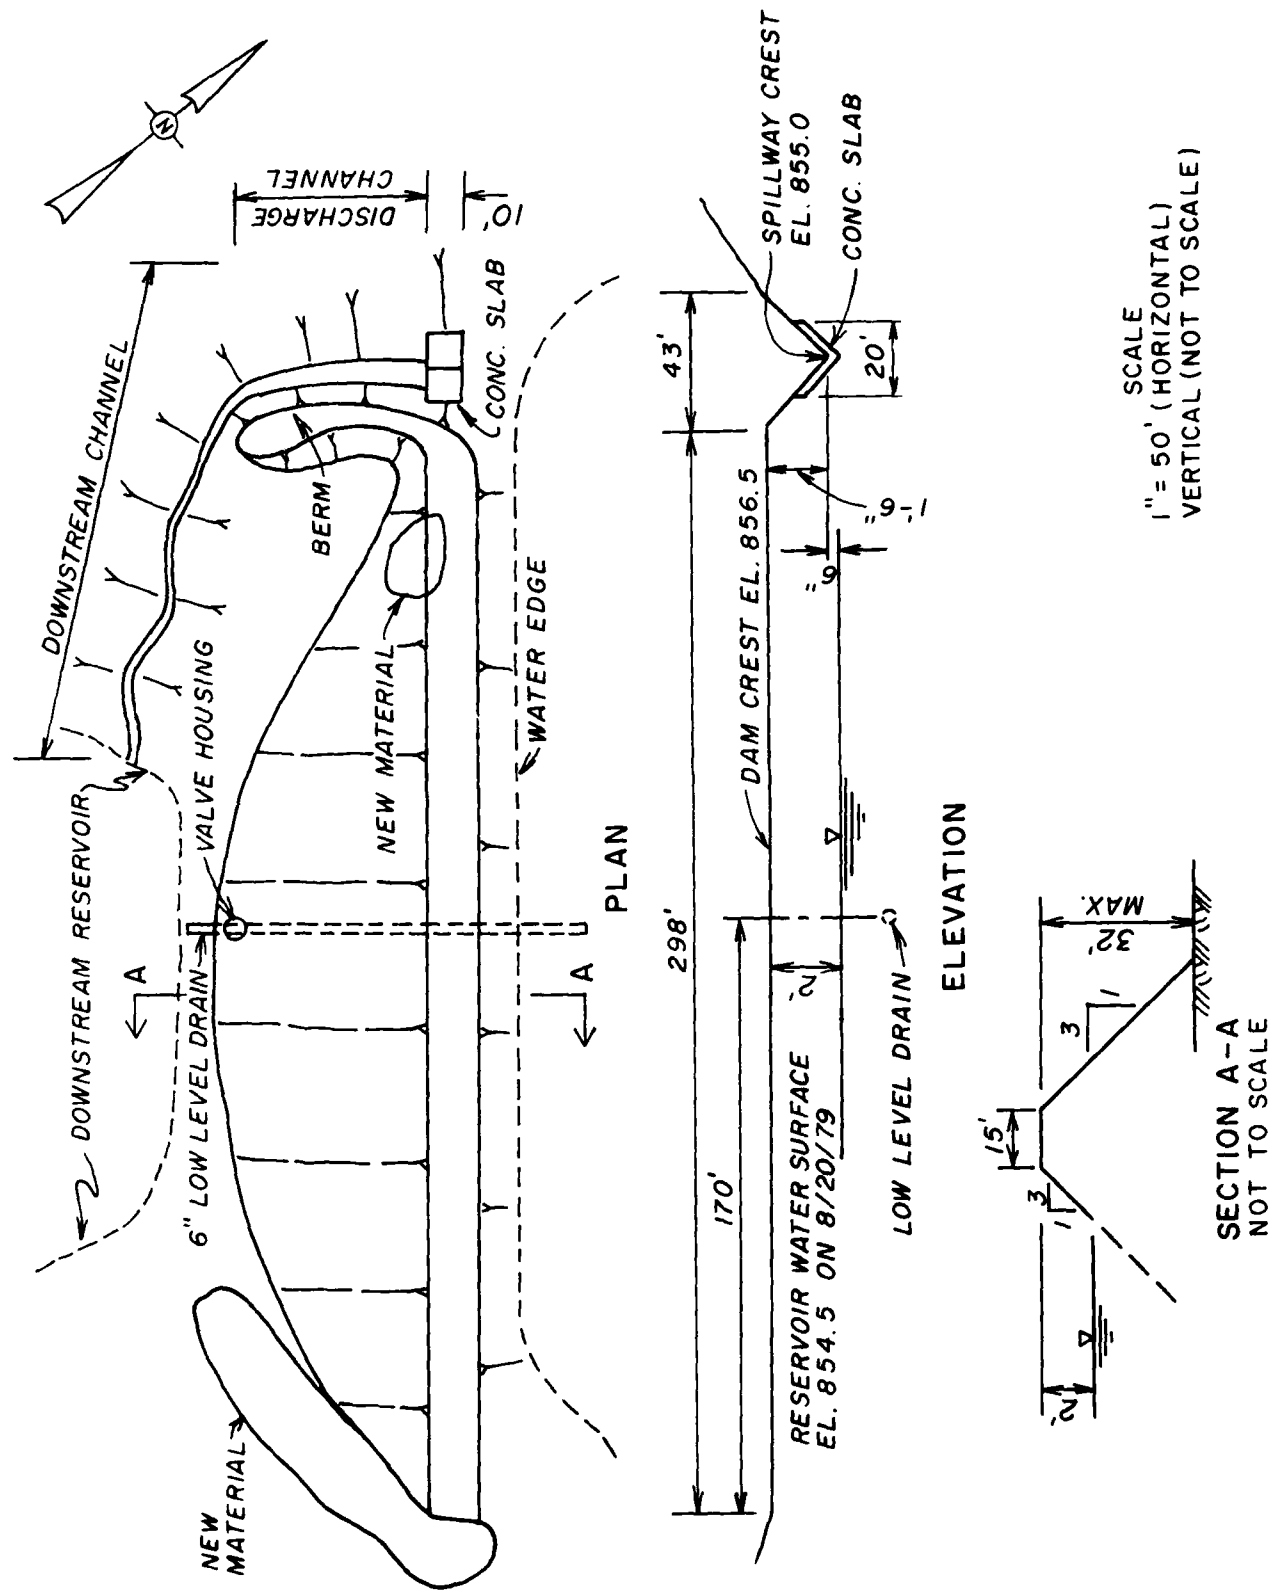
B & K LAKE NO. 2 DAM (MO. 11002)  
PLAN, ELEVATION & SECTION

The dam is a compacted earthfill structure between earth abutments. The crest width is about 15 feet, and the crest length is approximately 298 feet. The maximum height of the embankment was measured as 32 feet. The crest elevation is approximately 856.5 feet above MSL.

The downstream slope of the embankment was measured to be 1V to 3H. The upstream slope from crest to reservoir level was measured to be 1V to 3H. No riprap was placed on the upstream face.

The spillway for B & K Lake No. 2 Dam is a cut into the right abutment. The spillway section is V-shaped. The control section has a total top width of 43 feet and is 1.5 feet deep. A 20 foot wide and 10 foot long concrete slab is provided on the control section of the spillway. The discharge channel for the spillway is an earthcut channel approximately 75 feet in length with approximately the same cross section as the spillway. A berm was constructed on the left side of the channel to channelize spillway discharges away from the downstream slope of the dam.
