CEDAR HILL LAKE NO. 1 DAM
JEFFERSON COUNTY, MISSOURI
MO 30073

**PHASE I INSPECTION REPORT
NATIONAL DAM SAFETY PROGRAM**

Name of Dam: Cedar Hill Lake No. 1 Dam, Missouri Inv. No. 30073
State Located: Missouri
County Located: Jefferson
Stream: Unnamed Tributary of Big River
Date of Inspection: October 2, 1978

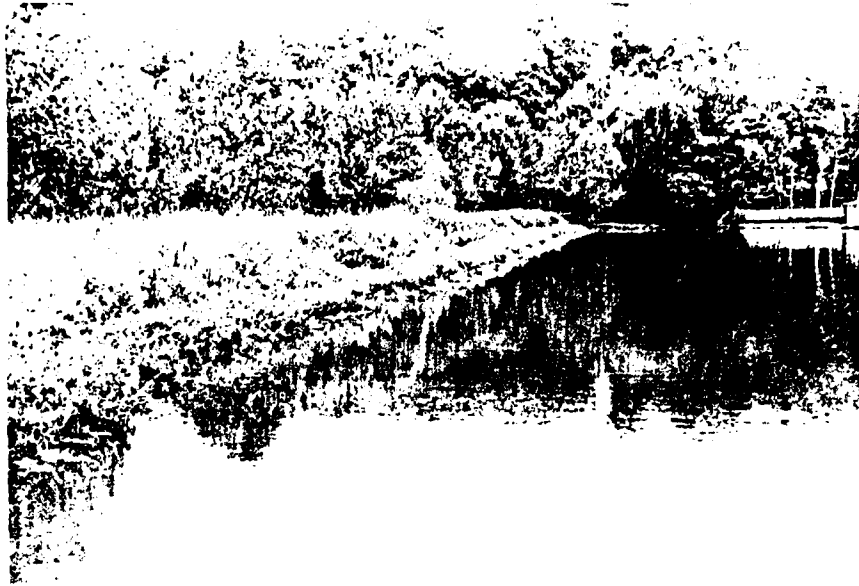
The upstream embankment slope does not have riprap for protection. As a result, some sloughing is occurring near the high water elevation. This has caused some steepening of the embankment slope, with the slope appearing to be as steep as 1V to 1H in some areas. Vegetation on the slope is not satisfactory for protection of the slope from erosion.

Photo 1 - View of upstream slope of embankment taken from left abutment. Spillway is located at far right side of dam.

d. Repair the erosion and sloughing on the upstream embankment slope as is becomes necessary.

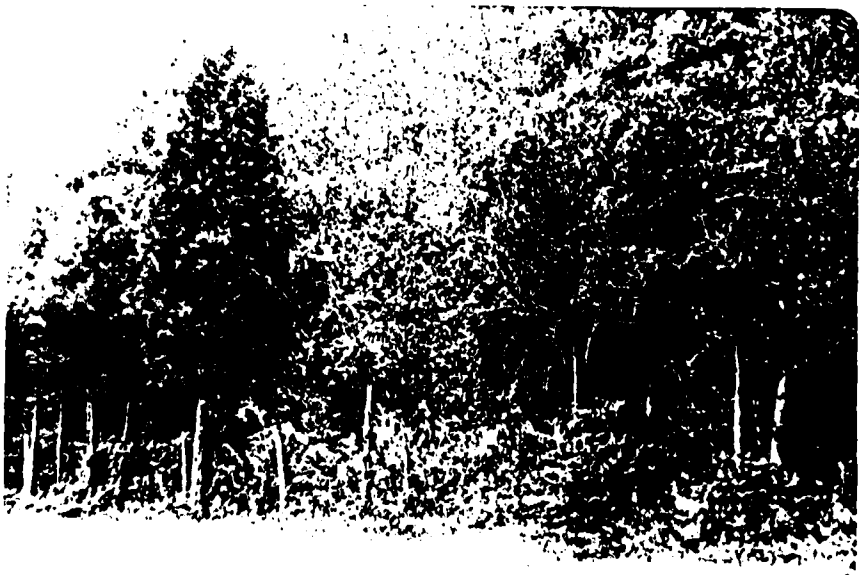
The downstream embankment slope is overgrown with trees and large brush. This heavy vegetation made proper inspection of the slope virtually impossible. Rodent activity was observed on the embankment slope.

The heavy brush and tree growth on the embankment slope pose a potential hazard to the dam. The extensive tree growth is considered unsatisfactory in terms of dam safety for several reasons: First, trees toppled by wind expose holes that invite rapid erosion, and second, decay of large existing root systems could form channels for eventual piping. Rodent activity also should be eliminated on the embankment.

Photo 2 - View of typical section of downstream embankment slope.

The heavy vegetative growth, including large trees, on the downstream embankment slope should be cleared as soon as possible. The growth prevents proper inspection of the embankment in addition to providing a hazard to the embankment.

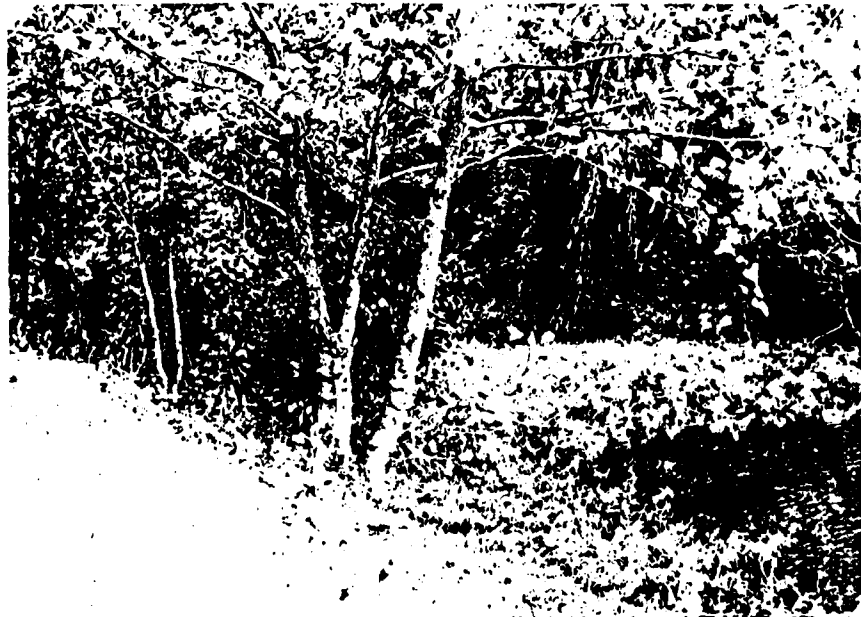
Photo 5 - Picture of approach channel for spillway at right abutment of dam.

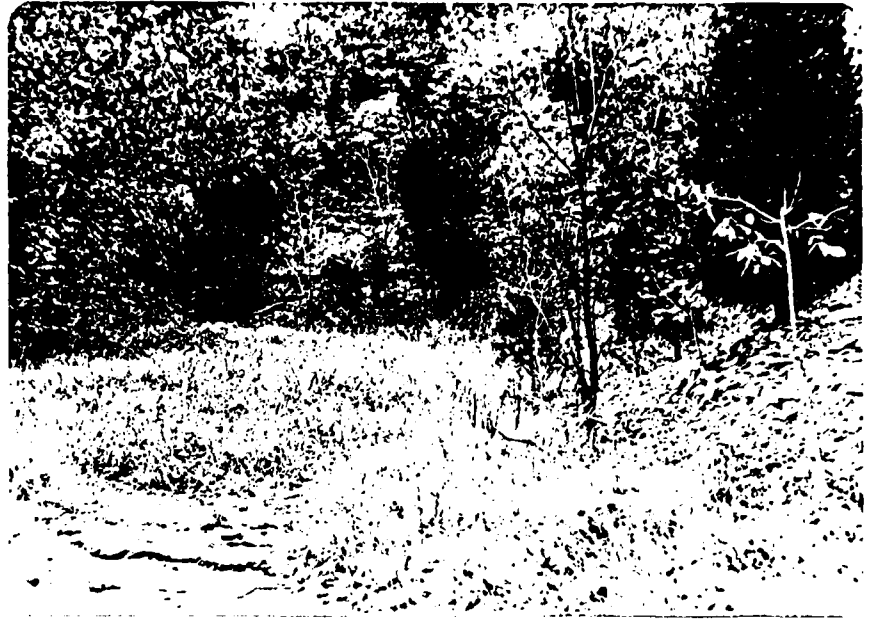
The rock spillway and falls, and the exit channel are well defined and were in good condition. However, the abundance of vegetation in the spillway area would adversely affect the hydraulic efficiency of the structure.

Photo 7 - Picture of spillway channel taken from road looking upstream.
