EHRlich LAKE DAM  
MONTGOMERY COUNTY, MISSOURI  
MO. 10993

**PHASE I INSPECTION REPORT**  
**NATIONAL DAM SAFETY PROGRAM**

PREPARED BY: U. S. ARMY ENGINEER DISTRICT, ST. LOUIS

DECEMBER 1980

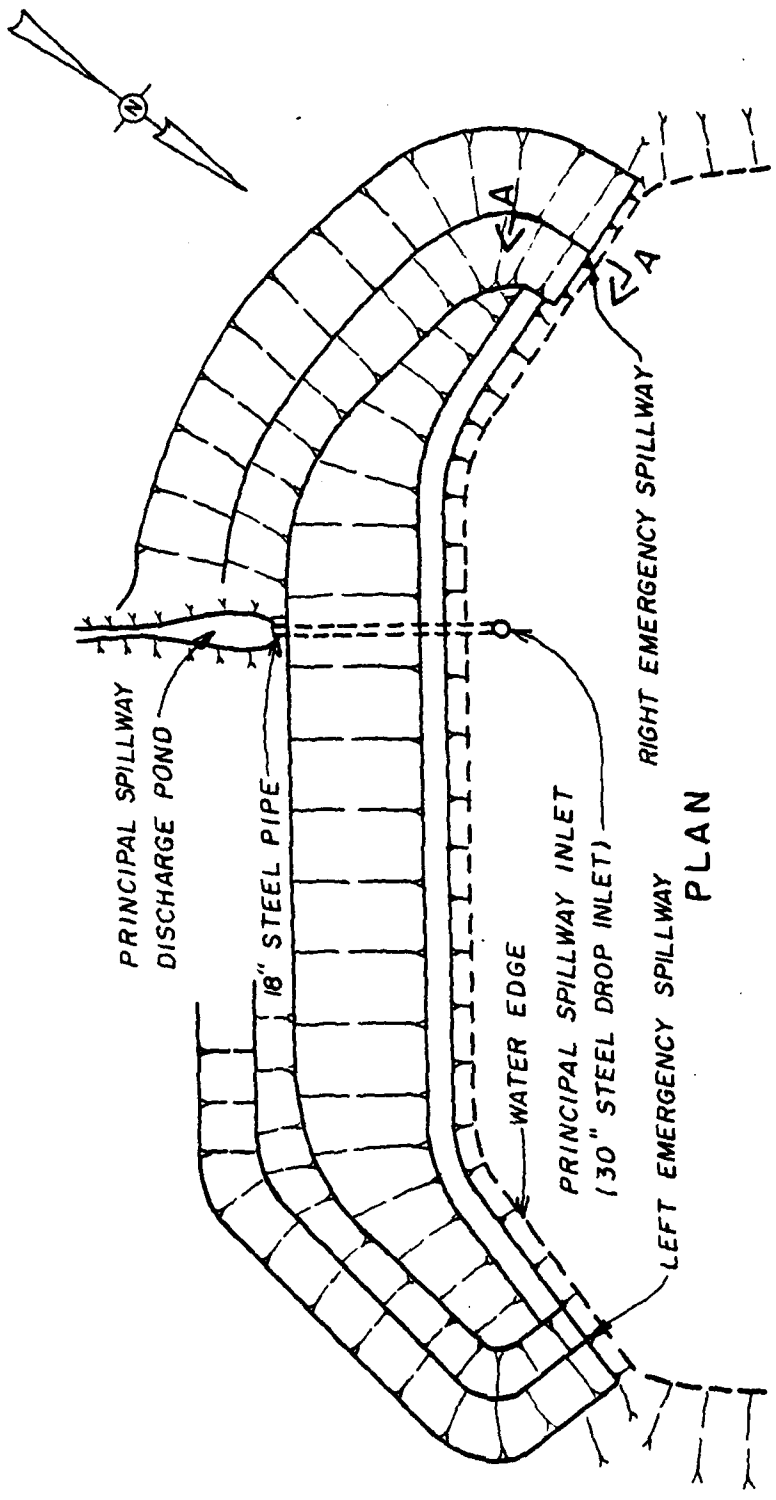
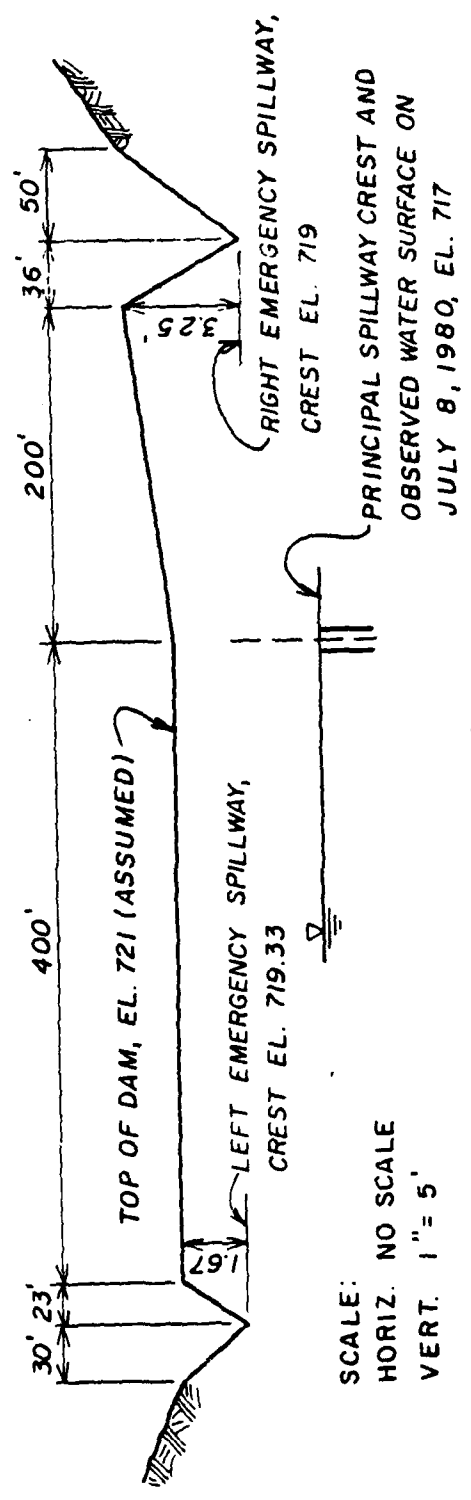
EHRlich LAKE DAM (MO. 10993)  
PLAN AND ELEVATION

The dam embankment is a compacted earthfill structure with a curved alignment between natural soil abutments (see Photo Overview). The estimated radius of curvature is about 500 feet with circle center upstream. A plan and elevation of the dam are shown on Plate 2, and Photos 1 through 3 show views of the dam. According to information obtained from Mr. Leverett, the dam was designed by the Soil Conservation Service and is a homogeneous fill section with a central core trench. The core trench was 16-feet wide, from 18- to 20-feet deep, and excavated into a solid clay foundation. The embankment crest is 14 feet wide and serves as an access road for farm equipment. The top is generally level for a distance of 400 feet to the right of the left side of the embankment at which point the crest slopes upward to the right end of the dam with a rise in elevation of 1.25 feet. The top of the dam was measured to be 600 feet along the crest centerline between the two emergency spillways which bound the embankment. The minimum crest elevation is assumed to be at 721 feet above mean sea level (M.S.L.) and the maximum height of the embankment was measured to be about 20 feet.

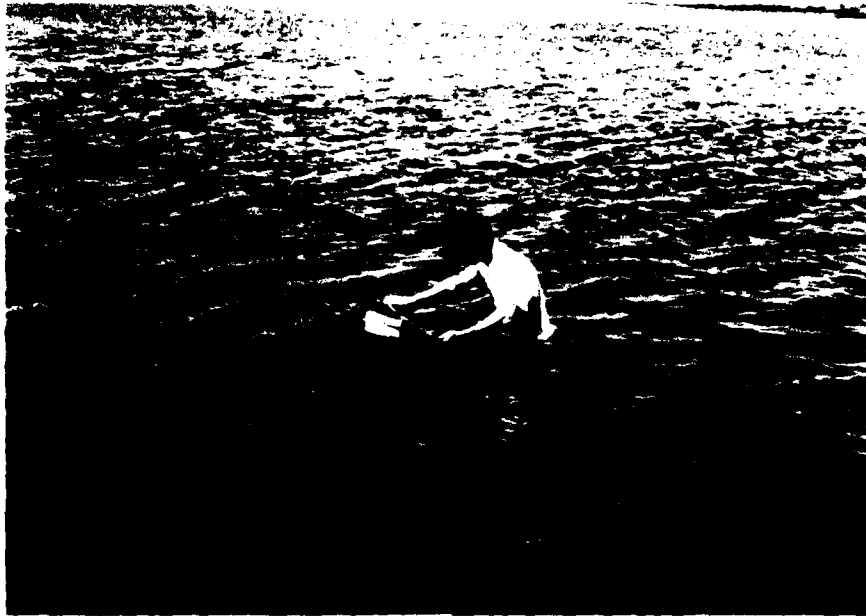
Photo 5

The trashrack provided for the spillway appears to be functioning the way it was intended. On the day of the inspection, some debris was observed on the top of the trashrack (see Photo 5). The trashrack, however, did not appear to be securely attached to the drop inlet. The spillway pipes do not appear to be obstructed due to the fact that the reservoir level on the day of the inspection was slightly above the spillway crest and water was observed discharging from the outlet end of the pipe. No seepage was ob-

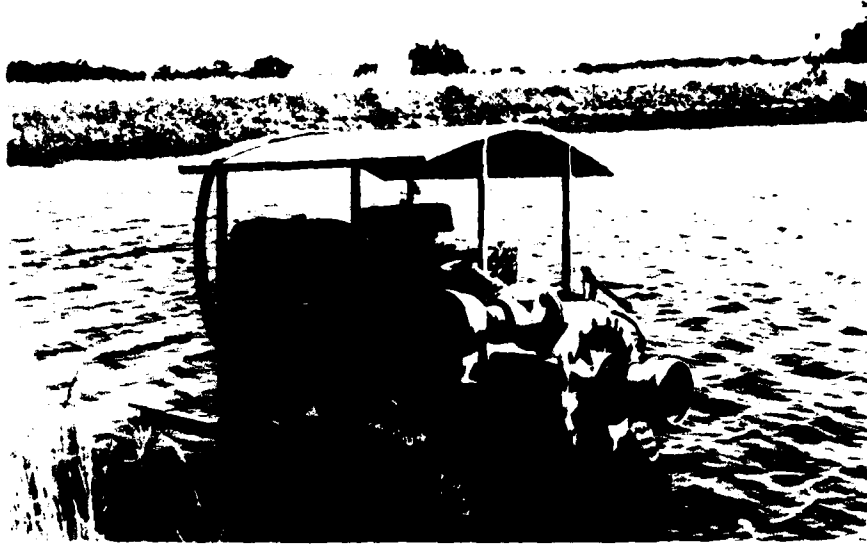
Photo 11

No low level outlets or outlet works were provided for this dam. However, a portable, gasoline powered, 18-inch, centrifugal pump is used at the damsite (see Photo 11). The pump is used to pump water from the reservoir to be used to irrigate row crops on the reservoir rim. The pump is used only when irrigation water is required and is generally used during the summer months.

There were no outlet works constructed for this dam. However, a portable, centrifugal pump is used at the damsite. According to Mr. Ehrlich, the pump is operable and may be used to drain the reservoir, if needed.
