KOHL IRRIGATION LAKE SOUTH DAM  
AUDRAIN COUNTY, MISSOURI  
MO. 11208

**PHASE I INSPECTION REPORT  
NATIONAL DAM SAFETY PROGRAM**

Name of Dam: Kohl Irrigation Lake South Dam,  
Missouri Inv. No. 11208  
State Located: Missouri  
County Located: Audrain  
Stream: An unnamed tributary of the Shady Creek  
Date of Inspection: July 9, 1980

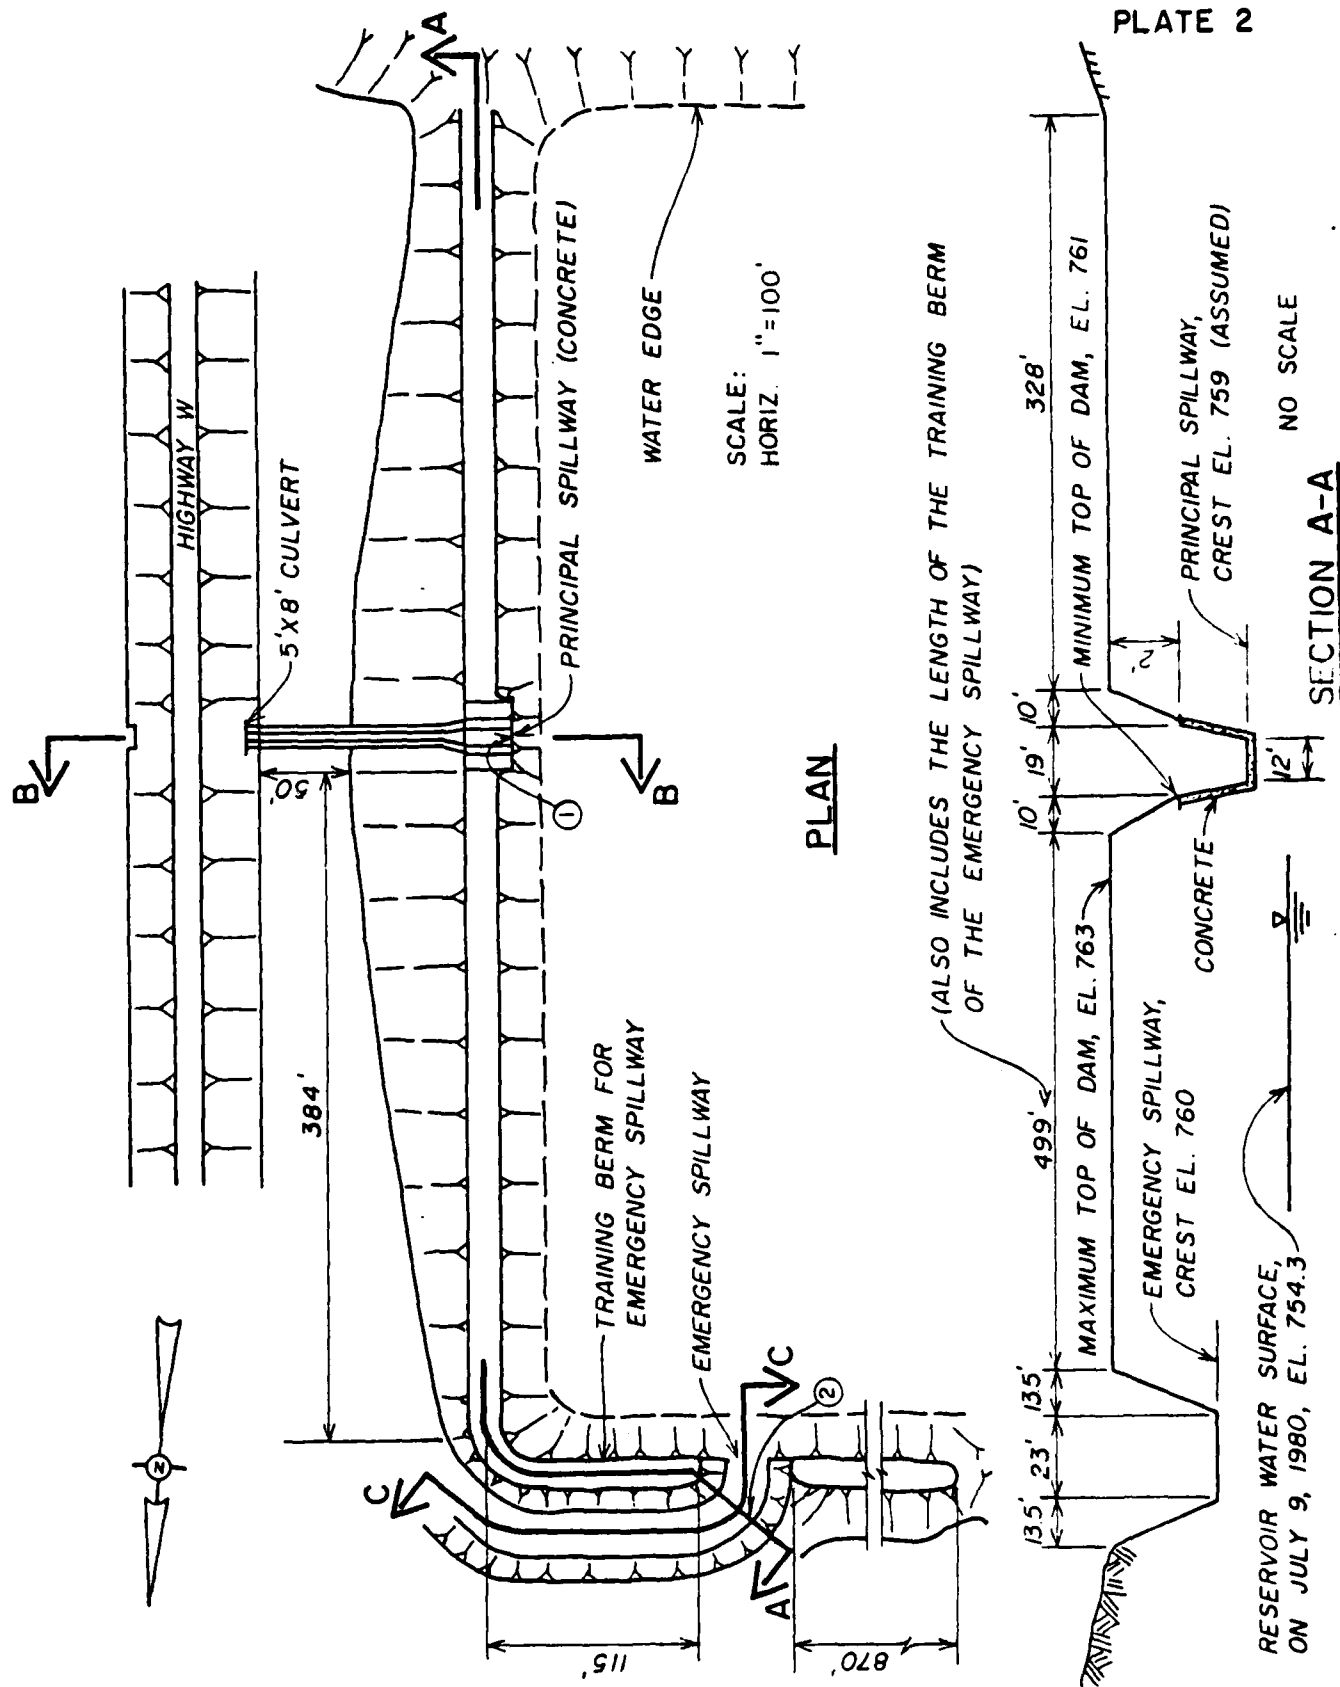
KOHL IRRIGATION LAKE SOUTH DAM (MO. 11208)  
PLAN & ELEVATION

According to Mr. Kohl, the dam is a zoned, rolled, earthfill structure with a straight alignment between earth abutments. A plan and elevation of the dam are shown on Plate 2 and Photos 1 through 3 show views of the embankment. According to Mr. Kohl, a 12-foot wide clay core trench with nearly vertical side slopes was excavated to a maximum depth of 10 feet into a gray and red mottled clay foundation soil. The core, which was constructed of a select clay soil, extends all the way up through the embankment. The upstream and downstream shells were constructed of a lesser quality clay material.
