ROGERS DAM
HOWARD COUNTY, MISSOURI
MO 10370

**PHASE I INSPECTION REPORT
NATIONAL DAM SAFETY PROGRAM**

PREPARED BY: U. S. ARMY ENGINEER DISTRICT, ST. LOUIS

DECEMBER 1978

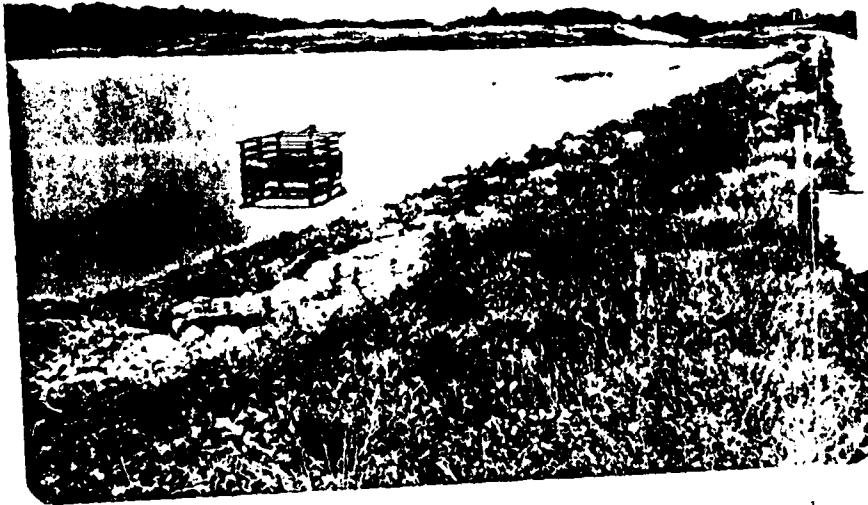
The horizontal alignment appeared as constructed. No surface cracking or unusual movement was obvious. The riprap on the embankment appeared to be in good condition. Some sloughing and shore erosion was noted along the shoreline (natural material) between the north end of the dam and the emergency spillway. This section was not riprapped.

Upstream Slope of Dam - Looking North

The shoreline between the north end of the dam and the emergency spillway may need riprap in the future to prevent further sloughing. The drainage blanket outlet pipe should be located, repaired if necessary, and marked to prevent future damage by maintenance equipment. Free drainage of the drainage blanket is important to avoid possible piping or stability problems in the future.

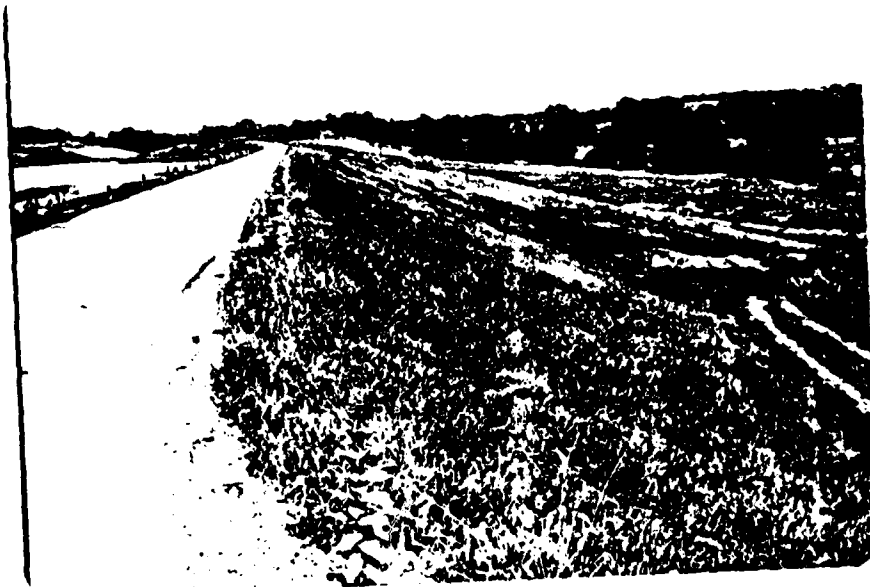
No sloughing of the embankment or seepage through or under the embankment was evident. The drain pipe for the drainage blanket could not be found and may have been damaged and covered by past mowing and maintenance equipment. The floodplain below the dam was green and moist. However, a rainstorm in the area about one hour before our site visit may account for the moist condition.

Downstream Slope of Dam - Looking North

- (5) The drainage blanket outlet pipe should be located, repaired and marked to prevent future damage by maintenance equipment.
- (6) Check the downstream slope periodically for seepage and stability problems (especially in the area of the raw water pipe under the dam). If wet areas or seepage flows are observed, or if sloughing is noted, then the dam should be inspected immediately and the situation evaluated by an engineer experienced in design and construction of dams. The area around the raw water pipe egress should be inspected periodically and if significant seepage and the beginning of erosion around the pipe are found, the situation should be evaluated by a geotechnical engineer.

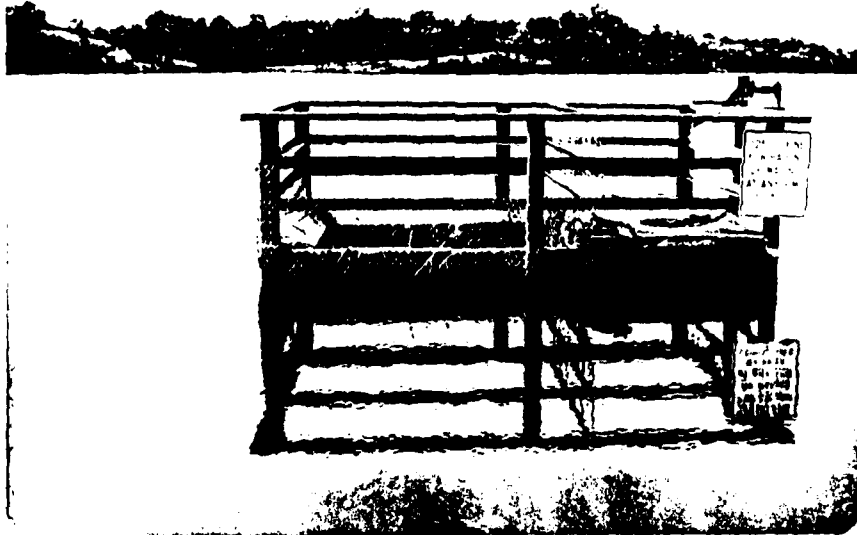
Primary Spillway Inlet

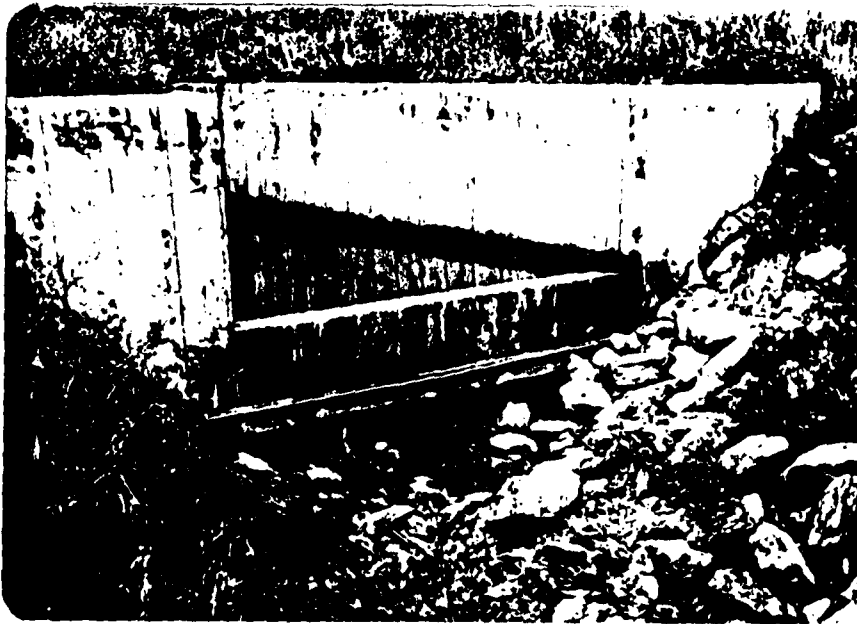
The riser structure could not be directly inspected since it is in the water. Visual inspection from the dam did not indicate any apparent problems. The outlet pipe and stilling basin structure are in good condition. Considerable erosion has taken place at the end of the stilling basin structure. Riprap has been carried away, and some of it is piled in the center of the outlet channel (see picture - Sheet 3 of Appendix D). The outlet channel is in fairly good condition downstream of this area.

The primary spillway and water supply structure could not be inspected since it was in the water. The outlet pipe and stilling basin are in good condition except for the erosion at the end of the sill block. This condition should be corrected as discussed in Section 3.4 to prevent possible undermining and damage to the outlet structure. The emergency spillway is in good condition and, according to a local resident, may have been used once.

Primary Spillway Outlet - Note Erosion

The erosion which was noted on the slope below the downstream berm and especially on the south abutment and at the end of the sill block at the primary spillway outlet should be corrected and maintained. The south abutment erosional area should be regraded, and an effort should be made to minimize future erosion. The erosional area at the end of the sill block should be corrected immediately and maintained.

- (2) The erosion which was noted at the end of the sill block at the primary spillway outlet should be corrected immediately and maintained.
- (3) The erosion which was noted on the slope below the downstream berm and on the south abutment should also be corrected in the near future and maintained. Possibly, future erosion can be minimized with the use of riprap or ditch checks.

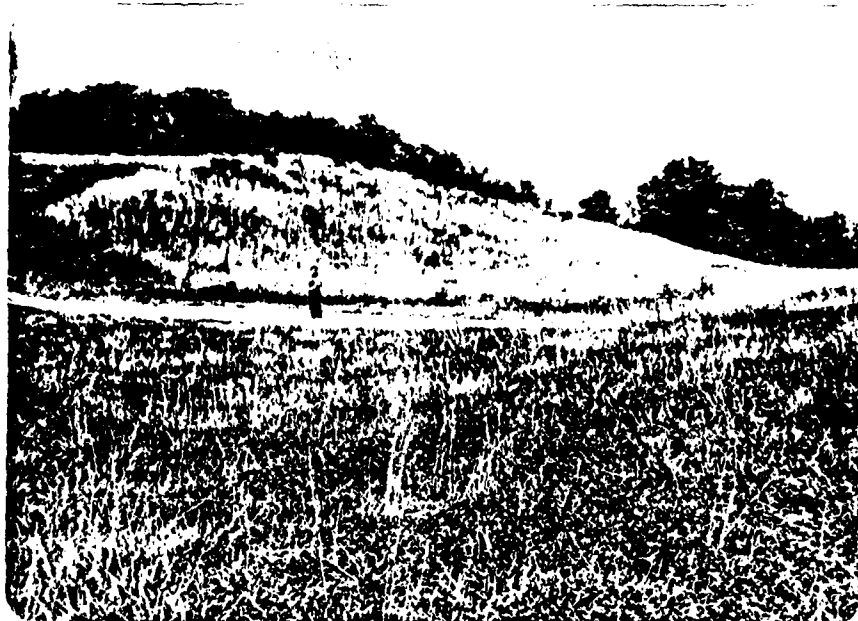
The emergency spillway is in good condition. It measures 100 ft in width at the concrete sill control section with 3h:1v side slopes. Information from a local source indicates that it may have been used once. The emergency spillway is not lined but is partially cut in rock. Some erosional damage would be incurred during full flow, but the damage would not be expected to be catastrophic and would be repairable.

Emergency Spillway - Looking Upstream
