**PHASE 1 INSPECTION REPORT  
NATIONAL DAM SAFETY PROGRAM**

| REPORT DOCUMENTATION PAGE | | READ INSTRUCTIONS<br>BEFORE COMPLETING FORM |
|---|---|---|
| 4. TITLE (and Subtitle)<br>Phase I Dam Inspection Report<br>National Dam Safety Program<br>Innsbrook Estates Dam No. 1 (MO 31714)<br>Warren County, Missouri | | 5. TYPE OF REPORT & PERIOD COVERED<br>Final Report |

**SUBJECT: Innsbrook Estates Dam No. 1 Dam Phase I Inspection Report**  
**Warren County Missouri**  
**Missouri Inventory No. 31714**

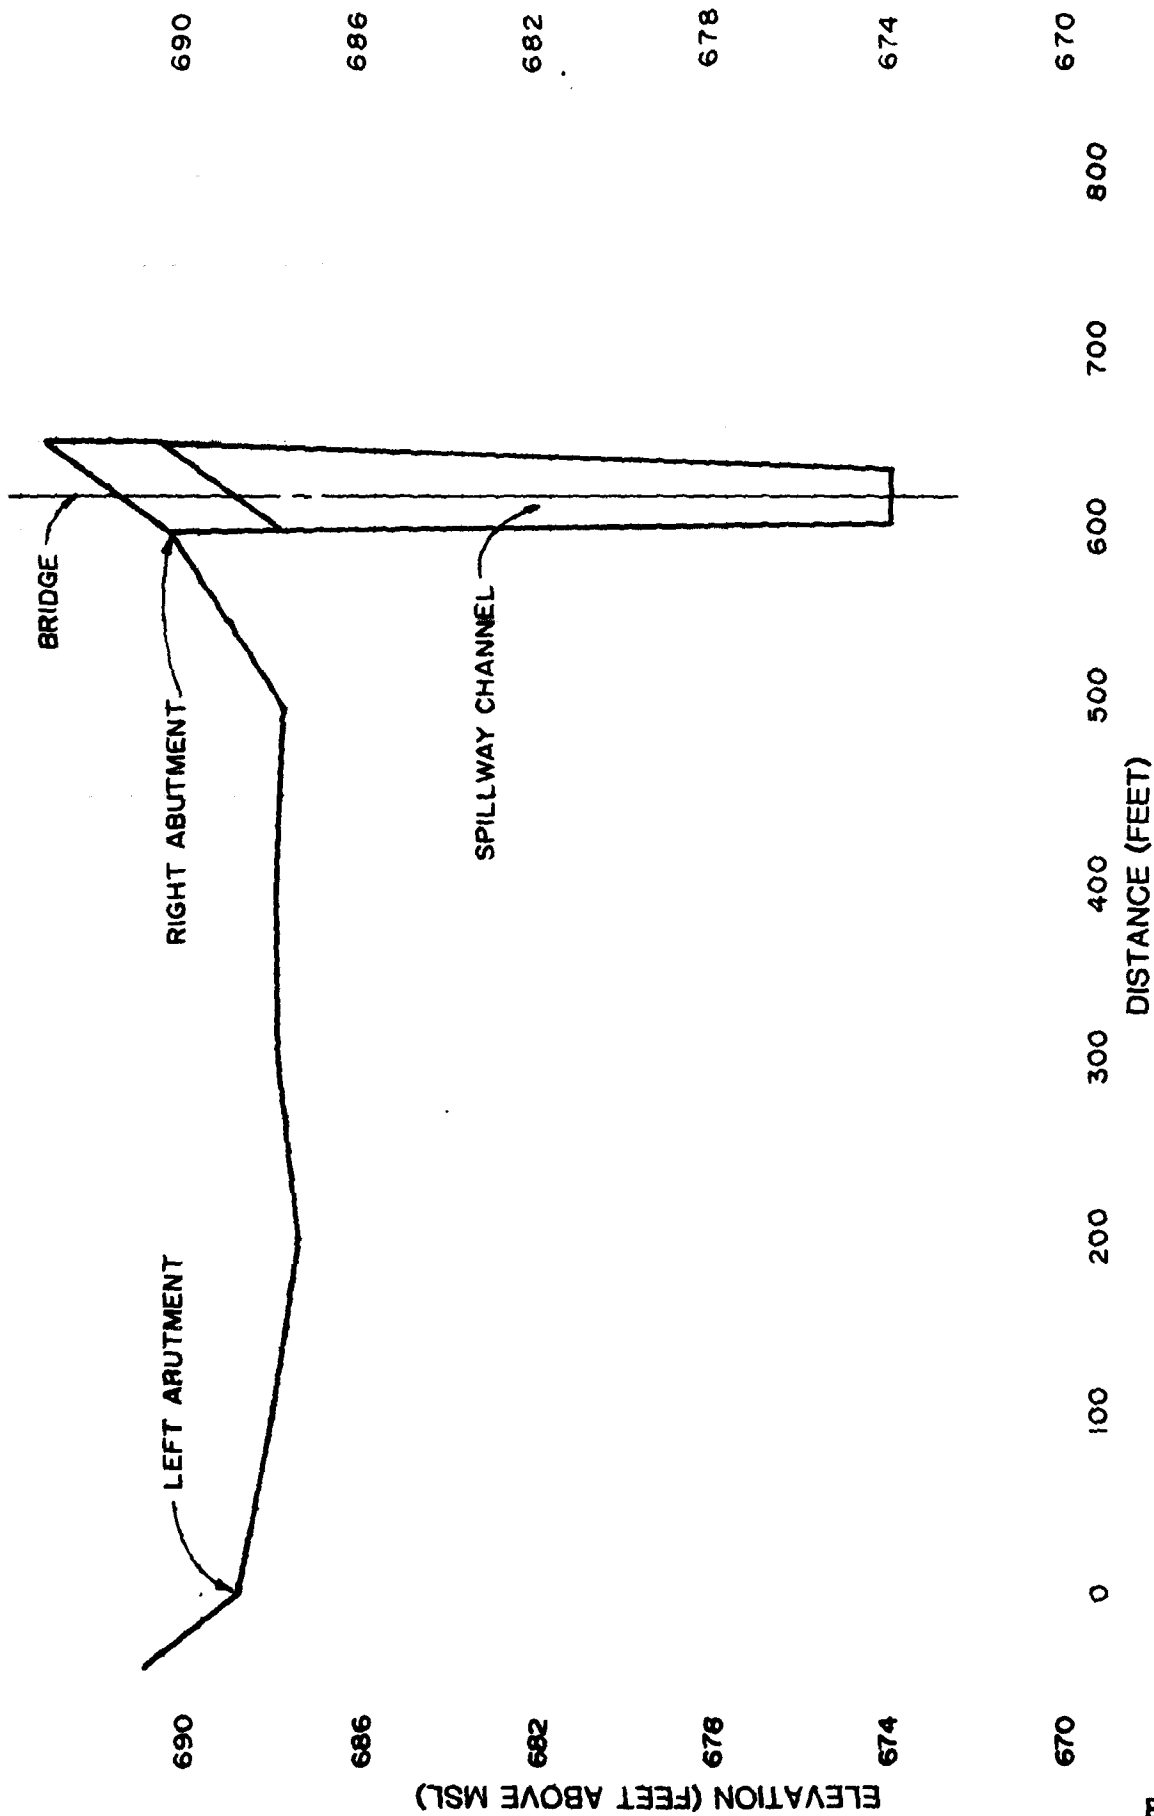
PROFILE OF DAM CREST  
INNSBROOK ESTATES DAM NO.1 M031714

The elevation of the centerline of the crest of the dam varies from 687.9 to 689.0 or approximately 1.1 feet. The low point of the embankment was apparently caused by greater settlement near the area of the greatest height of fill. This area is located towards the left abutment near the site of the original creek bed. A profile of the crest of the dam is shown on Exhibit 3 of Appendix B.
