## MISSOURI - KANSAS CITY RIVER BASIN

HAUCK LAKE DAM  
CALLAWAY COUNTY, MISSOURI  
MO. 10989

## PHASE I INSPECTION REPORT NATIONAL DAM SAFETY PROGRAM

SEPTEMBER, 1980

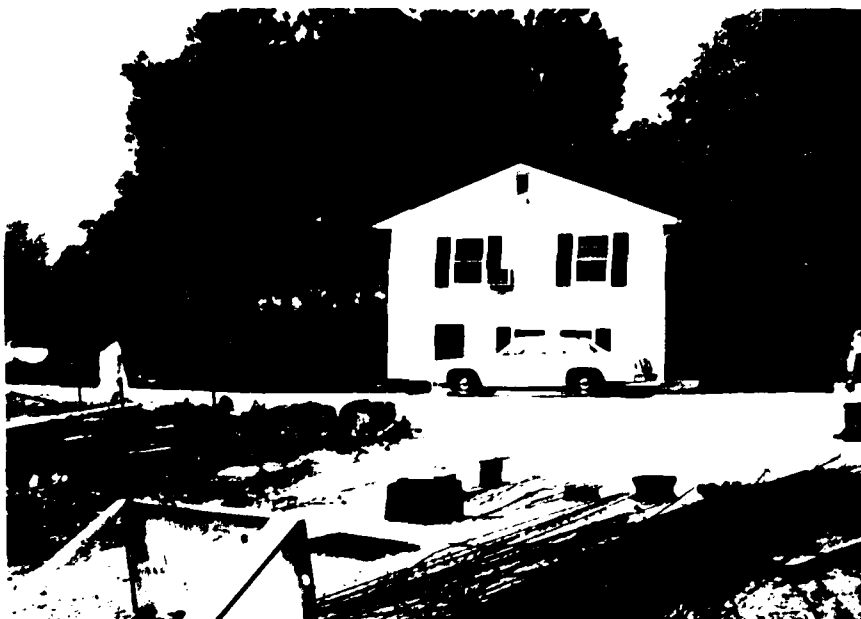
Photo 13

The dam has been classified as having a "high" hazard potential in the National Inventory of Dams, on the basis that in the event of failure of the dam or its appurtenances, excessive damage could occur to downstream property, together with the possibility of the loss of life. From a visual inspection of the downstream area, our findings concur with this classification. There are six dwellings, one building, two sheds, one school, a junkyard and a park within the estimated damage zone, which extends approximately four miles downstream of the dam (see Photos 13 and 14).
