MOORES LAKE DAM  
BOONE COUNTY, MISSOURI  
MO. 11173

**PHASE I INSPECTION REPORT**

**6 NATIONAL DAM SAFETY PROGRAM.**

Moore Lake Dam (MO 11173),  
Missouri - Kansas City River Basin,  
Boone County, Missouri. Phase I Inspection  
Report.

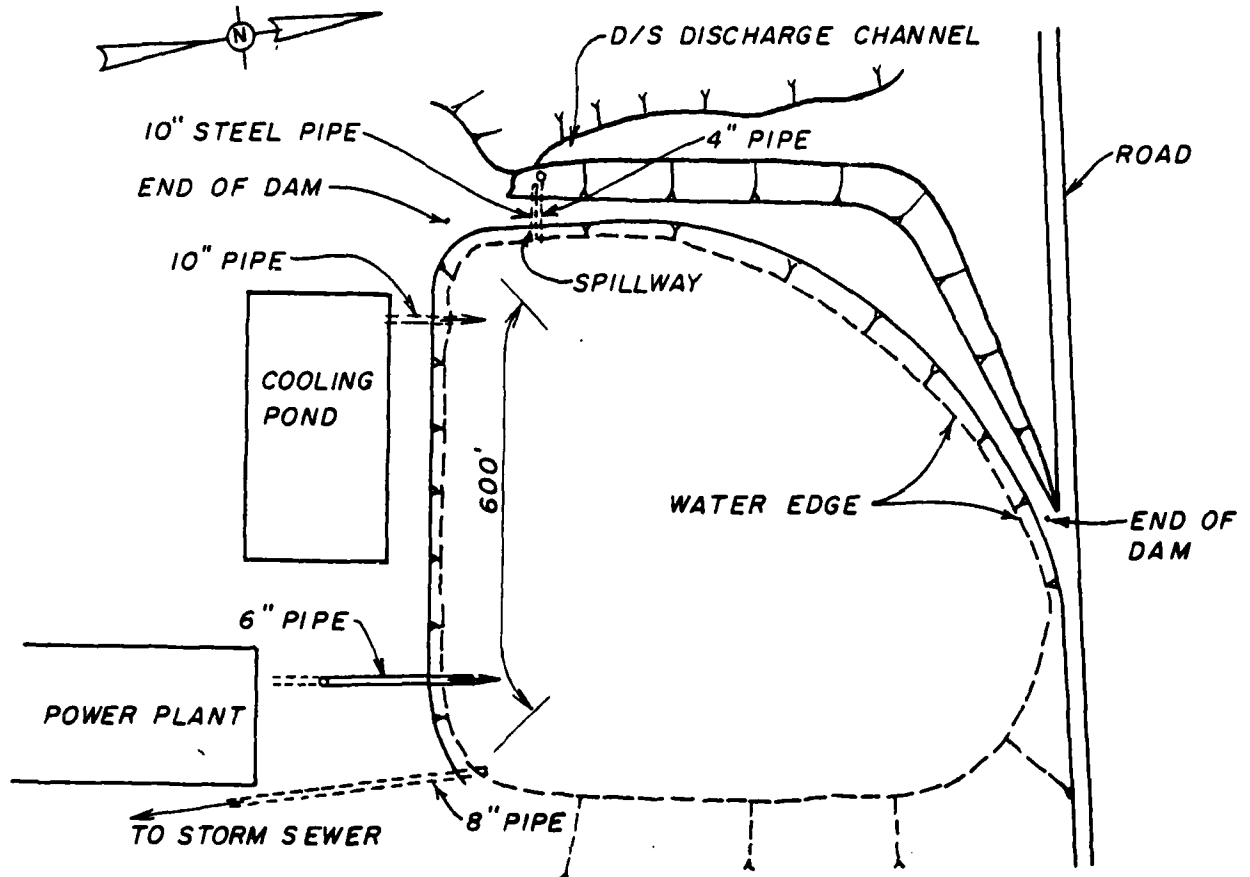
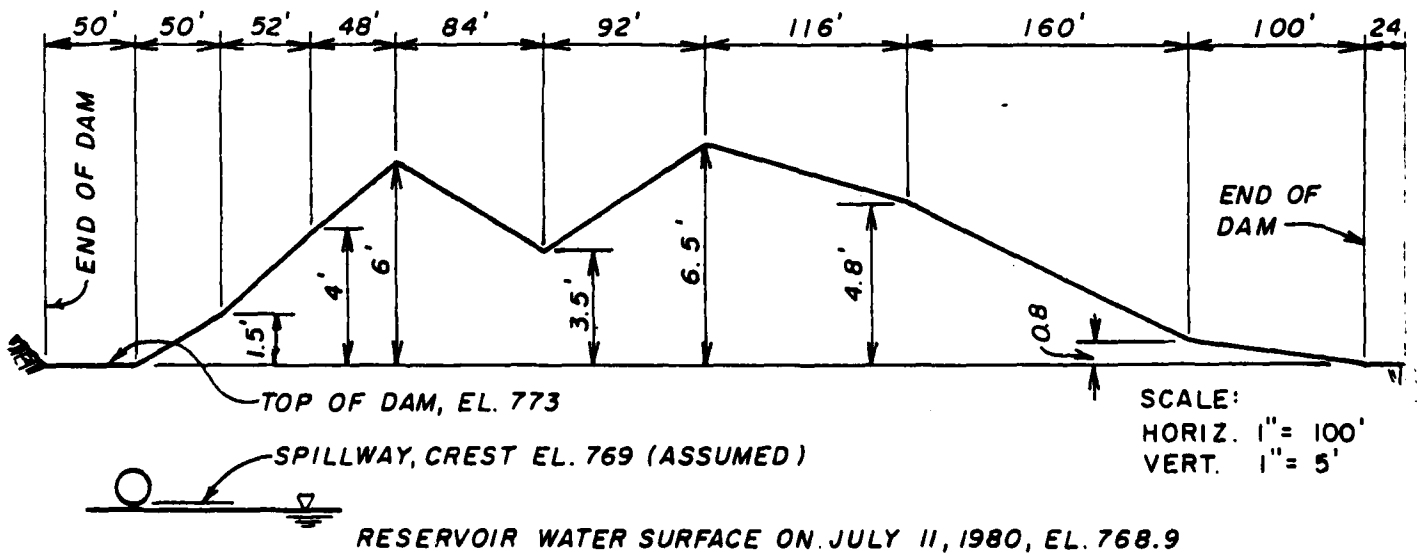
MOORES LAKE DAM (MO. 11173)  
PLAN AND ELEVATION

The 8-inch diameter pipe is located at the southeast corner of the reservoir (for the actual location see Plate 2). Flows through the pipe discharge into a creek to the south of the power plant. The top of the pipe was about 4 inches below the reservoir water surface level on the day of the inspection. This pipe, according to Mr. Gary Anderson, is going to be plugged in October of 1980. On the day of the inspection, very little water was observed flowing through the pipe, which leads the inspection team to believe that the pipe is already partially plugged. Therefore, this pipe is assumed to be abandoned and was not used to determine the capacity of the spillway system. Therefore, there are essentially only one spillway and one low level outlet utilized at this damsite.
