**BARTLETT'S FISHING LAKE DAM**

**STODDARD COUNTY, MISSOURI**

**MO 40046**

**PHASE 1 INSPECTION REPORT**

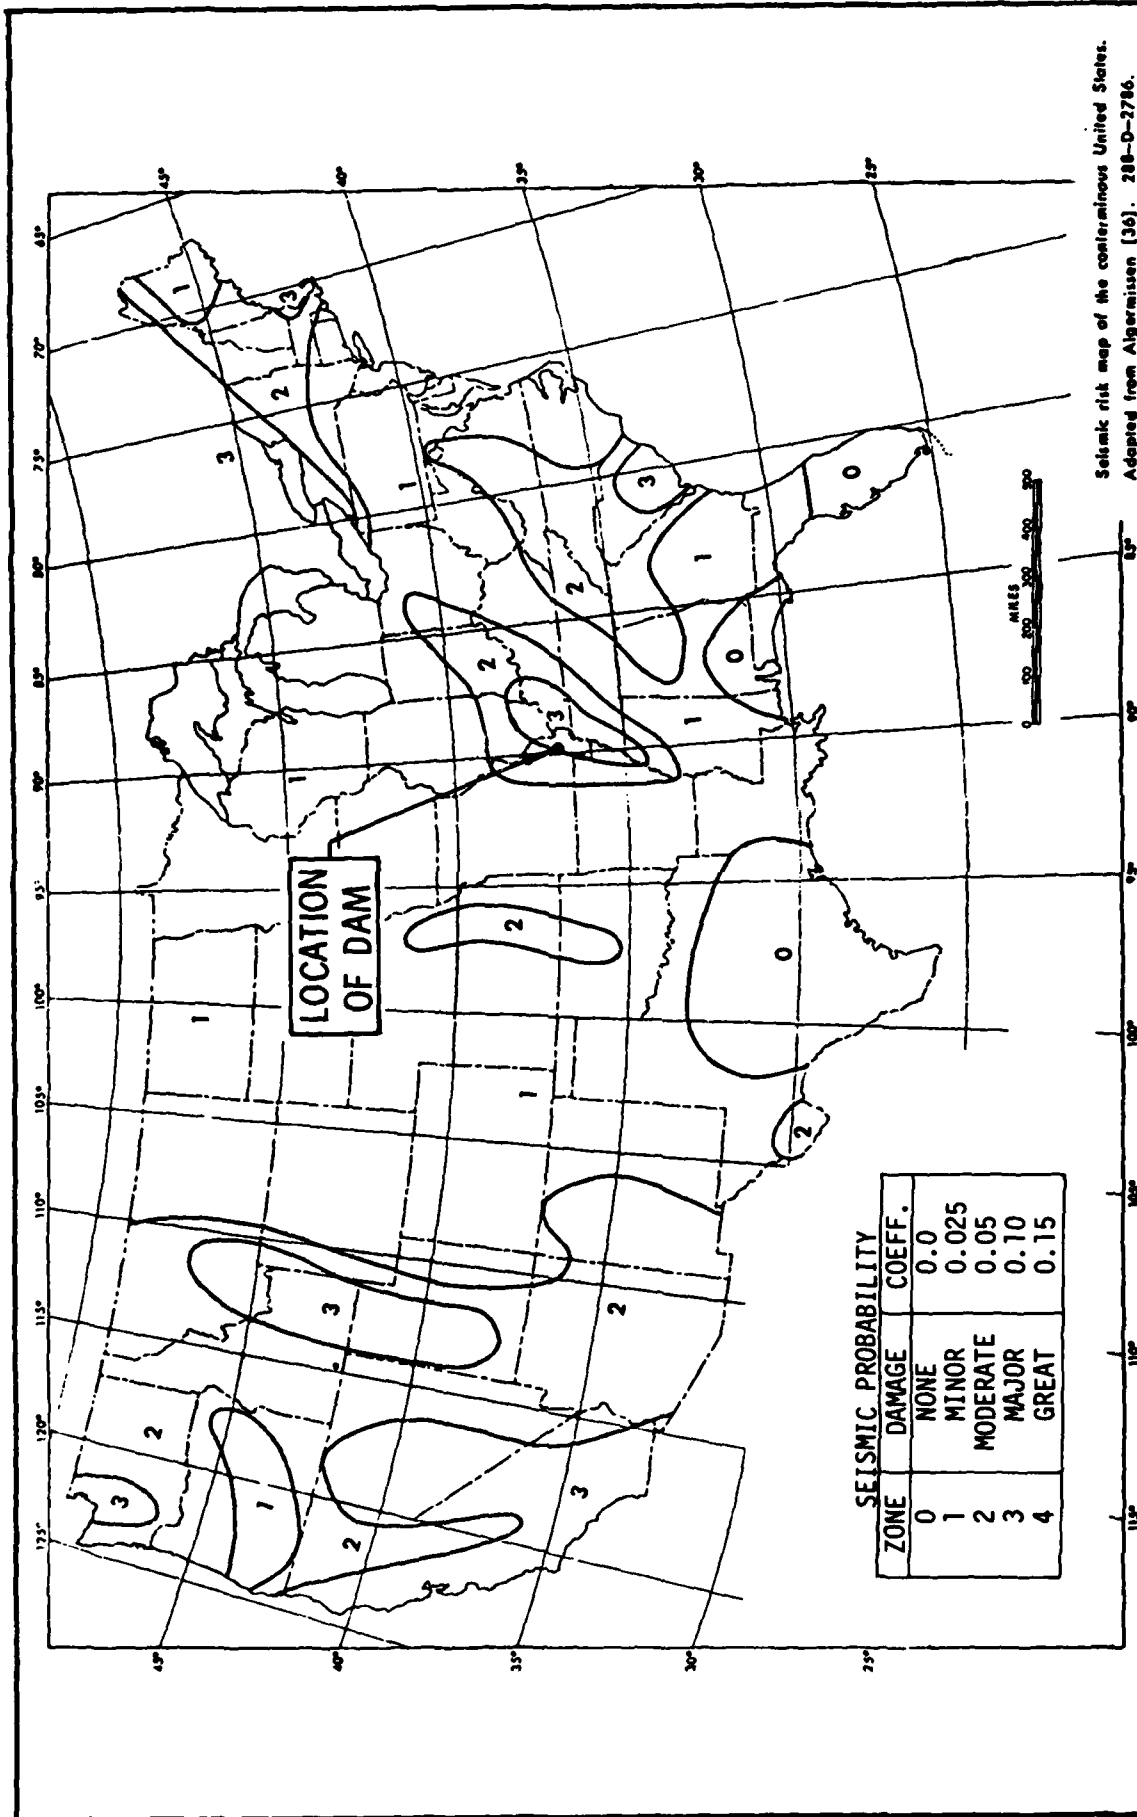
# SEISMIC ZONE MAP OF CONTIGUOUS STATES BARTLETT'S FISHING LAKE DAM MO.40046

This dam is located in or near Seismic Zone 3, as shown on the Seismic Zone Map on Plate 3 of Appendix A. Zone 3 delineates areas in which major damage would result from the expected seismic activity in this area. An accurate slope stability analysis with seismic loading cannot be made because of the lack of original design data and soil strength parameters. It should be noted that slopes of the embankment vary and some are relatively steep. Due to this factor, in the event of seismic loading, some of the slopes may become unstable and suffer damage, possibly severe.
