LAKE HARMONY DAM

MADISON COUNTY, MISSOURI

MO 30612

**PHASE 1 INSPECTION REPORT**  
**NATIONAL DAM SAFETY INSPECTION.**

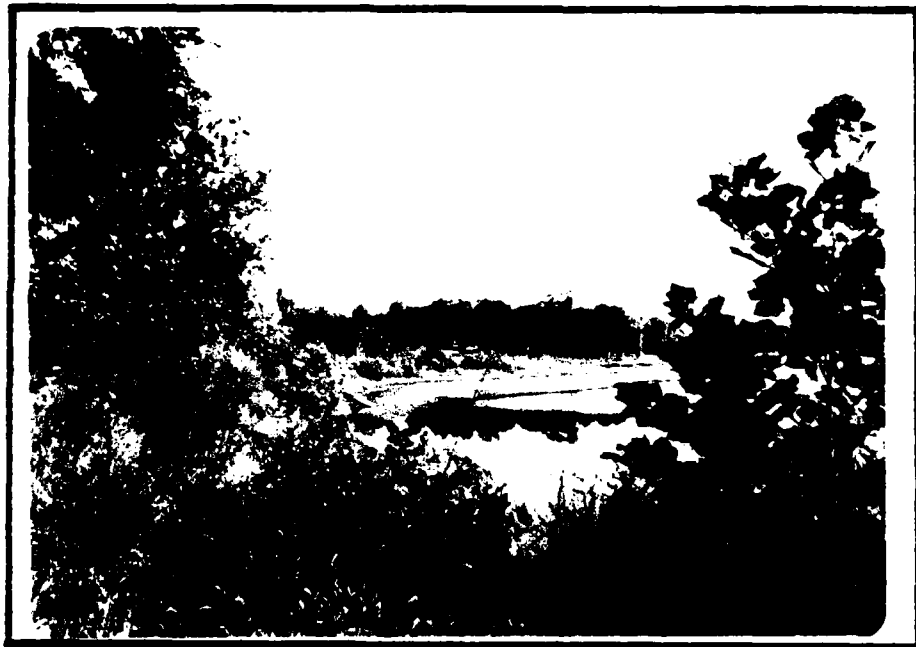
Photograph No. 1

Overview of crest and upstream slope.
