**F. A. TOTTEN LAKE
WEBSTER COUNTY, MISSOURI
MO 20398**

**PHASE 1 INSPECTION REPORT
NATIONAL DAM SAFETY INSPECTION**

SUBJECT: F. A. Totten Lake Dam Phase I Inspection Report

Name of Dam: F. A. Totten Lake Dam
State Located: Missouri
County Located: Webster County
Stream: Tributary to James River
Date of Inspection: 16 May 1979

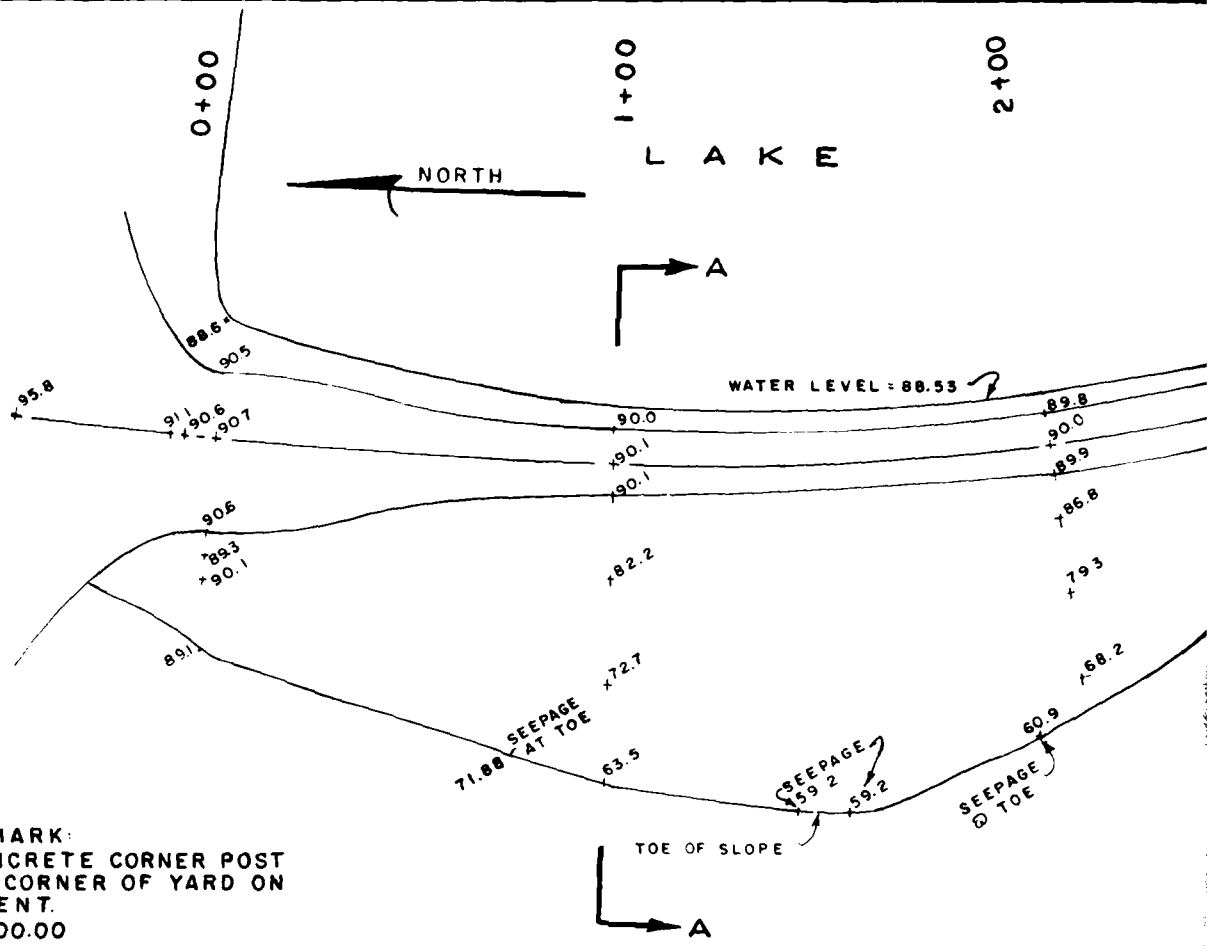
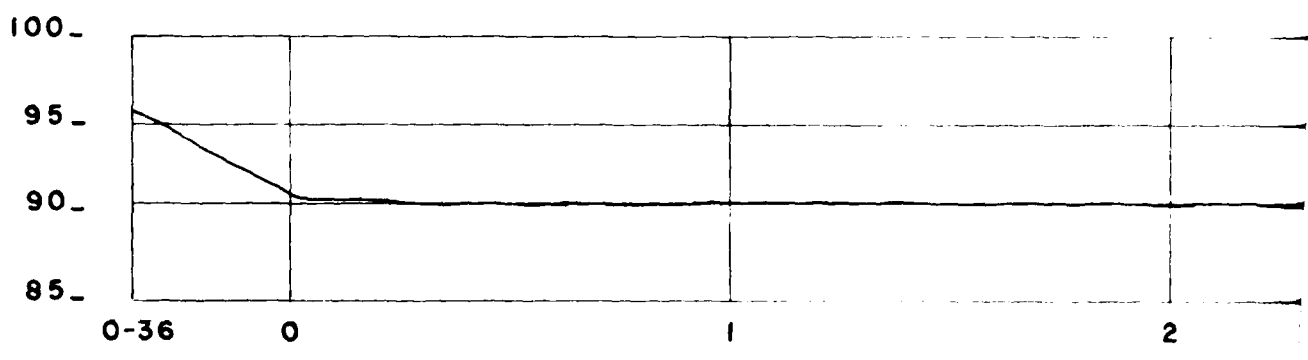
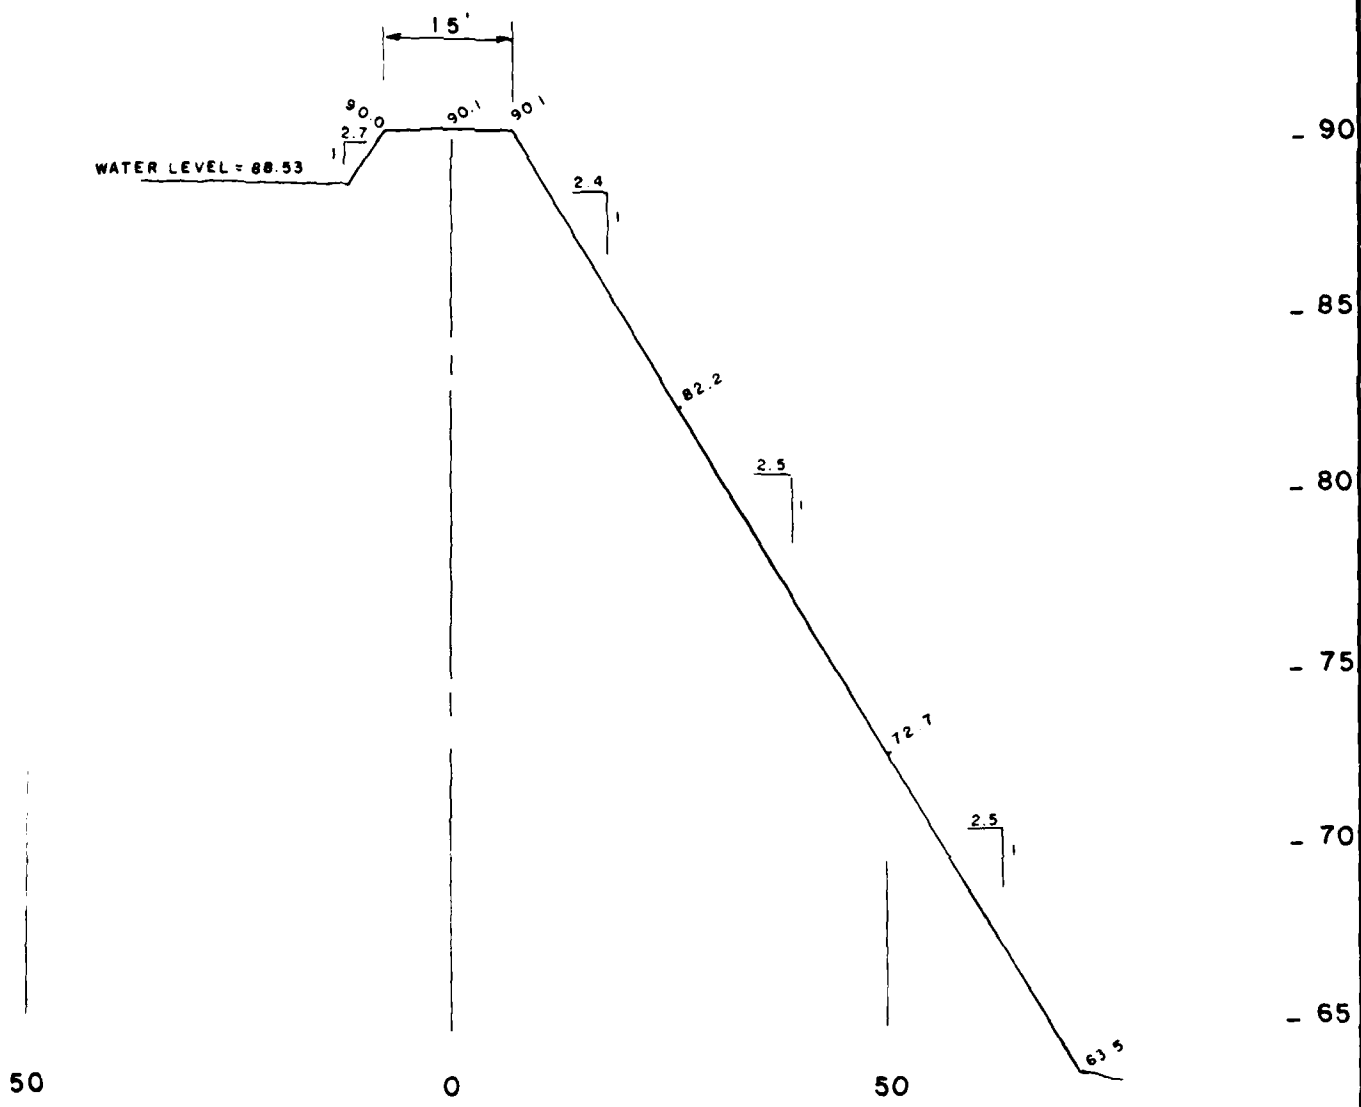
PLAN VIEW
 SCALE: 1" = 40'

F. A. Totten Lake Dam is an earth fill structure approximately 31 ft. high and 290 ft. long at the crest. The appurtenant works consist of an unlined earth spillway in the south abutment. Sheet J of Appendix A shows a plan, profile and typical section of the embankment.
