LEO JOURNAGAN LAKE  
GREENE COUNTY, MISSOURI  
MO 20395

**PHASE 1 INSPECTION REPORT  
NATIONAL DAM SAFETY INSPECTION**

LEO JOURNAGAN LAKE  
GREENE COUNTY, MISSOURI  
MISSOURI INVENTORY NO. 20395

Name of Dam: Leo Journagan Lake  
State Located: Missouri  
County Located: Greene County  
Stream: Tributary to James River  
Date of Inspection: 16 May 1979

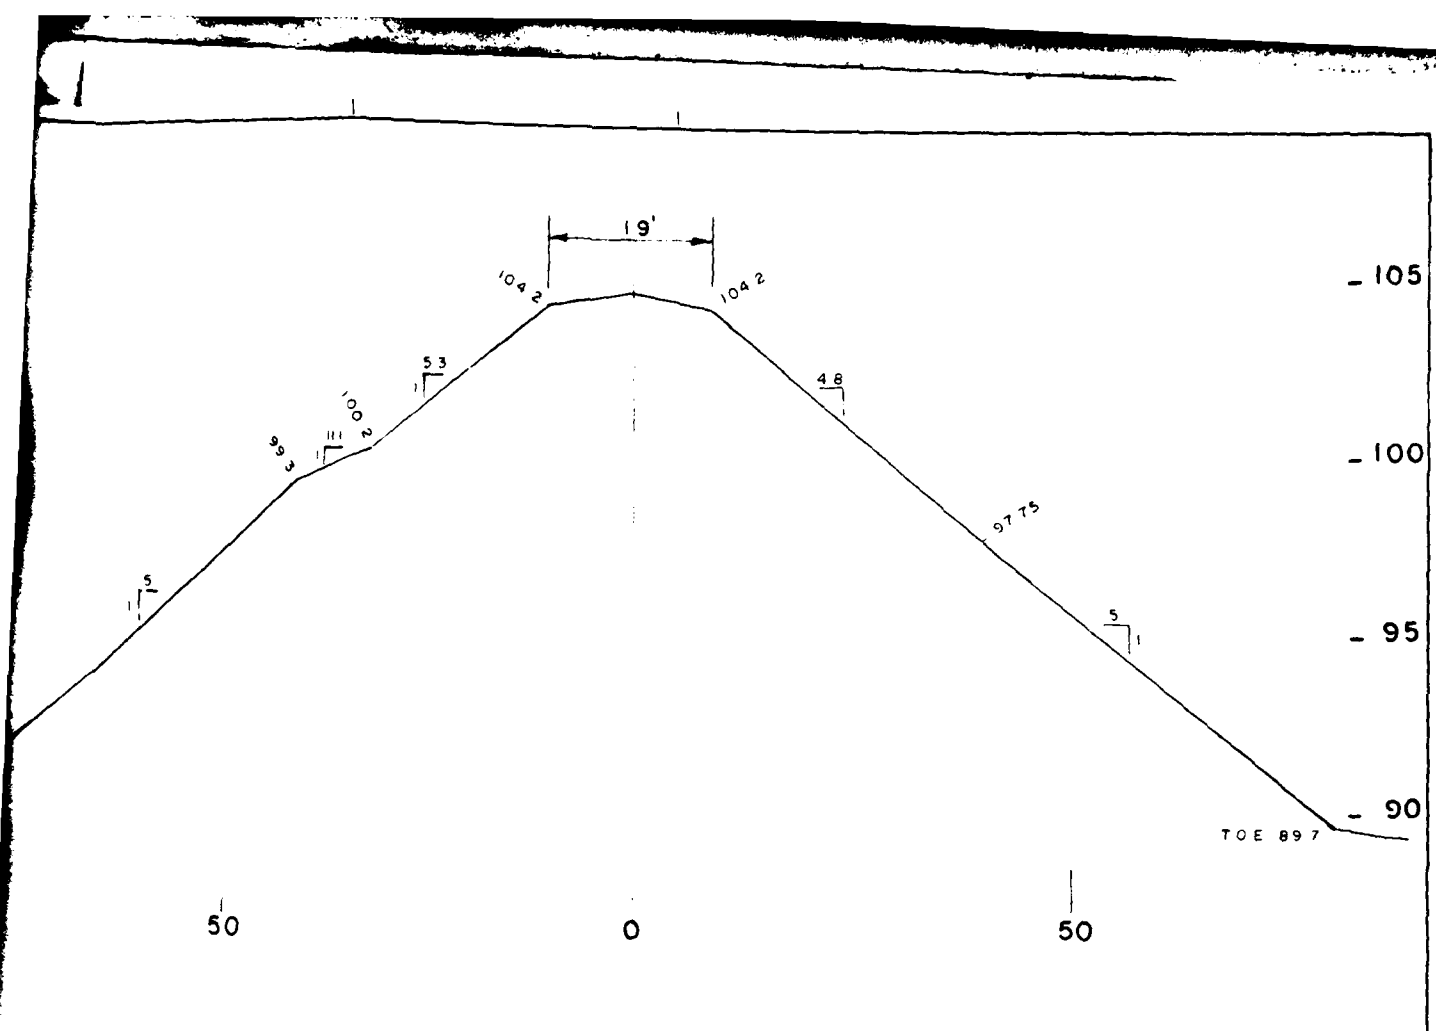
SECTION A-A STA 5+00

The Soil Conservation Service designed an embankment cross section which is shown on Sheet 5 of Appendix A. No other foundation or embankment design information was available. Information from the owner indicates that the dam is composed of silty clay soils from the lake area. There is apparently no particular zoning of the embankment and no internal drainage features are known to exist. No construction inspection test results have been obtained.

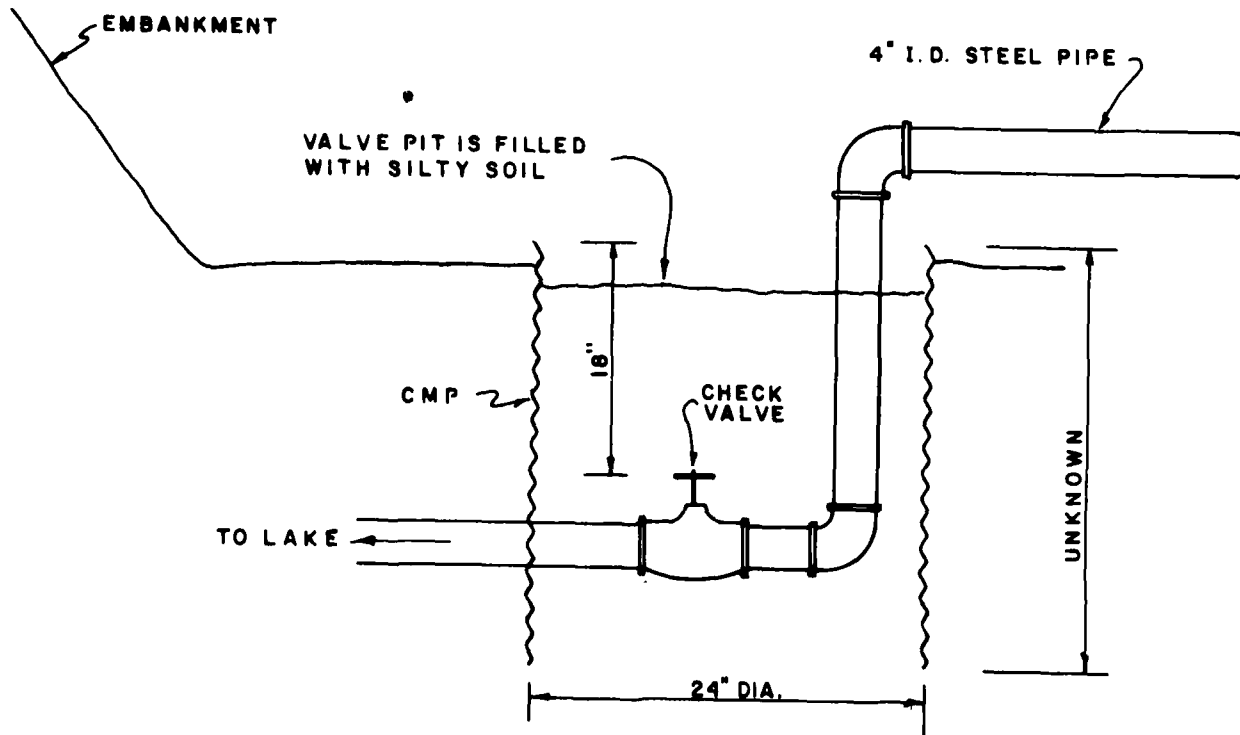
LAKE DRAWDOWN VALVE PIT

A dewatering pipe was found at the downstream toe of the embankment at sta. 3 + 86. The four-inch I.D. steel pipe comes out of a 24 inch diameter CMP valve pit covered with a steel lid. The valve is a gate valve and the control wheel is located 18 inches below the top of the pit. At the time of the inspection the valve pit was filled with silty soil. The four-inch pipe was not seen on the upstream side, therefore, it must be below the lake level, elevation 91.83, at the time of inspection. A detail of the dewatering valve pit is included on Sheet 4 of Appendix A.

Facilities available to drawdown the pool appear to be in good condition except for soil that has washed in and filled the valve pit. The primary spillway is located near the west end of the dam and the emergency spillway is located on the east abutment. Spillway releases would not be expected to endanger the integrity of the dam.
