LAKE HOLLENBECK DAM  
CAPE GIRARDEAU COUNTY, MISSOURI

MISSOURI INVENTORY NO. 40050

PHASE I INSPECTION REPORT  
NATIONAL DAM SAFETY PROGRAM

NOVEMBER, 1978

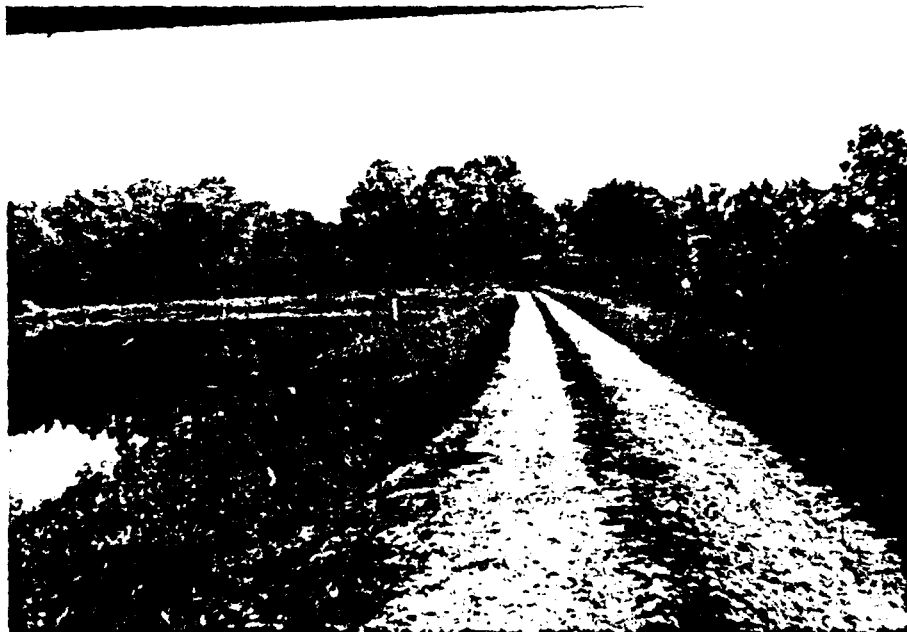
PHOTO 2 Crest of Dam

B. Dam. The inspection team observed the following at the dam. The dam is an earth embankment with a hard packed earth road running the length of the crest. No detrimental settlement, depressions or cracking was observed along the crest or adjacent to the embankment. Upstream slope erosion protection consists of a cover of grass.

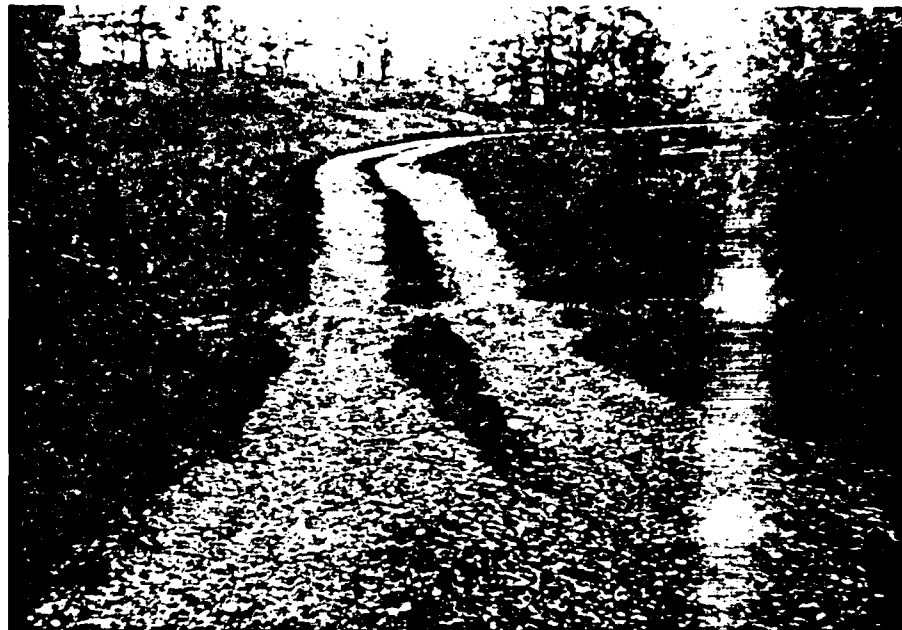
PHOTO 5 View of Emergency Spillway

The emergency overflow spillway is located on the north side of the lake and its discharge presents no problem to the dam's integrity.

(2) The emergency overflow spillway is located on the north side of the lake and its discharge presents no problem to the dam's integrity.
