LAKE PRIMROSE DAM

ST. FRANCOIS COUNTY, MISSOURI

MISSOURI INVENTORY NO. 30904

PHASE I INSPECTION REPORT  
NATIONAL DAM SAFETY PROGRAM

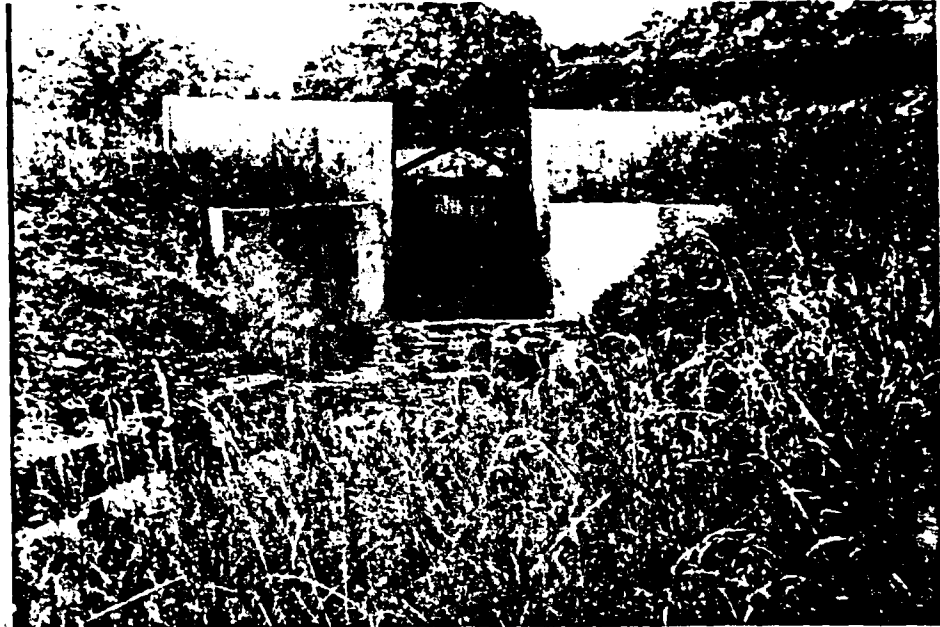
PHOTO 3: Spillway Entrance Looking Downstream.

(2) The spillway consists of a 10' diameter CMP, apparently deformed (actual measurements 11' x 9'). The conduit is preceded by a concrete paved approach channel laid on an approximate slope of 21%.
