SEE TAL LAKE DAM
(Formerly Glennon Epple Dam)
GASCONADE COUNTY, MISSOURI

MISSOURI INVENTORY NO. 30668

PHASE I INSPECTION REPORT
NATIONAL DAM SAFETY PROGRAM

NOVEMBER, 1978

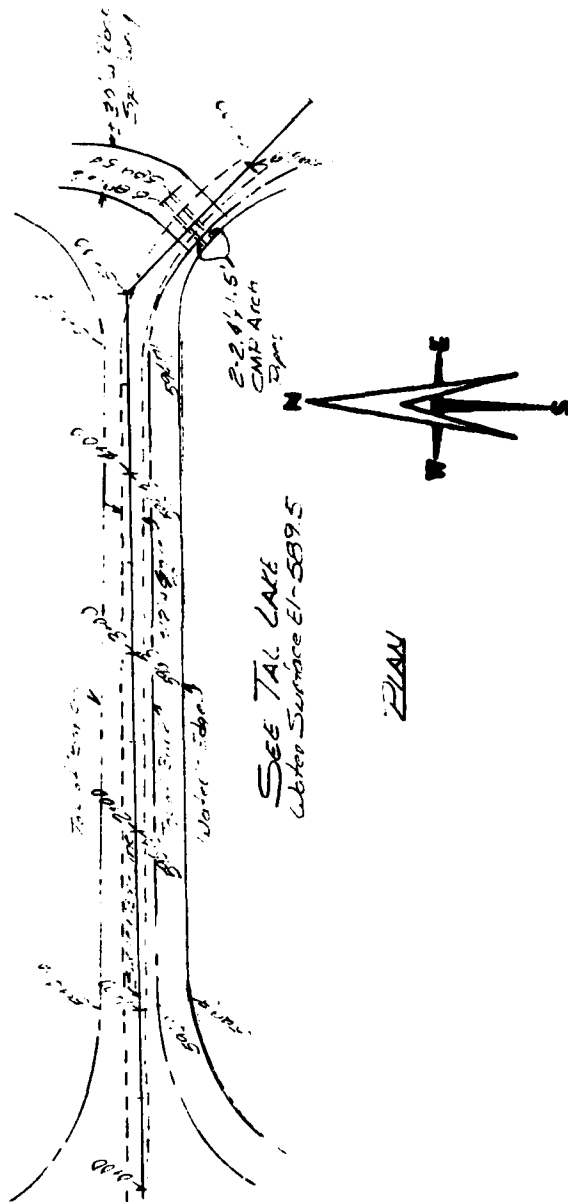
SCALE: 1"=100' PLATE 3

TOP OF DAM
ELEVATIONS

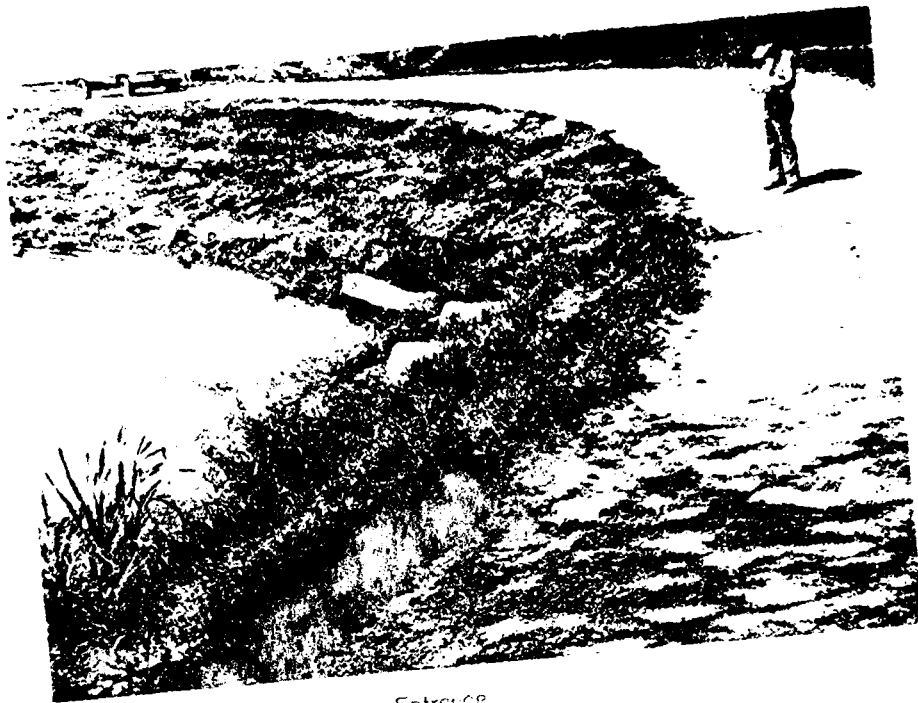
C. Appurtenant Structures. The principal spillway consists of two 29 x 18 inch corrugated metal arch-pipes embedded at the junction of right abutment and the dam embankment. The spillway outlet channel is cut in bedrock and is riprapped at the lower end. A number of small trees were growing in the outlet channel. Spillway discharges will not endanger the integrity of the dam.

PHOTO 3 Spillway Entrance
