HILLTOP FISHING LAKE DAM  
DUNKLIN COUNTY, MISSOURI  
MO 40064

# PHASE 1 INSPECTION REPORT NATIONAL DAM SAFETY PROGRAM

MARCH 1981

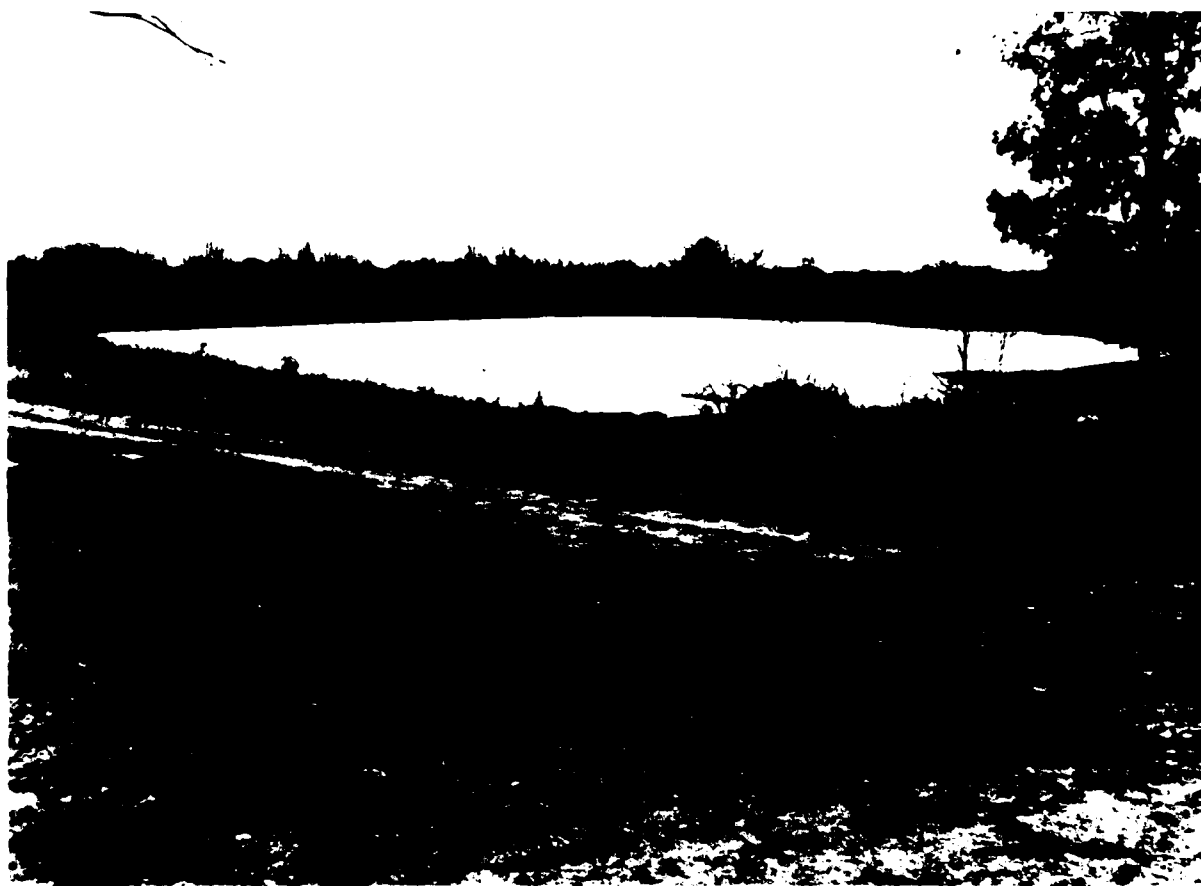
PHOTOGRAPH 1. OVERVIEW OF HILLTOP FISHING LAKE DAM.

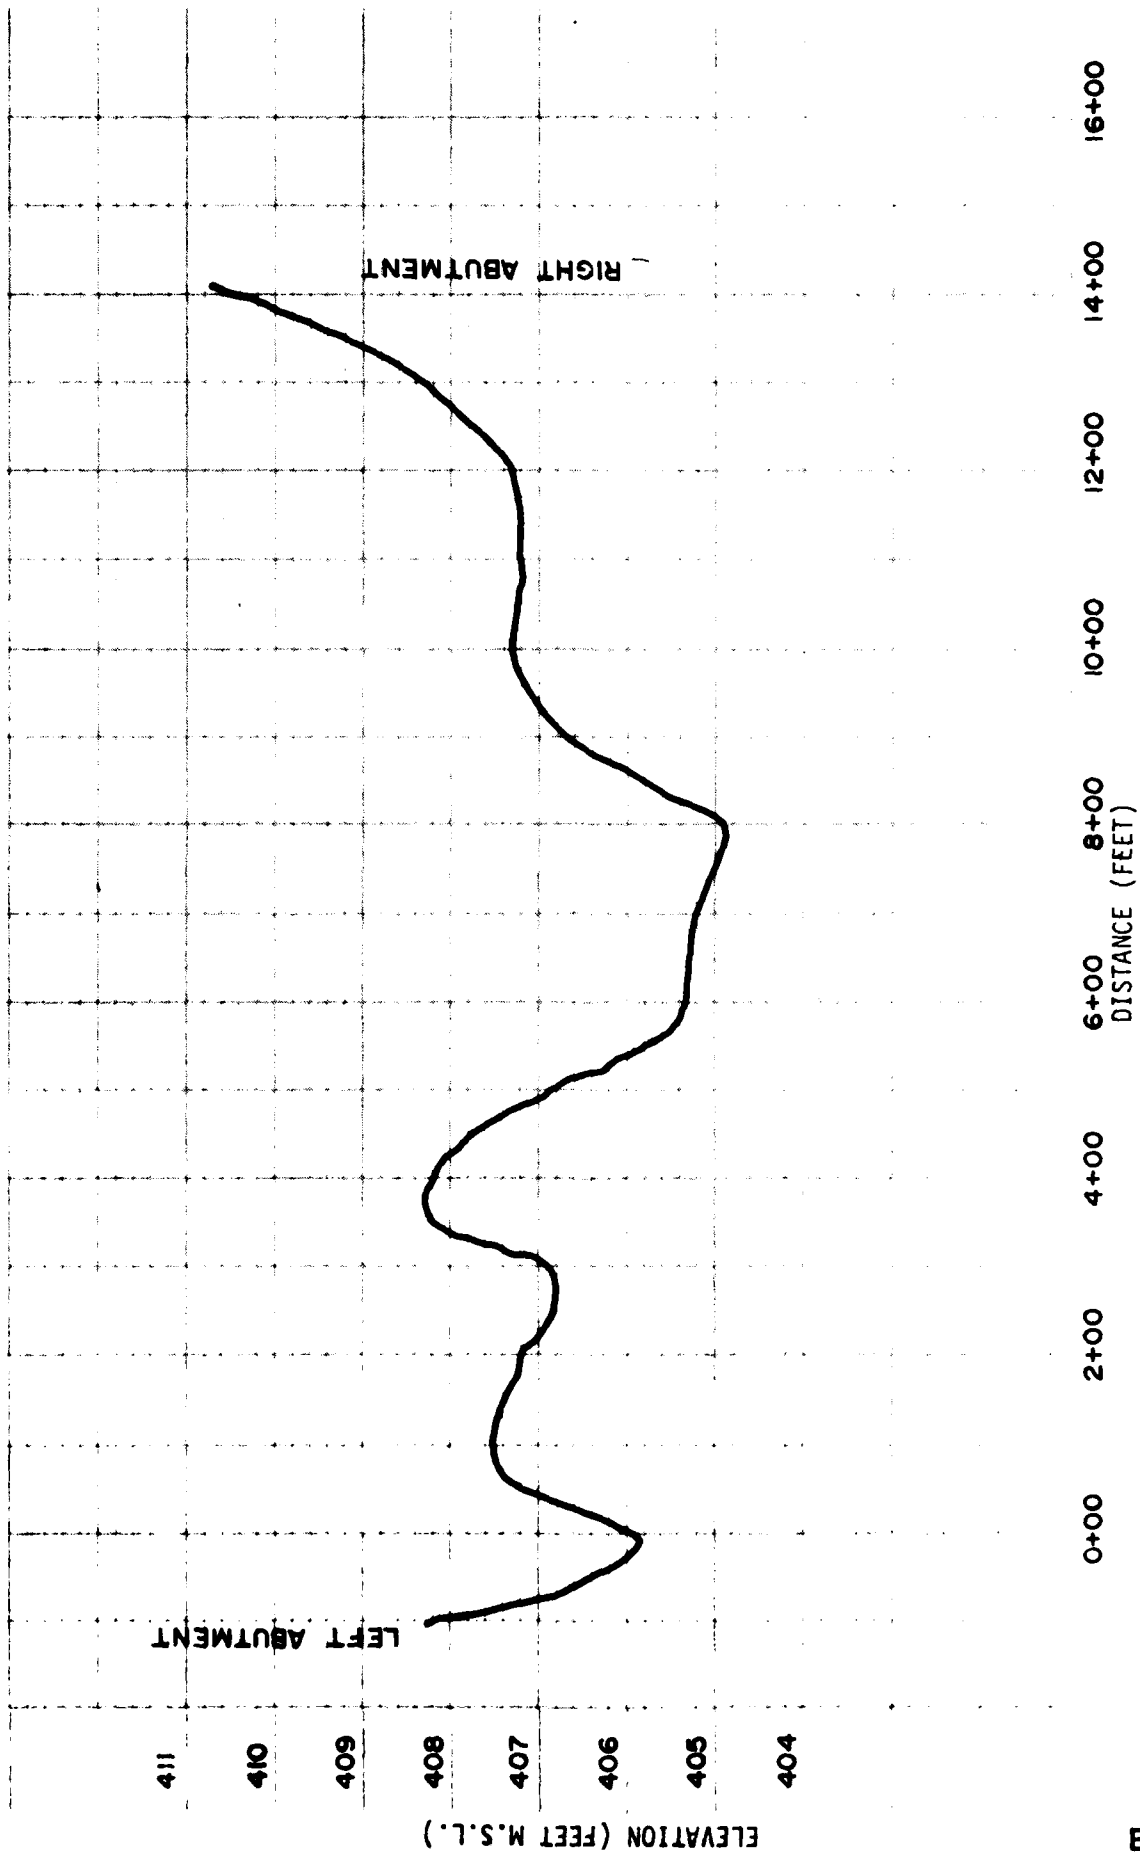
EXHIBIT 3

The embankment appears to be in poor condition. The vertical alignment of the crest is not uniform and the crest elevation varies from 404.9 to 410.7. There is no apparent reason for this variation in elevation other than the fact that it was constructed that way. A profile of the crest can be seen on Exhibit 3 of Appendix B.
