LITTLE DIXIE DAM
CALLAWAY COUNTY, MISSOURI
MO 10888

PHASE I INSPECTION REPORT
NATIONAL DAM SAFETY PROGRAM.

PHASE I INSPECTION REPORT
NATIONAL DAM SAFETY PROGRAM

Name of Dam: Little Dixie Dam
State Located: Missouri
County Located: Callaway County
Stream: Owl Creek
Date of Inspection: 23 August 1978

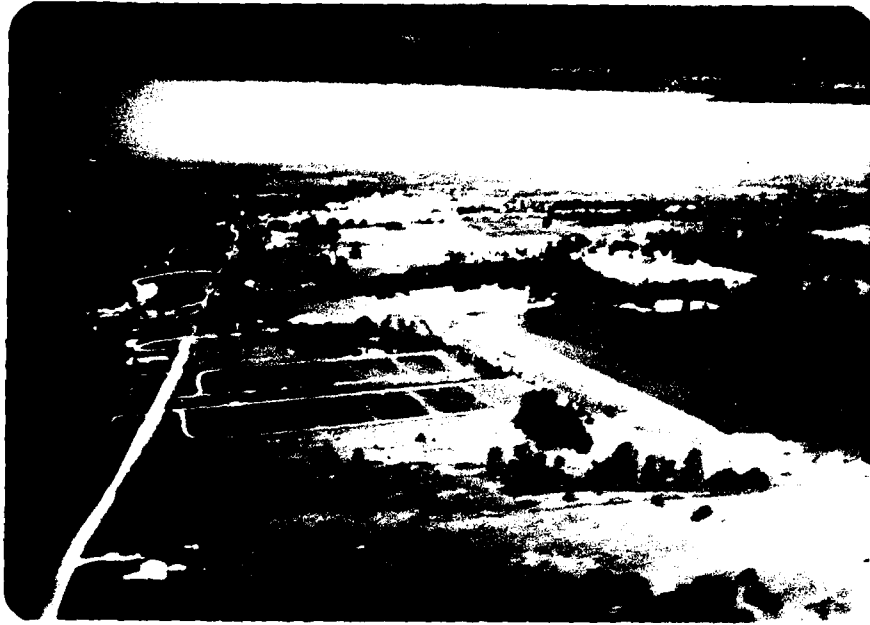
Aerial View of Lake and Dam

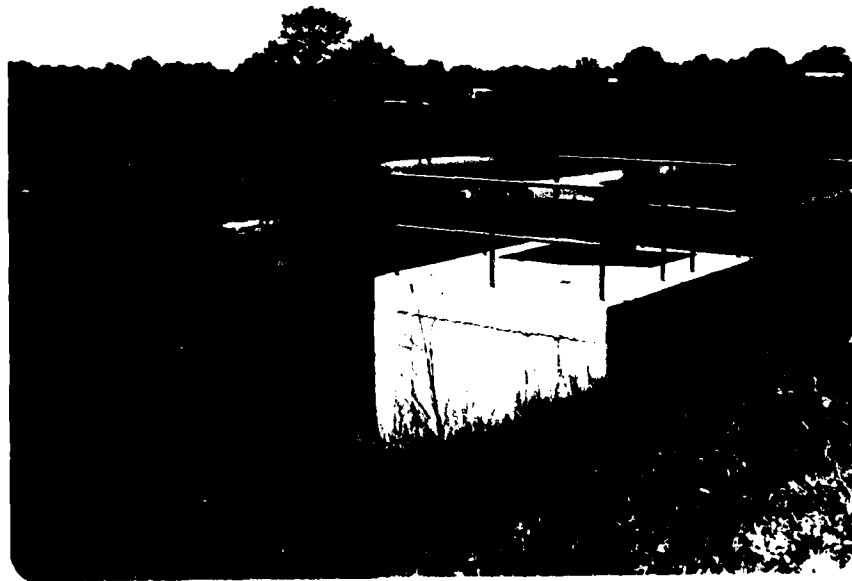
Rearing Pool Feed Line Gate Valve

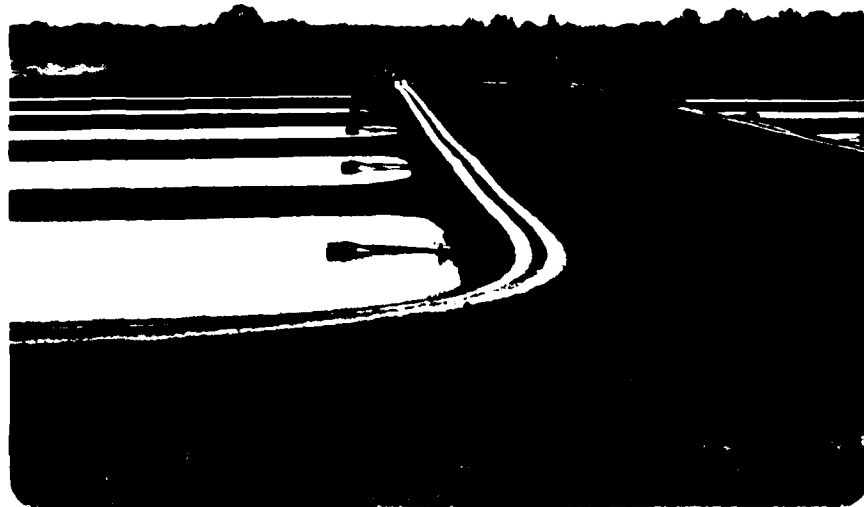
Fish Rearing Ponds - Looking Downstream
