D & R PIPELINE CONSTRUCTION COMPANY LAKE
GREENE COUNTY, MISSOURI
MO 20396

PHASE 1 INSPECTION REPORT

(b) NATIONAL DAM SAFETY INSPECTION

D and R Pipeline Construction Company Lake
(MO 20396). Osage - Gasconade Basin,
Greene County, Missouri. Phase I Inspection
Report.

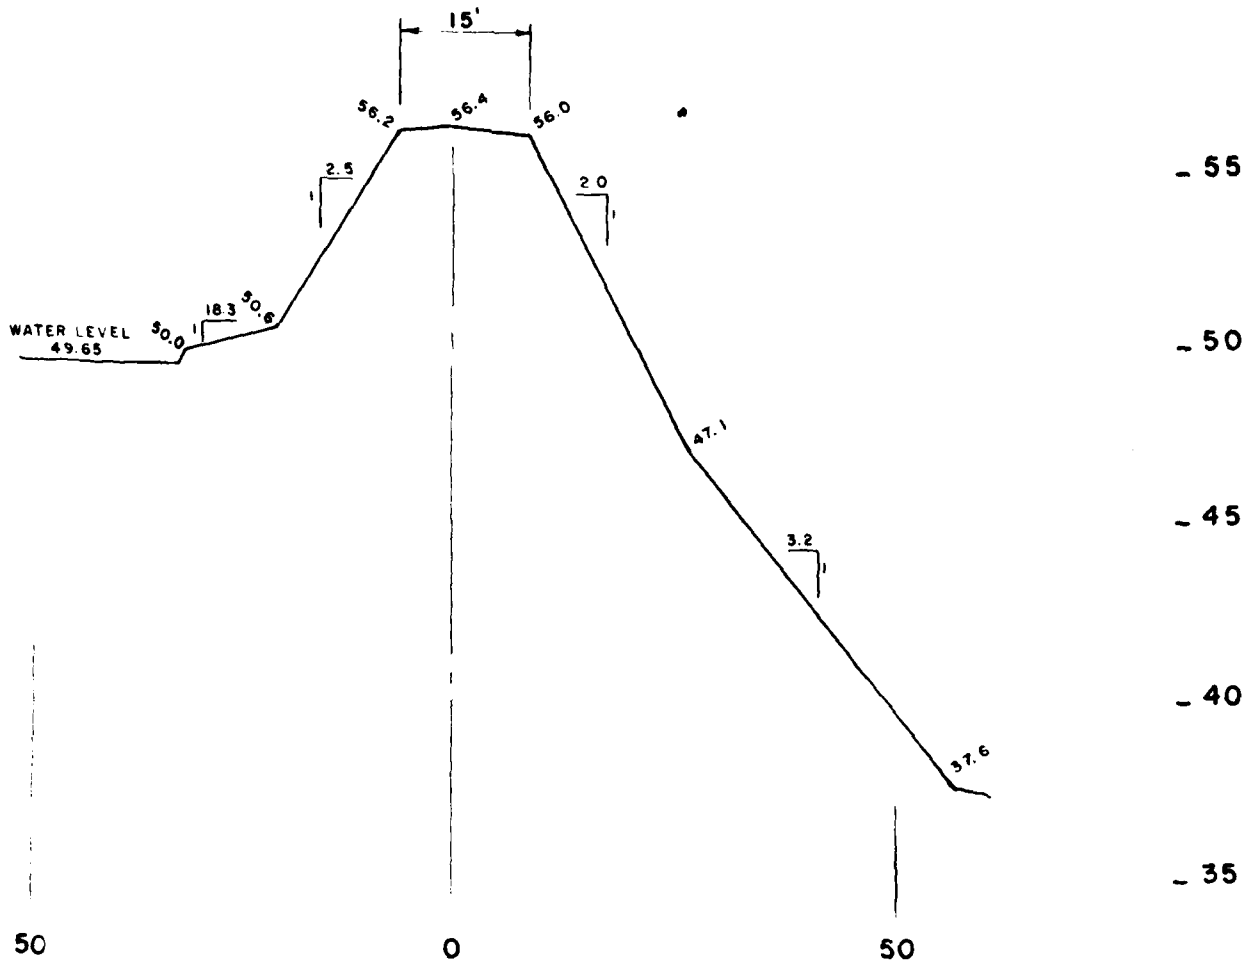
SECTION A-A STA 1+00

The Soil Conservation Service designed an embankment cross section which is shown on Sheet 4 of Appendix A. No other foundation or embankment design information was available. Information from the past owner, E. H. Green, indicates that the dam was constructed from the silty clay soils from the lake area. There is apparently no particular zoning of the embankment and no internal drainage features are known to exist. No construction inspection test results are available.

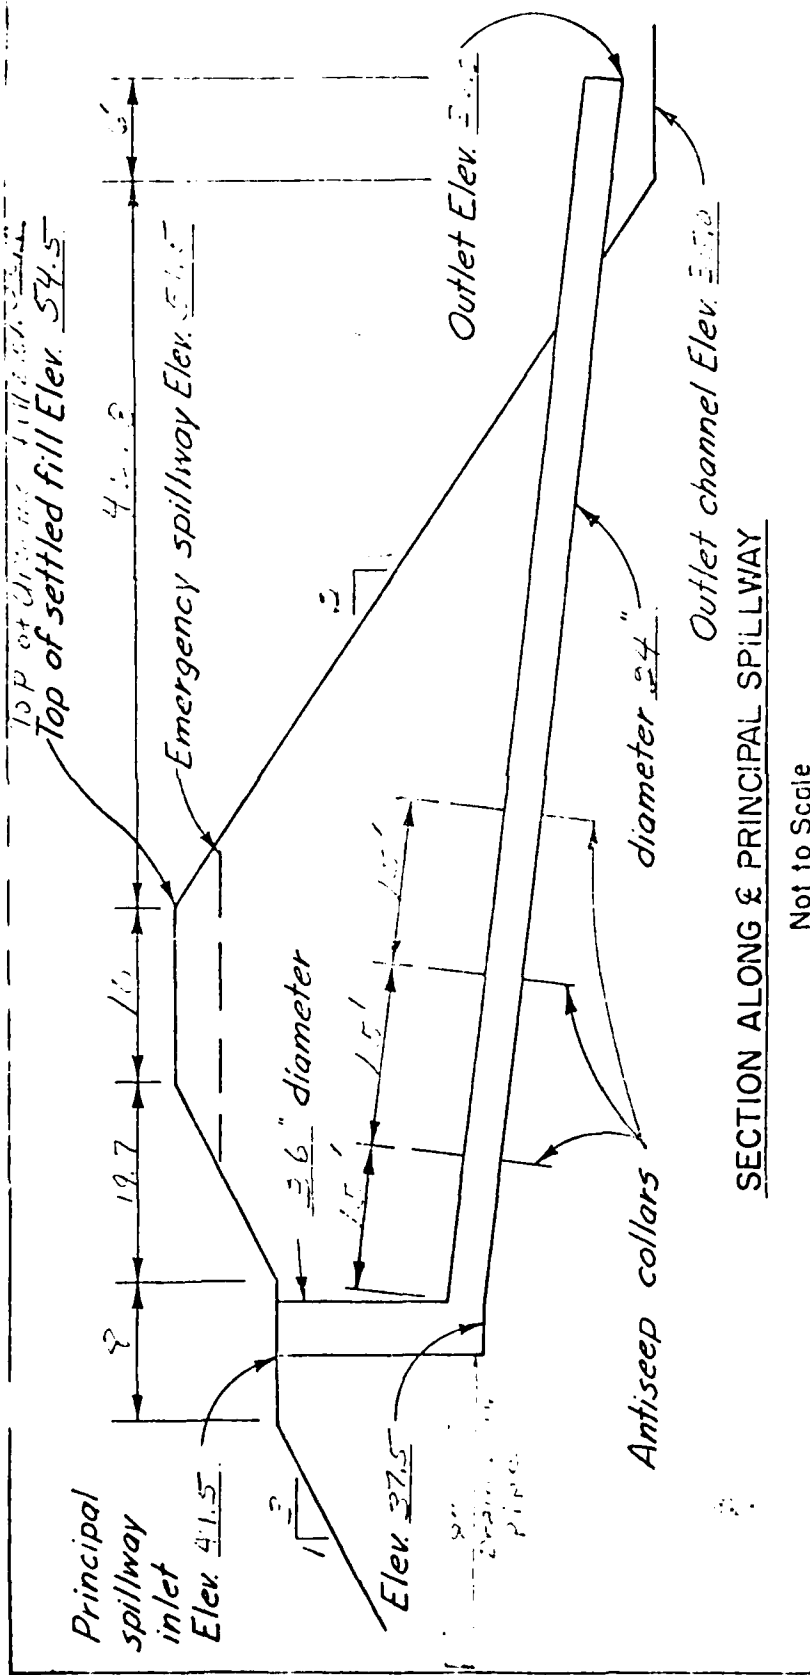
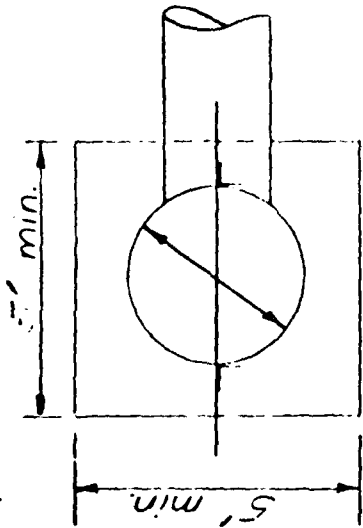
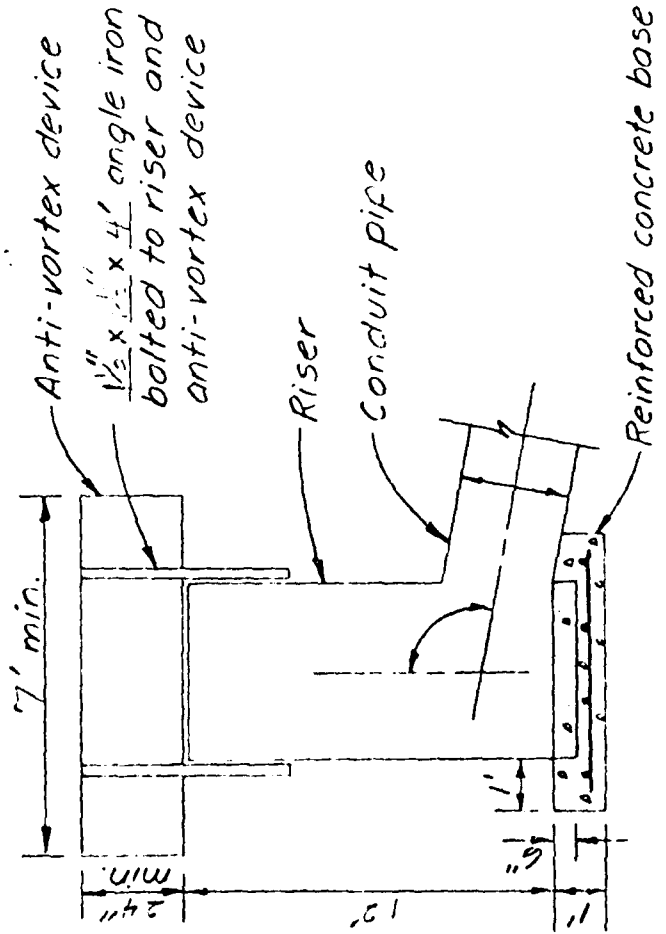
Sheet 7 of Appendix A

The primary spillway consists of a 36 inch vertical CMP riser at the front face of the embankment near the west abutment. The lower portion of the riser pipe was plugged with logs and debris. The logs pass through a steel bar trash rack that sits on top of the spillway riser. The approach to the spillway is generally clear however there is some debris around the trash rack. The 24 inch outlet pipe is in good condition and assumed to be partially blocked since only a small amount of water was coming out of this pipe at the time of inspection even though there was approximately 3 feet of water standing inside the riser. The outlet pipe entrance must be partially blocked. No seepage was noted around the outside of the primary spillway pipe near the outlet end.

The emergency spillway should be repaired. Continued use of the spillway will cause it to severely erode. The primary spillway riser should be cleared of logs and debris and the trash rack modified to keep logs and trash from entering the drop inlet pipe. Trees and brush on the downstream face near the 24 inch outlet pipe should be cleared and the rest of the embankment cleared on an annual basis. Removal of large trees should be under the guidance of a professional engineer experienced in the design and construction of earthen dams. The wet area (possibly underseepage) at the downstream toe should be investigated by an engineer experienced in the design and construction of dams.
